(NASA-CR-135169) AEROSPIKE THRUST CHAMBER  
PROGRAM Final Report (Rocketdyne) 167 p HC  
A08/MF A01 CSCL 21H

AEROSPIKE THRUST CHAMBER PROGRAM  
FINAL REPORT

by J. Campbell, Jr. and S. M. Cobb

ROCKETDYNE DIVISION  
ROCKWELL INTERNATIONAL

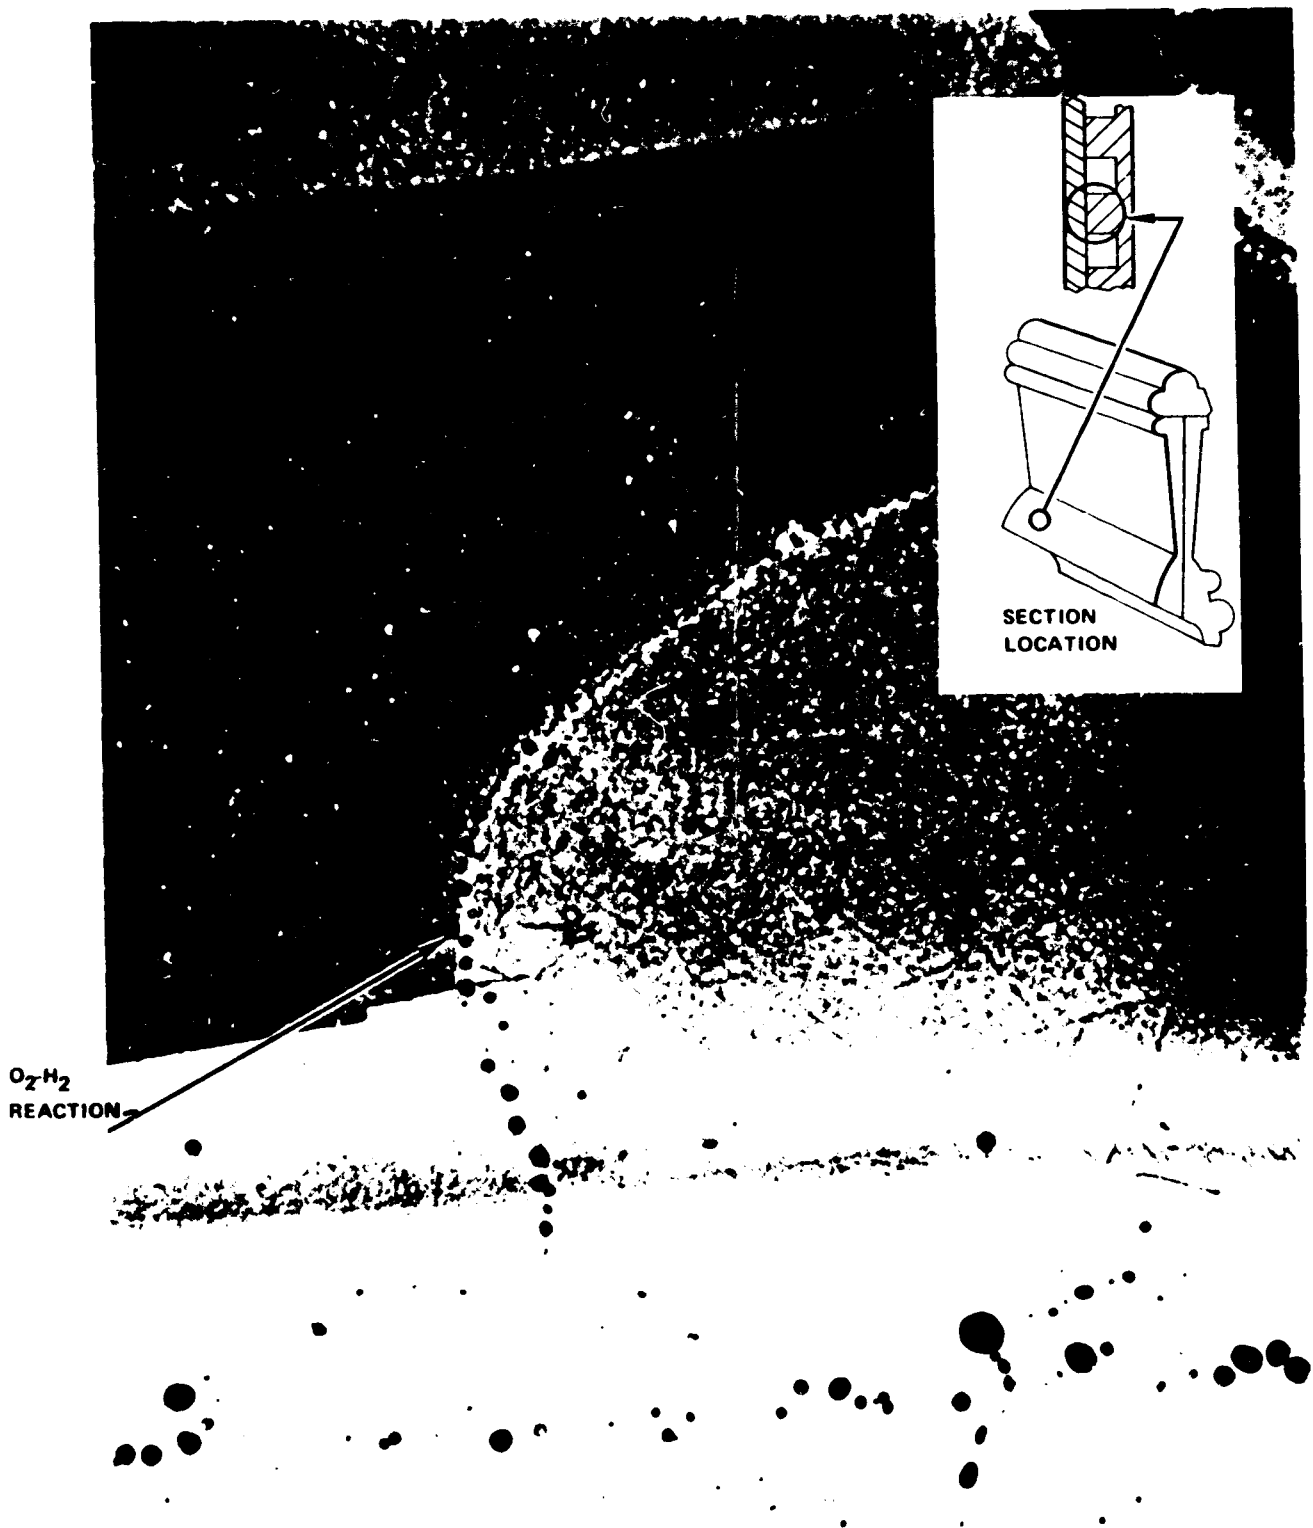
The NARloy-A cracking encountered on units 507R and 510R was so nontypical that it engendered a metallurgical and historical investigation, concurrent with the repair effort on 507R and 510R, to understand the problem and to assess its implications for all the combustors. Methods of removing samples from existing combustors were developed which permitted metallurgical examination of the NARloy material and, if necessary, replacement of the removed sample so as to be able to fire the combustor. Microscopic examination of these samples indicated that the fundamental cause of the cracking of 507R and 510R was that the NARloy material properties had been degraded by the reaction of hydrogen with previously dissolved oxygen. Figure 4 is a photomicrograph of material removed from unit 510R. It shows the voids along the grain boundaries that result when steam is formed. The source of hydrogen was readily ascribed to the hydrogen atmosphere furnace brazing that had been utilized during the initial fabrication of the combustors. An investigation was conducted as to the source of oxygen and it was determined that the most probable source was oxidation of the inner surfaces of **the liners** and cover-sheets during the initial fabrication (i.e., in 1974). This inner surface oxidation had apparently occurred despite the utilization of inert atmospheres during these operations and despite the imposition of well-developed disciplines for the maintenance of cleanliness.

The results of the metallurgical examination of all combustors sampled are presented in Table 2, which indicates a correlation between the presence of embrittled NARloy-A and the conduct of final brazing cycles in a hydrogen atmosphere. On the basis of the data displayed in Table 2, the conclusion appears inescapable that a large majority of the combustors have been affected by the hydrogen/oxygen phenomenon during their initial fabrication (prior to the start of this contract), and will display substantially reduced ductility under conditions of thermal strain. As it had been demonstrated during the repair procedures on 507R and 510R that the thermal strains involved in cryogenic testing did result in cracking of the embrittled NARloy, and as the test program planned for the thrust chamber assembly

Figure 4. Section Near Crack in Outer Half of Segment 510 (400X)

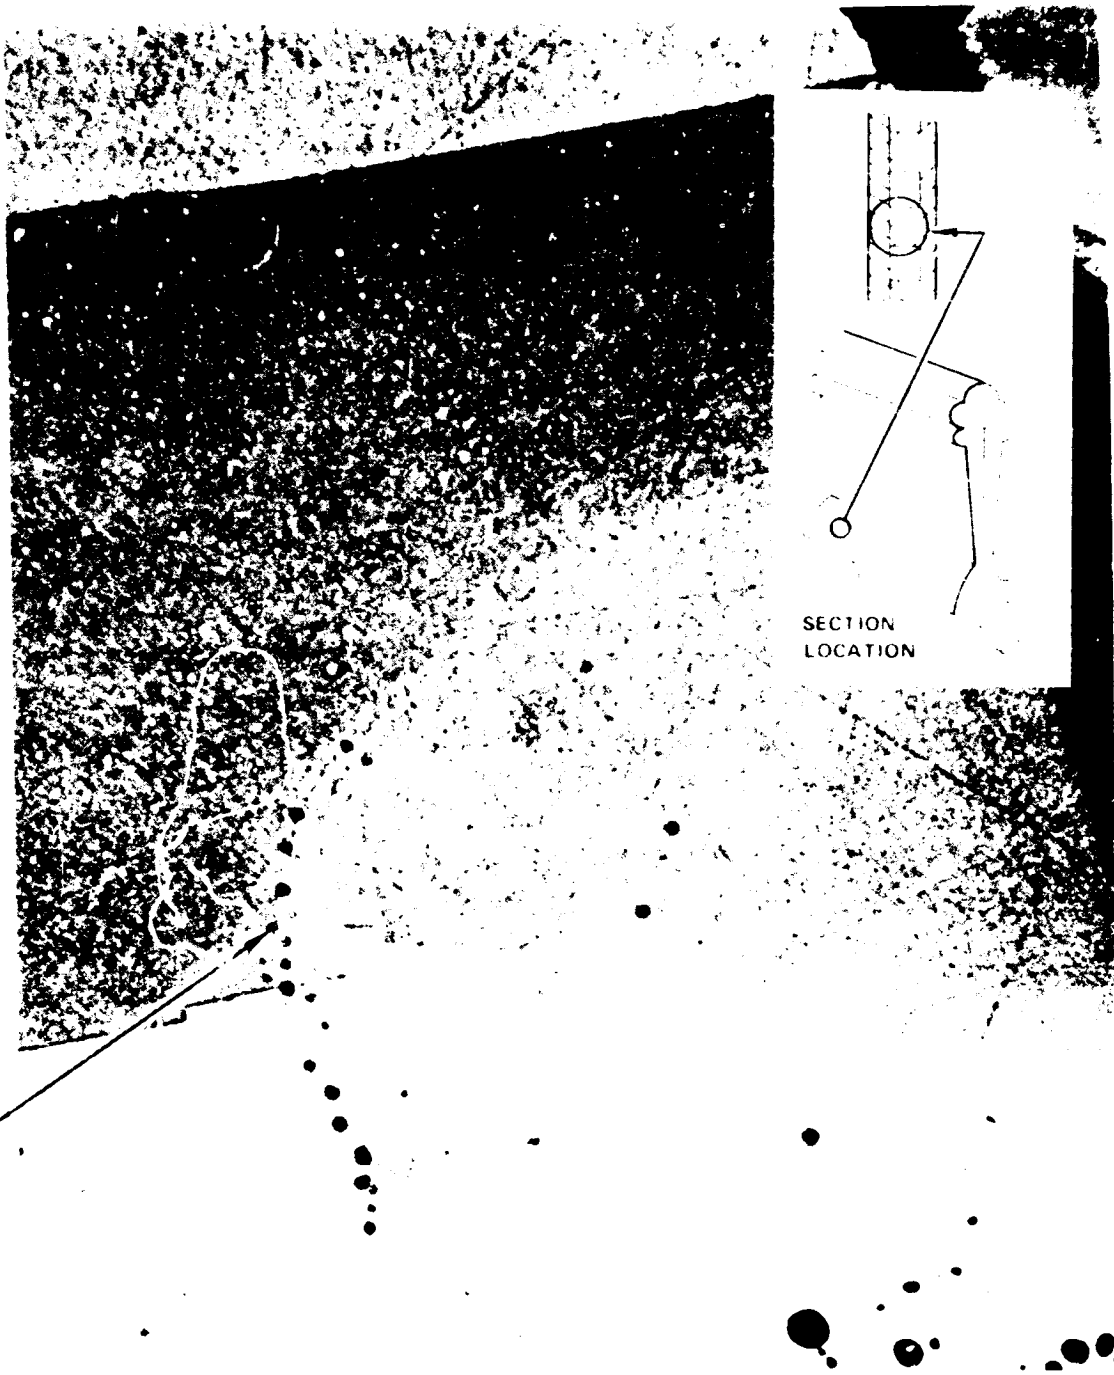
Figure 39. Section Near Crack in Outer Half of Segment 510 (400X)

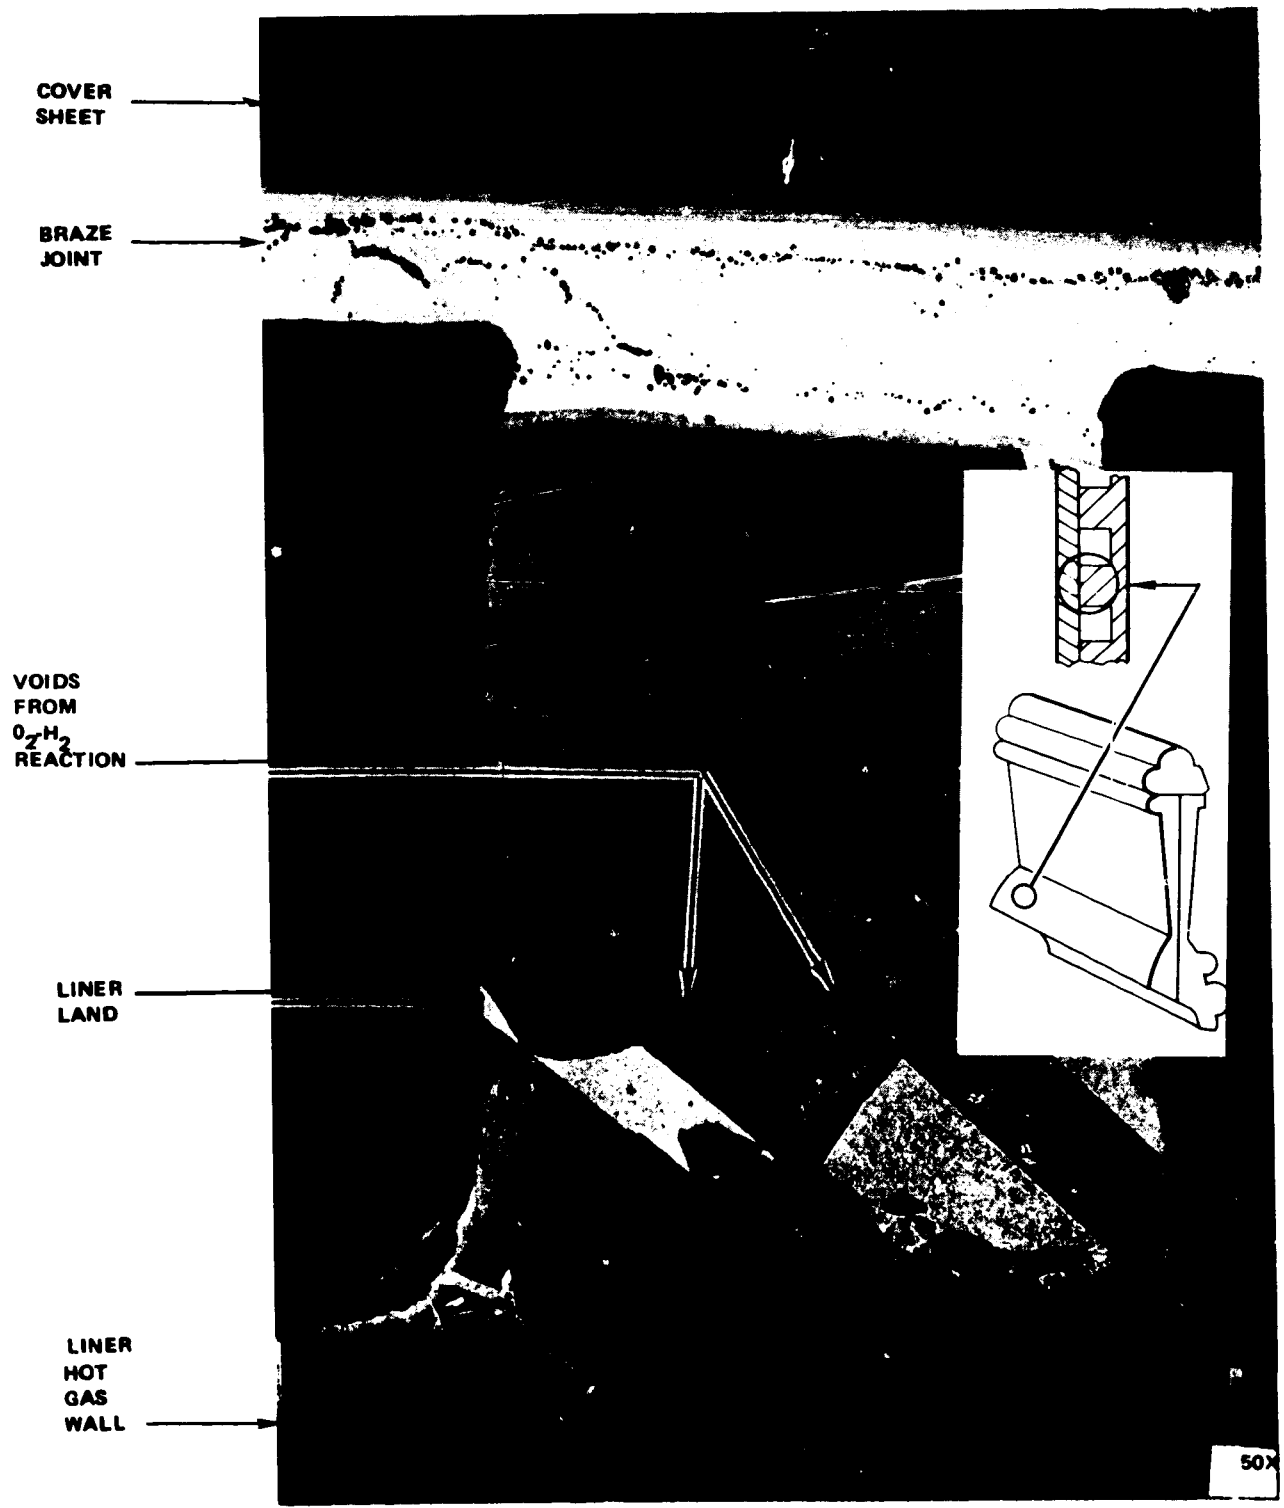
Figure 41. Section From Outer Half of Segment 514 Showing Severe O<sub>2</sub>-H<sub>2</sub> Reaction (100X)
