SPACE SHUTTLE MAIN ENGINE THE FIRST TEN YEARS

Bob Biggs
Project Engineer, SSME Systems Analysis
Rocketdyne Division, Rockwell International

*American Astronautical Society
National Conference & Annual Meeting
Nov. 2, 1989, Los Angeles*

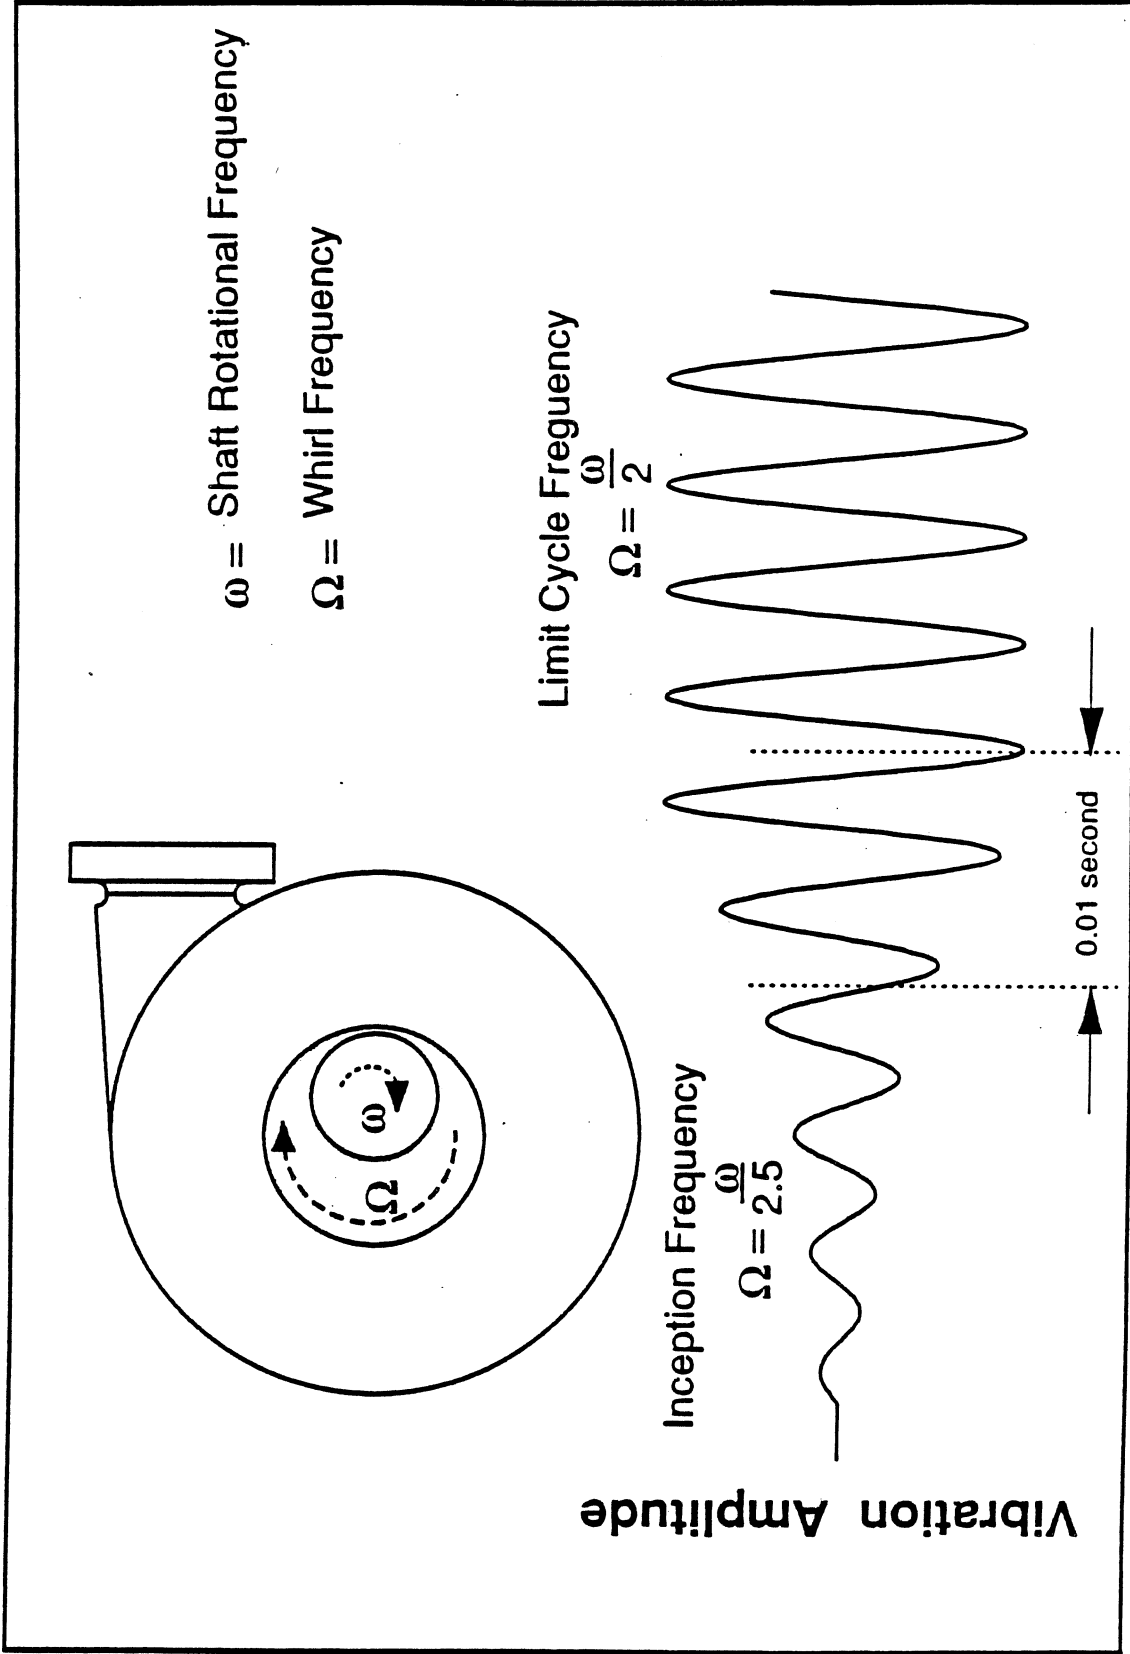
Figure 12. HPFTP Whirl Vibration Characteristics

The HPFTP subsynchronous whirl was a violent instability which caused a gyration of the rotor in the direction of normal rotation at a frequency of about half of the pump speed (see Figure 12). This caused a forward precession of the rotor, which was actually an orbiting of the normal rotating axis. Being a true instability, the whirl was self-initiating and would usually start when the pump speed exceeded twice the first critical speed of the rotating assembly, with an inception frequency equal to the first critical speed (originally about 8,500 RPM). The amplitude would increase rapidly; and within half a dozen cycles, with bending of the rather flexible rotor, the normal clearances would be breached and internal rubbing would occur at many locations. With clearances closed and bearing supports bottomed out, the system stiffness increased significantly, preventing further increase in amplitude (limit cycle) and raising the first critical speed and, therefore, the whirl frequency. Bearing loads in the limit cycle condition were higher on the turbine end than the pump end by a factor of three, and a significant number of turbine bearing failures were experienced.

As the design changes allowed operation at higher speeds, it became evident that the turbine bearings were being overheated by some mechanism unrelated to whirl. Instrumentation added to the turbopump to gain data for the whirl problem indicated that inadequate hydrogen coolant flow was allowing hot gas to backflow into the bearing. Detailed analysis of the cooling system finally identified the existence of a free vortex at the base of the pump shaft through which the coolant flow was provided. The addition of a baffle at this location changed the free vortex to a forced vortex and reduced the pressure loss from 500 psi to 12 psi [23]. With this change, and the whirl problem eliminated, the HPFTP was capable of supporting the engine test program in mid-January 1977. For the first time, the SSME could be tested for extended durations.

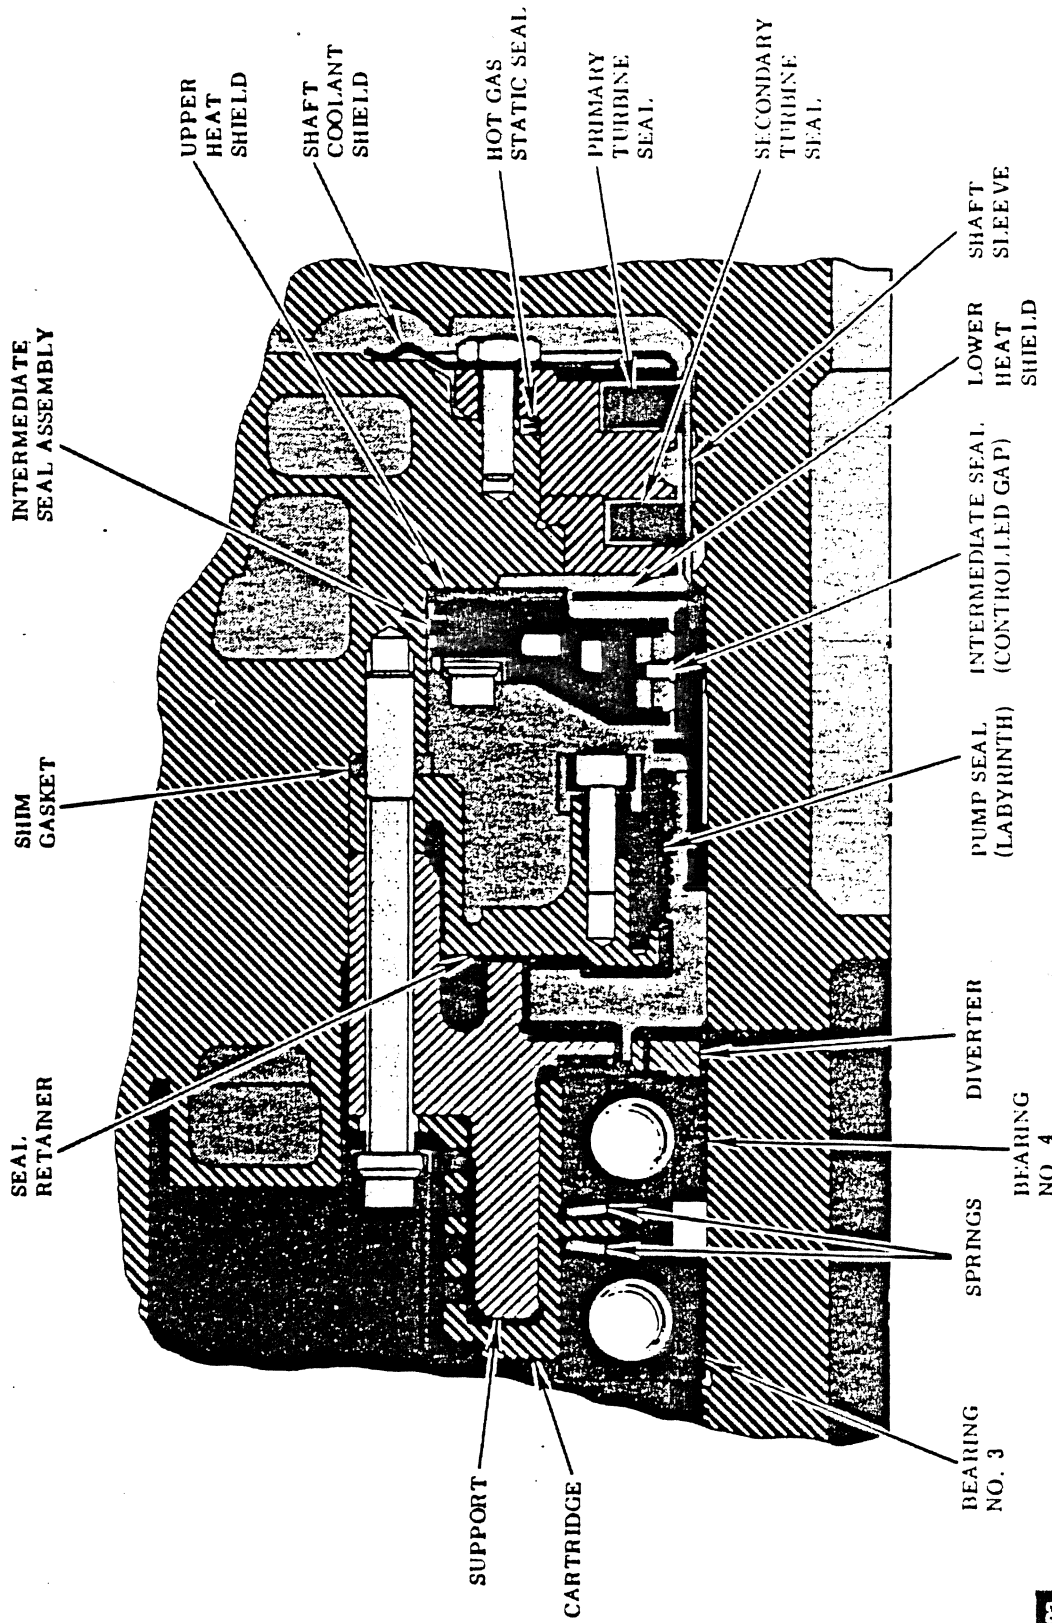
Figure 14. HPOTP Shaft Seals and Drains

located between the turbine end bearings and the second-stage turbine wheel (Figure 14). The turbine seal assembly is shown on the right-hand side of Figure 14, next to the second-stage turbine wheel. The turbine seal is comprised of two controlled-gap, self-centering carbon floating ring seals that are used with a shaft-mounted mating ring. The space between the two seals is vented through fourteen flow passages to the primary turbine seal overboard drain line. All of the primary turbine seal leakage is vented through this system to the thrust chamber nozzle exit plane. The primary LOX seal is a three-step, shaft-mounted labyrinth seal used with a stationary plastic (Kel-F) wear ring. A slinger is used at the inlet of the primary LOX seal to isolate it from the turbine end bearing coolant inlet pressure and to convert potential leakage flow from a liquid to a gas. The downstream side of the primary LOX seal is vented through eleven radial flow passages to the primary LOX seal overboard drain line. Additional isolation is provided between the turbine seal assembly and the primary LOX seal by the intermediate seal assembly. The intermediate seal assembly is a pair of controlled-gap, self-centering carbon floating ring seals with a shaft-mounted mating ring. The annular space between the two rings is purged with high pressure helium at a flow rate of 260 standard cubic feet per minute (scfm). The helium flow is split between the two intermediate seals with part of it flowing out the primary LOX seal drain line and part of it out of the intermediate seal drain line (a vent between the intermediate seal and the secondary turbine seal). This system is backed up by the control system by monitoring two pressure measurements for engine shutdown if the predetermined limits (redlines) are exceeded. The system is designed to operate safely with any one of the seals missing and with both redlines at the limit simultaneously.

On March 24, 1977, Test 901-110 on Engine 0003 experienced a major fire [24]. With the instrumentation being used for the Engine 0003 test series, it was possible to conclude that the fire originated in the general area of the HPOTP primary LOX seal drain cavity. Due to the severity of the fire, however, little physical evidence remained (Figure 15). The configuration of the primary LOX seal was significantly different from the eventual flight (and current) configuration. The seal was a bellows-loaded hydrodynamic liftoff seal. Under static conditions, a positive seal was maintained by the load applied to the seal face from the bellows. Under operation, the design of the seal face was such that fluid was forced into small depressions (Rayleigh steps), which provided a hydrodynamic lift and caused the seal to operate in an almost closed but not touching position. Several failures of this seal were hypothesized to have caused the HPOTP fire. They were: loss of hydrodynamic lift, resulting in rubbing and subsequent ignition; failure of the bellows weld, allowing gross LOX leakage; seal instability, causing interference with the shaft axial balance; and seal contamination. Other hypothesized failures were all related to communication between the LOX drain and the hot gas system because of sneak leak paths, manufacturing defects, or unknown high pressure differentials [24].

No clear, concise redesign was evident or forthcoming. It was, therefore, decided to take steps to guard against all of the hypothesized failure modes and resume testing with additional instrumentation directed toward better understanding of the primary LOX seal environment. Low resistance drain lines were installed and the intermediate seal purge flow rate was increased by a factor of ten, from 50 scfm to 500 scfm. (This was later dropped to 260 scfm by reducing the diameter of the intermediate seal [25]). The instrumentation included nine new redlines to provide detection of abnormalities.

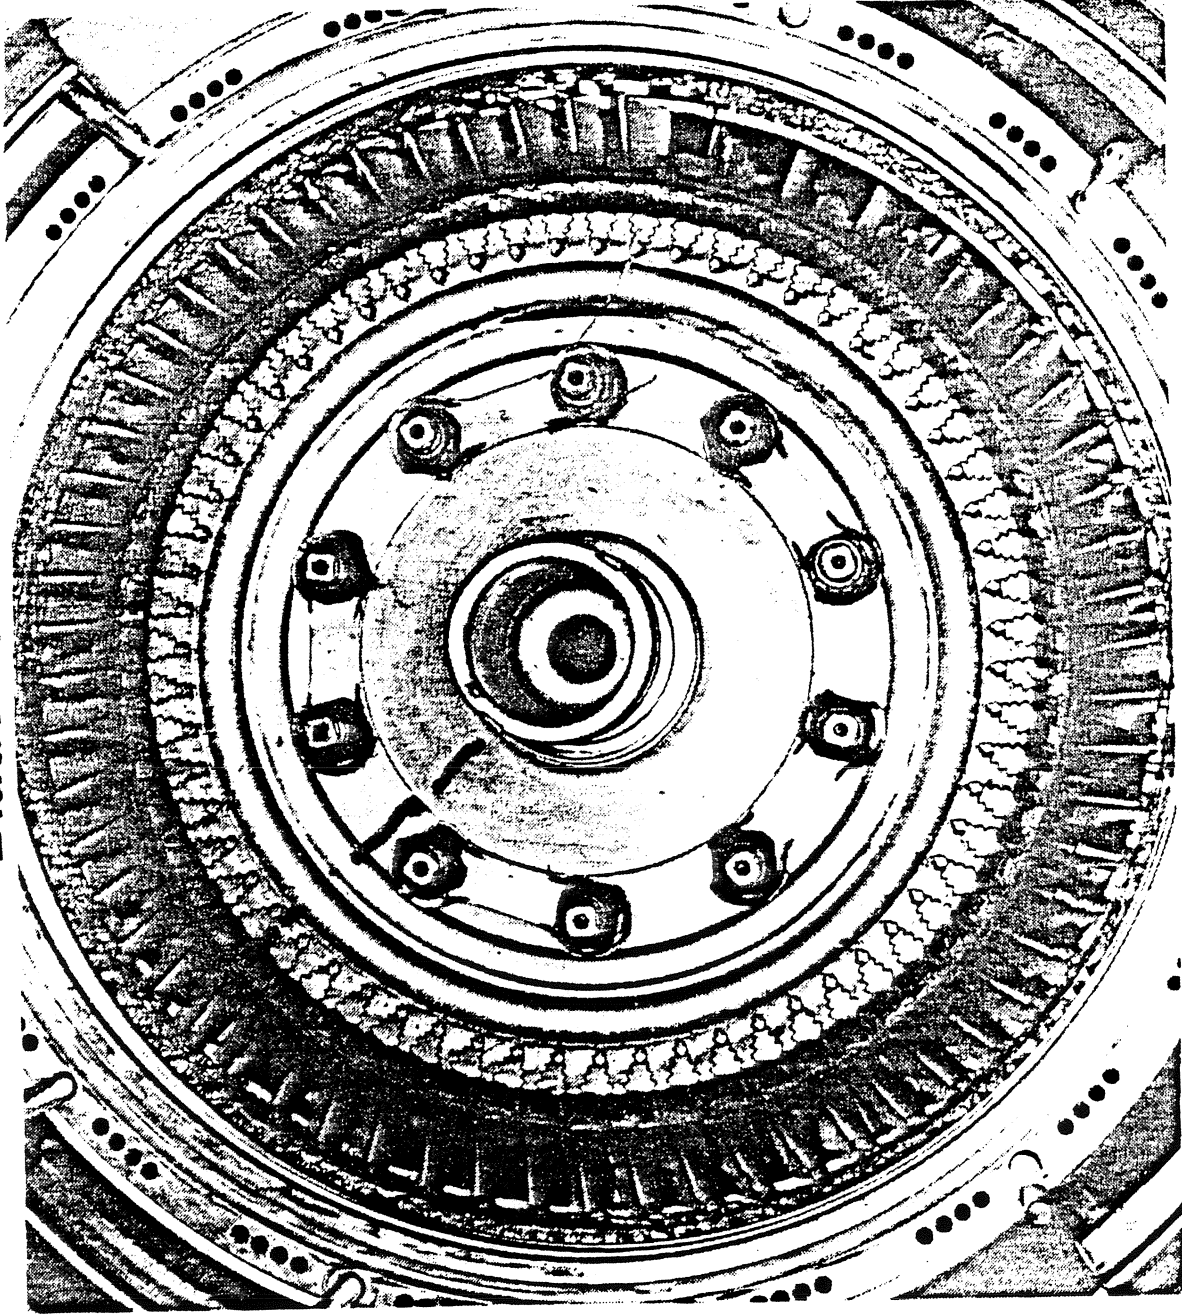
Figure 17. HPFTP First Stage Turbine - Test 902-095

Blade Failure

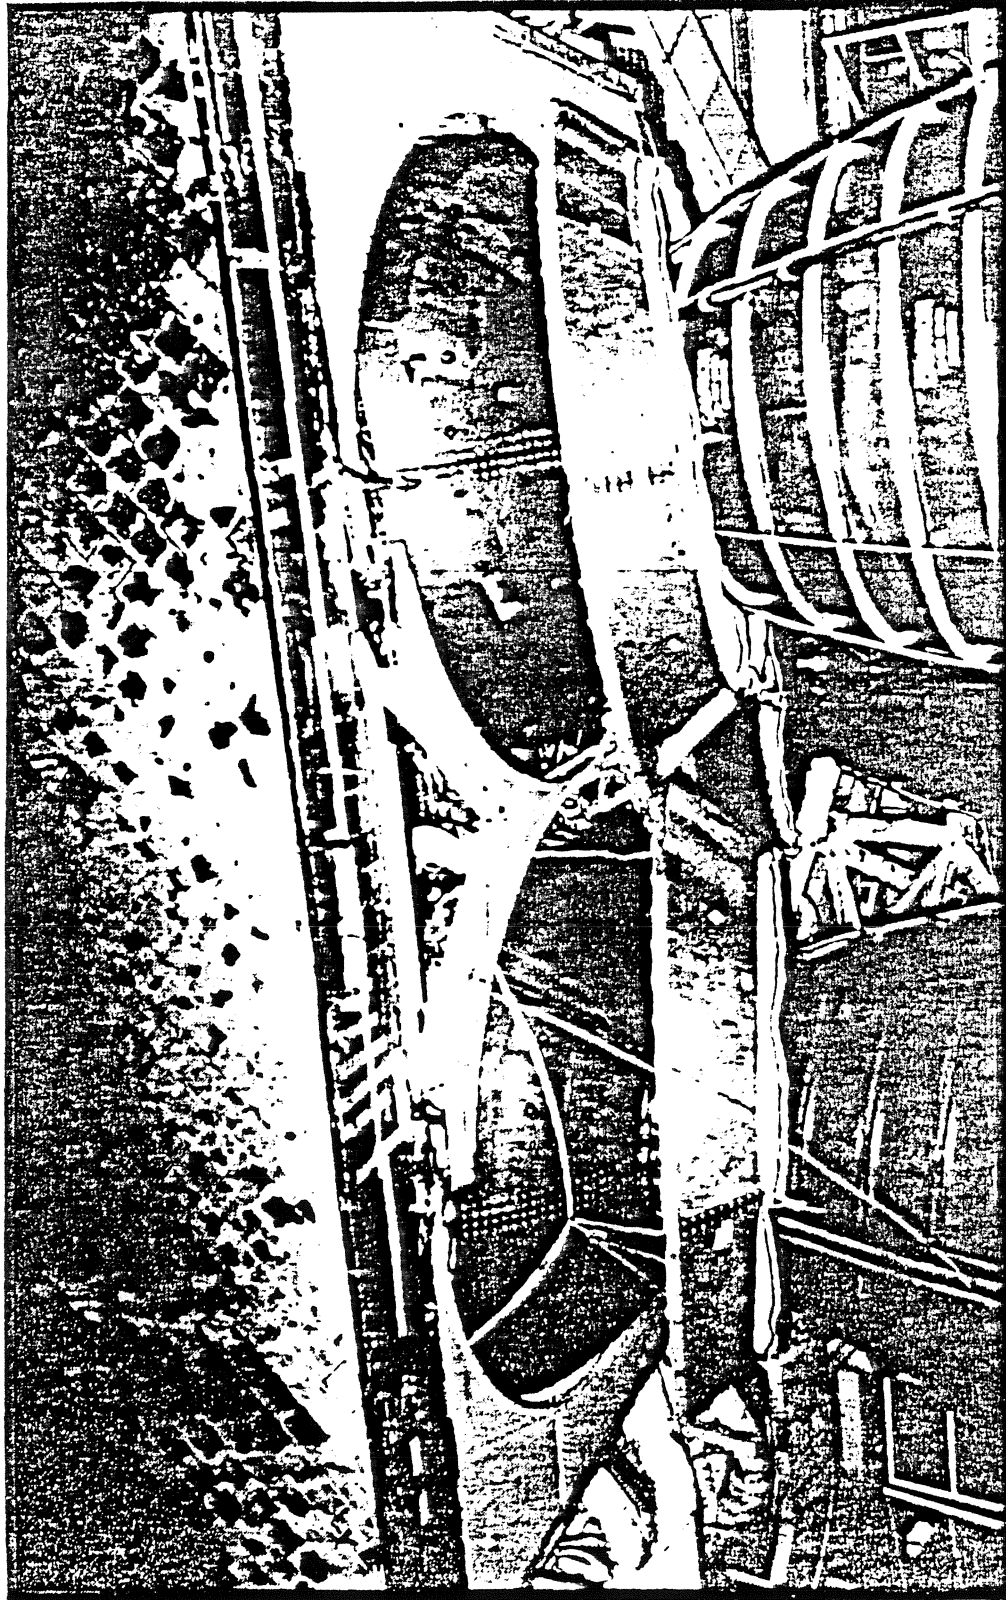
Overall View of Orbiter Heat Shield Damage on Engine Positions 1 & 2

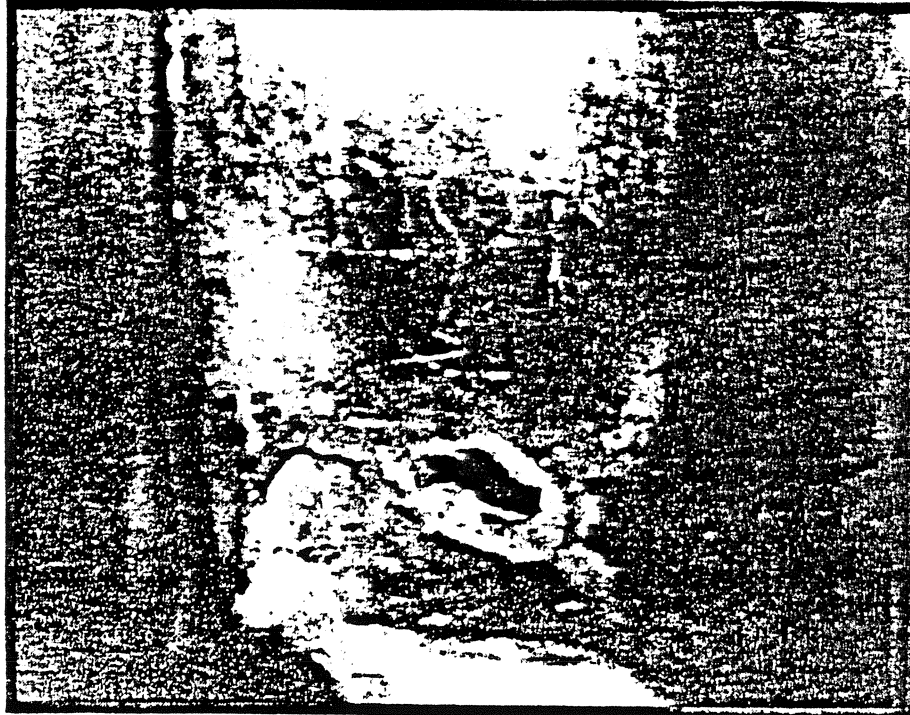
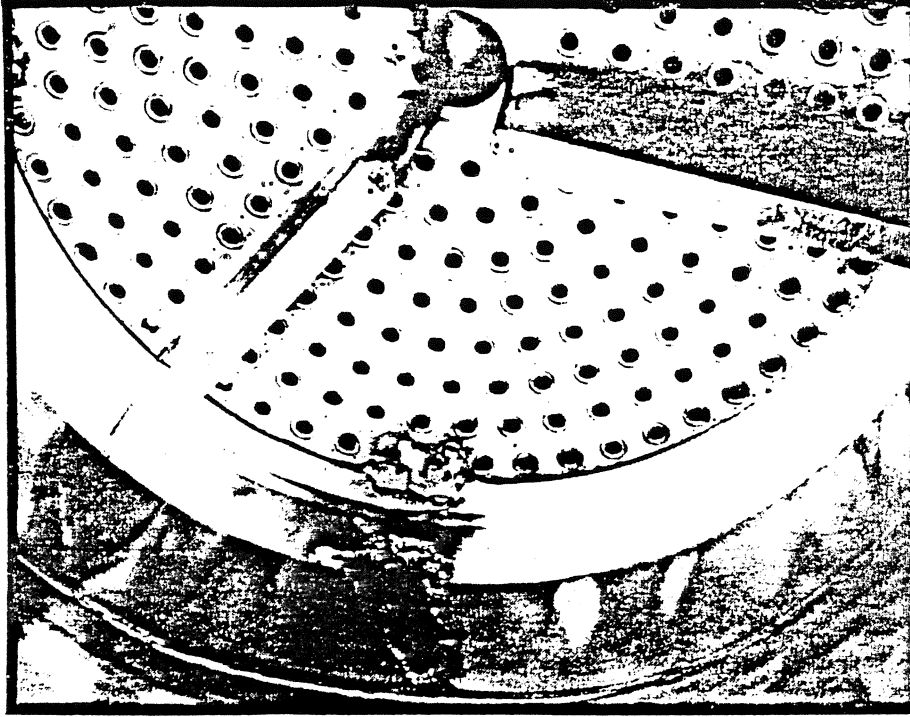
Engine 0006 Fuel Preburner

concluded from inspection of all other preburners that the bowed condition was unique to the failed unit. In addition, a review of historical problem reports disclosed that this FPB had experienced more reported cases of overheating or minor erosion than all other preburners combined. The cause of the deformity was never identified; however, periodic inspections were added for all preburners to verify outer row element concentricity in the future.

Even though the failure was caused by a unique hardware condition, a major effort was undertaken to preclude additional occurrences of this type of problem by making the preburner insensitive to maldistribution of the propellants. A two-dimensional, four times scale, water-flow model was constructed and tested to evaluate propellant streamlines in the outer row and along the liner wall. Two flow paths were discovered which could contribute to burning if the localized gases were at a higher mixture ratio. A recirculation field existed along the liner wall for about three inches (twelve inches on the water table) which disrupted the local boundary layer and increased the potential heat transfer. The flow path was found to be caused by the existence of an empty space along the faceplate between the element and the liner. The recirculation was eliminated by the incorporation of a new liner which added a divergent section on the inside of the liner to occupy the empty space. To further reduce the potential heat transfer to the liner, the new liner was coated with zirconium oxide. Another flow path was found which would cause hot gas to flow into the coolant circuit between the liner and the FPB body. With a small axial gap between the liner and the faceplate, the fluid at the faceplate would be forced by an adverse pressure gradient to flow through the gap into the coolant circuit. The new liner included coolant flow control orifices which assure that the coolant flow pressure is always higher than the hot gas pressure. This favorable pressure gradient prevents flow through any gap and also acts as an erosion inhibitor by automatically cooling any small hole in the liner with additional hydrogen.
