SPACE TRANSPORTATION SYSTEM
Johnson Space Center, 2101 NASA Parkway
Houston
Harris County
Texas

HAER TX-116
HAER TX-116

SPACE TRANSPORTATION SYSTEM HAER No. TX-116

Report Prepared by: Joan Deming, Principal Investigator
Patricia Slovinac, Architectural Historian
Archaeological Consultants, Inc. (ACI)
8110 Blaikie Court, Suite A
Sarasota, Florida 34240

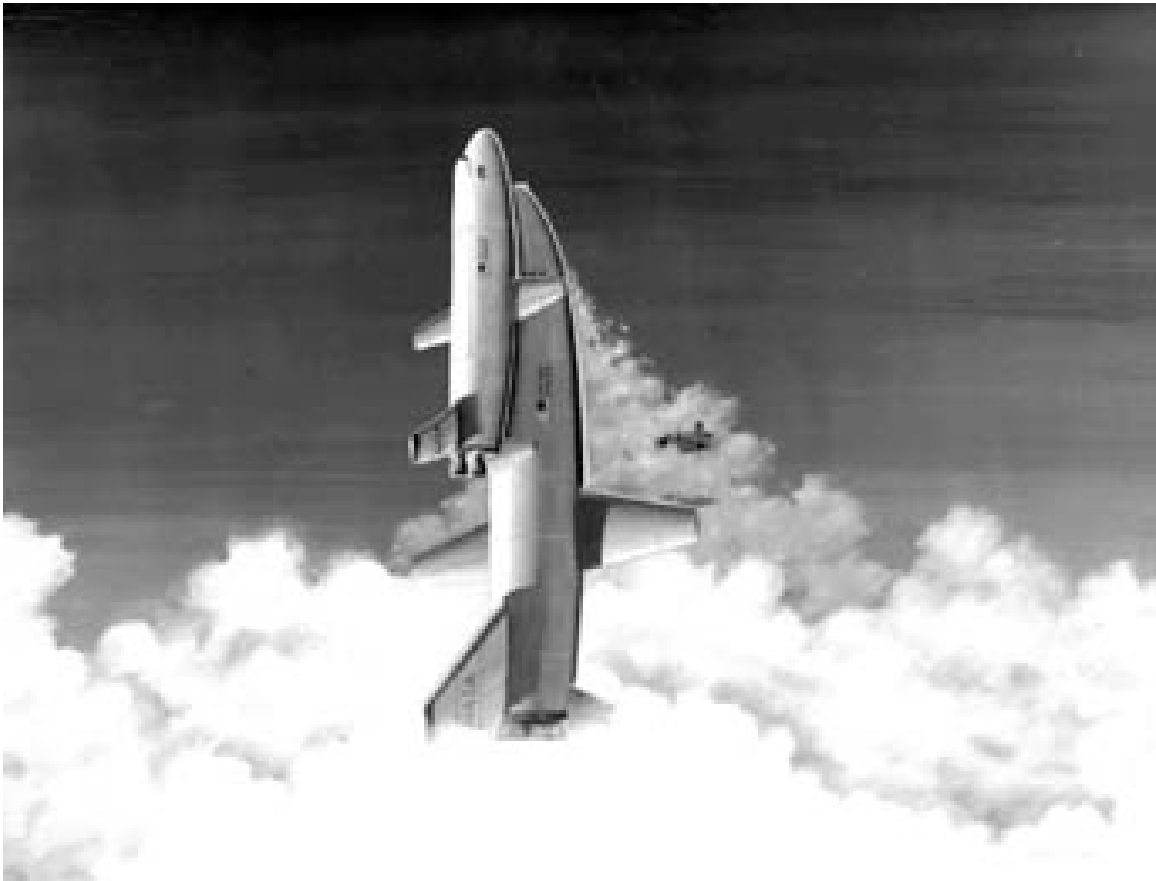
Figure No. A-3. Maxime Faget's straight wing design.
Source: NASA, as printed in T. A. Heppenheimer's, *The Space Shuttle Decision*, 208.

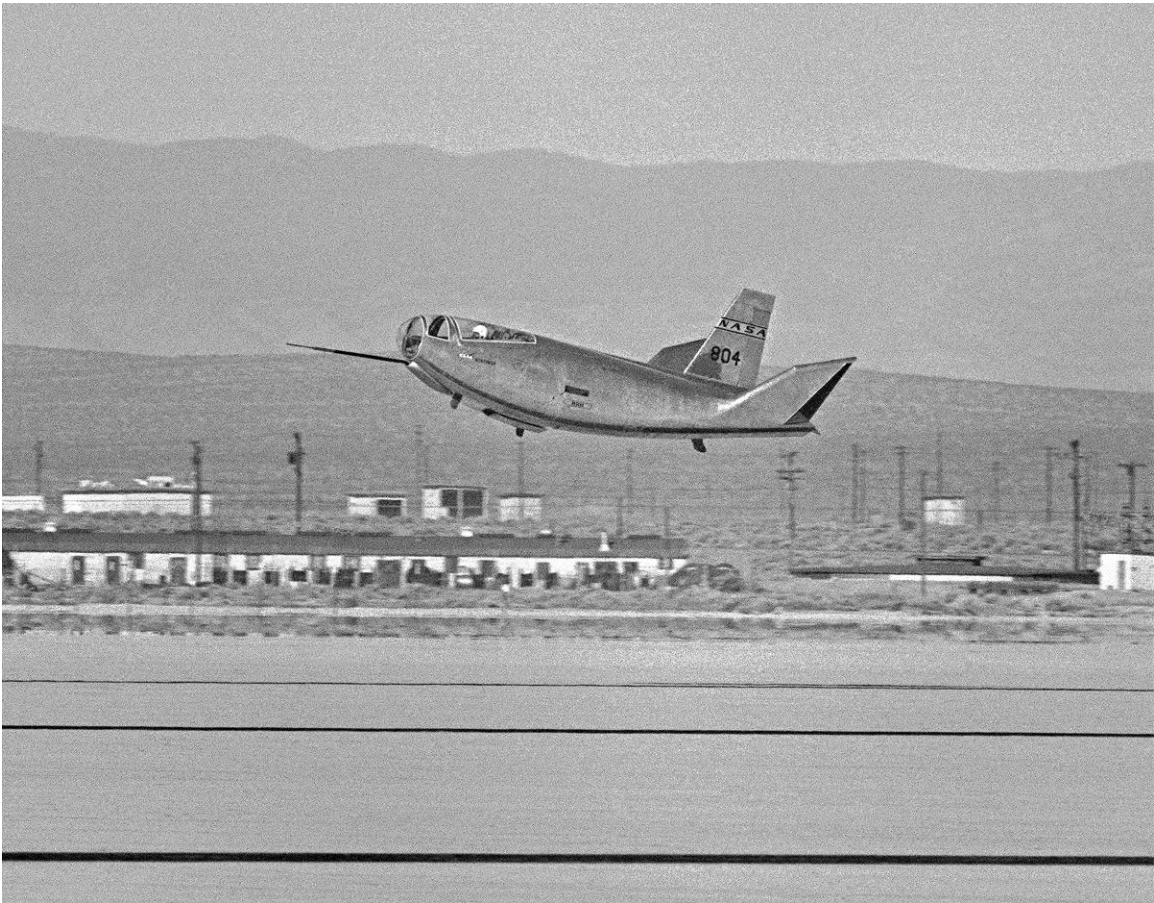
Figure No. A-4. First landing of a HL-10 lifting body, 1966.
Source: NASA Dryden Flight Research Center, E-16207, accessed May 2012, at
<http://www.dfrc.nasa.gov/gallery/photo/HL-10/Small/E-16207.jpg>.

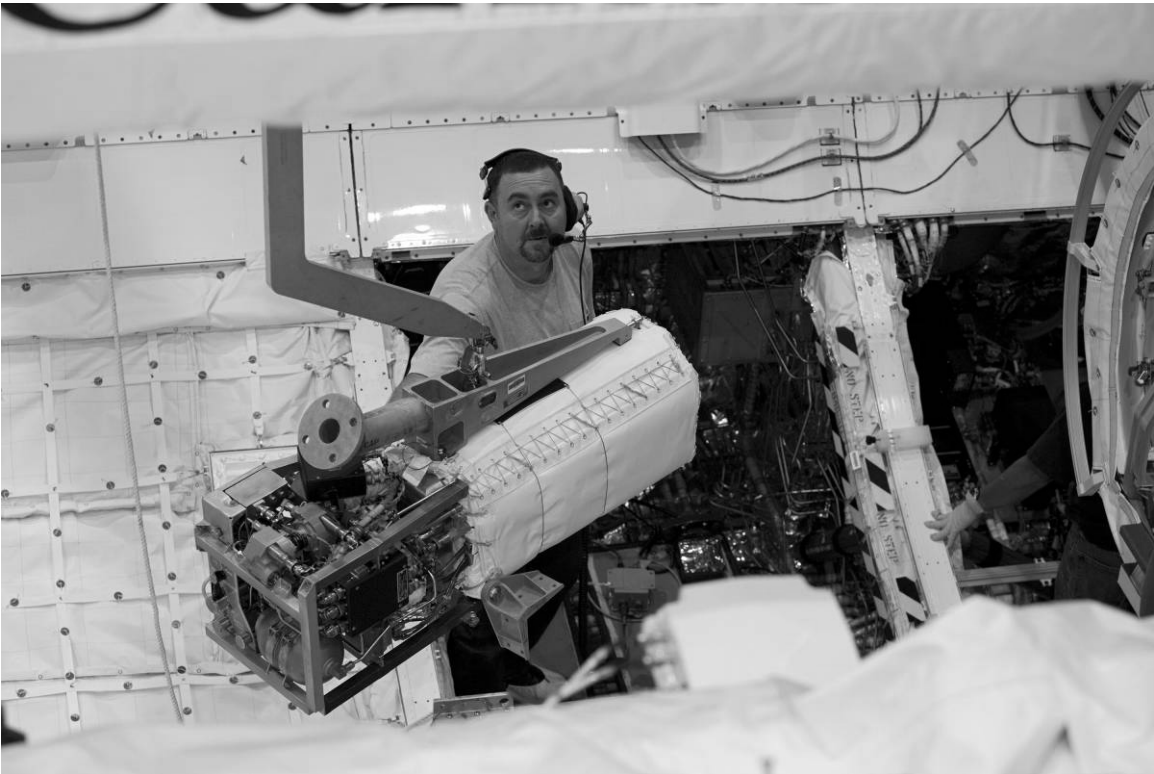
Figure No. A-24. Installation of a replica shuttle main engine into *Discovery's* aft fuselage. Three replica engines were installed as part of the shuttle transition and retirement efforts, December 5, 2011.

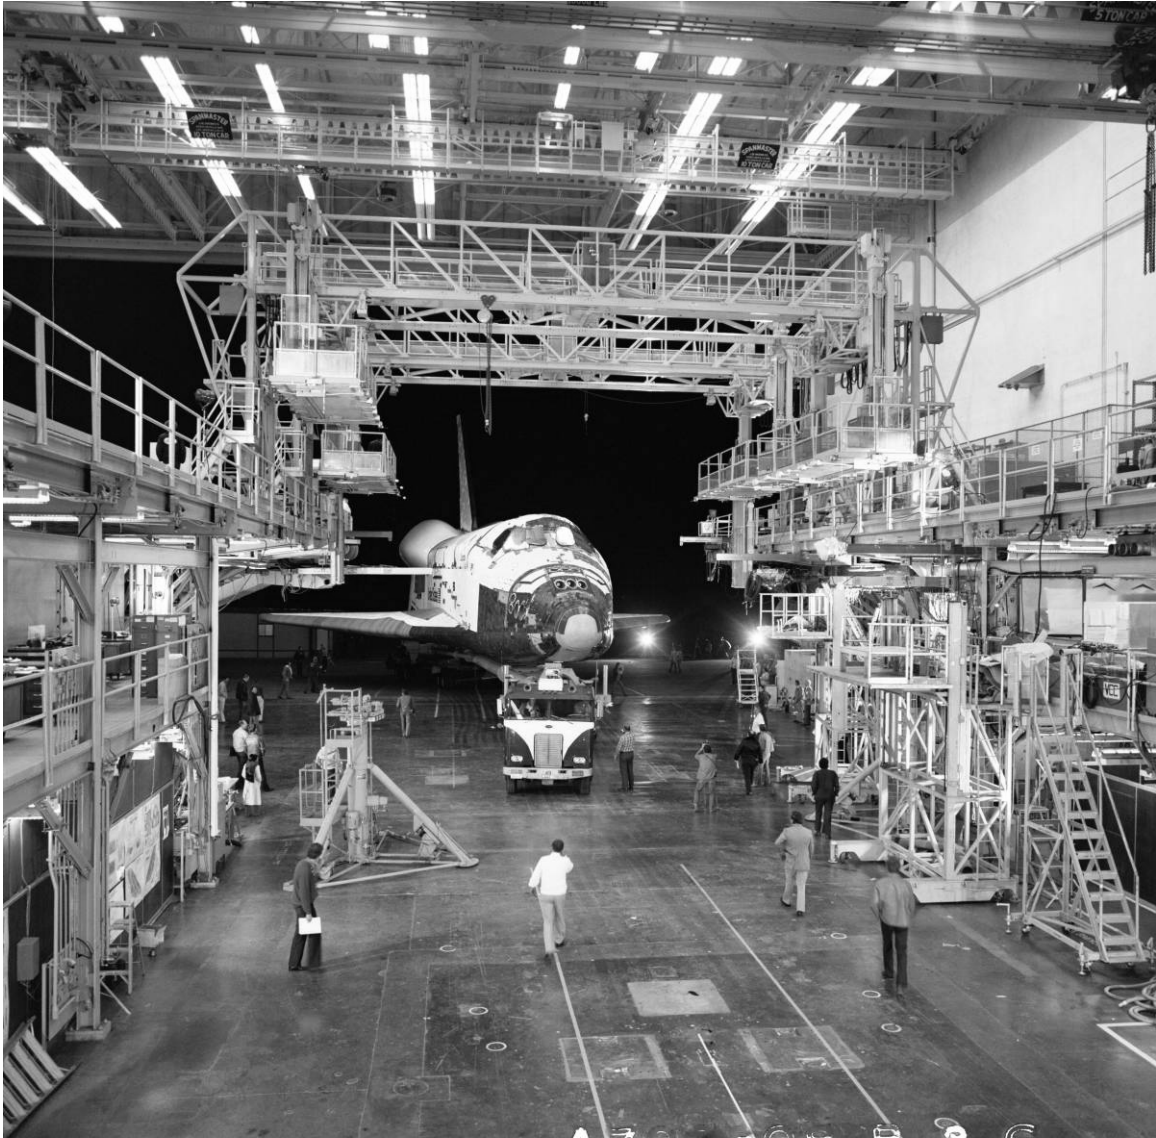
Figure No. A-28. STA-099 at Lockheed Martin for testing, February 17, 1978.
Source: NASA, Johnson Space Center Image Repository, JSC2010-02304.

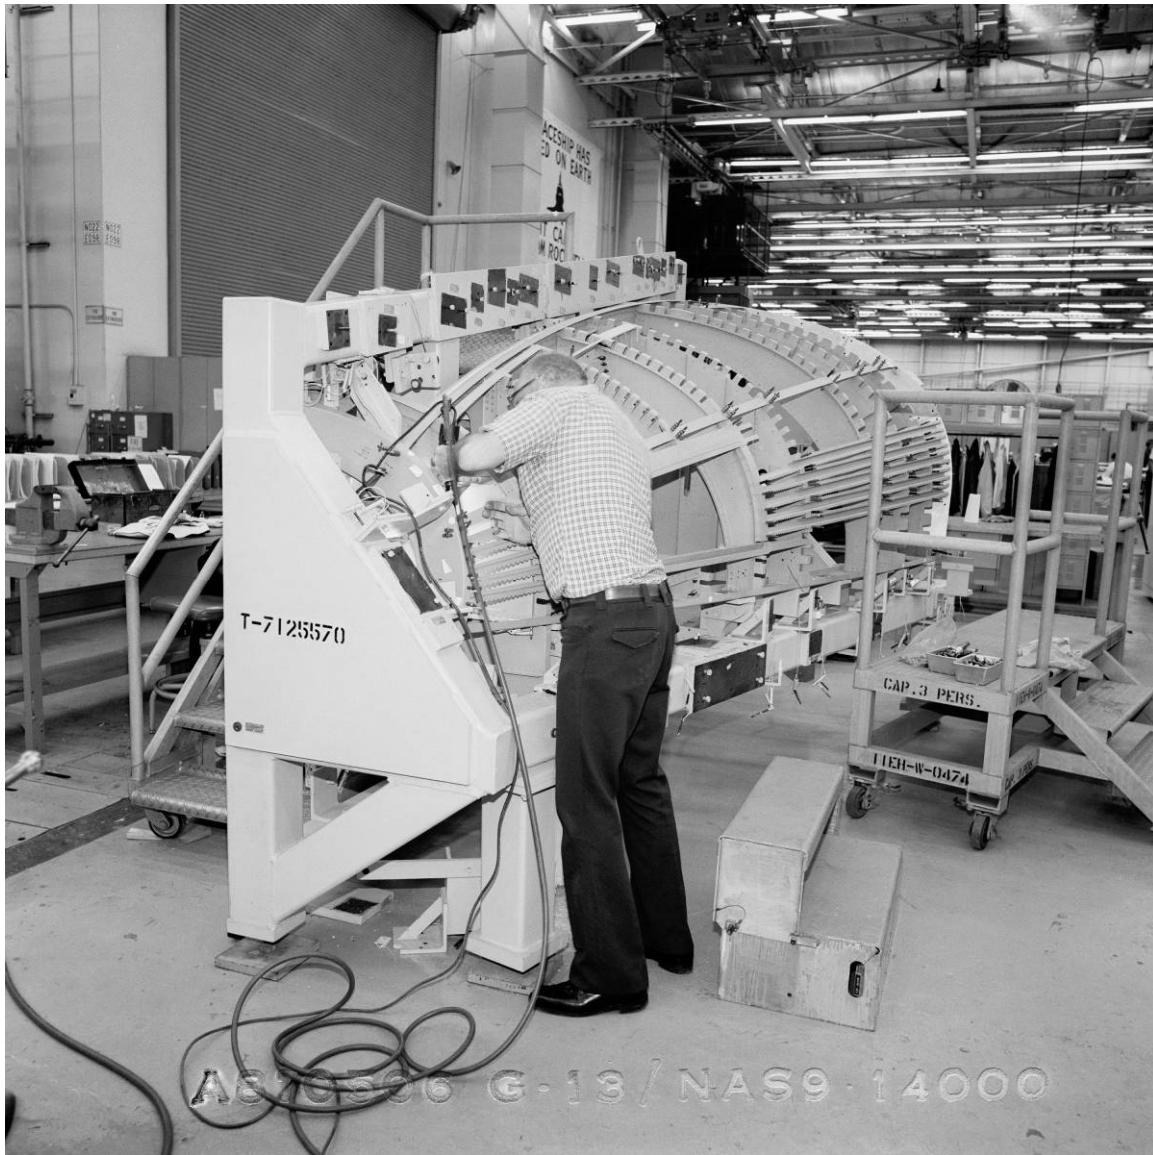
Figure B-1. Manufacturing of *Discovery's* lower forward fuselage, NAR Building 290, Downey, California, May 6, 1981.
Source: NASA, Johnson Space Center Image Repository, JSC2010-03096.

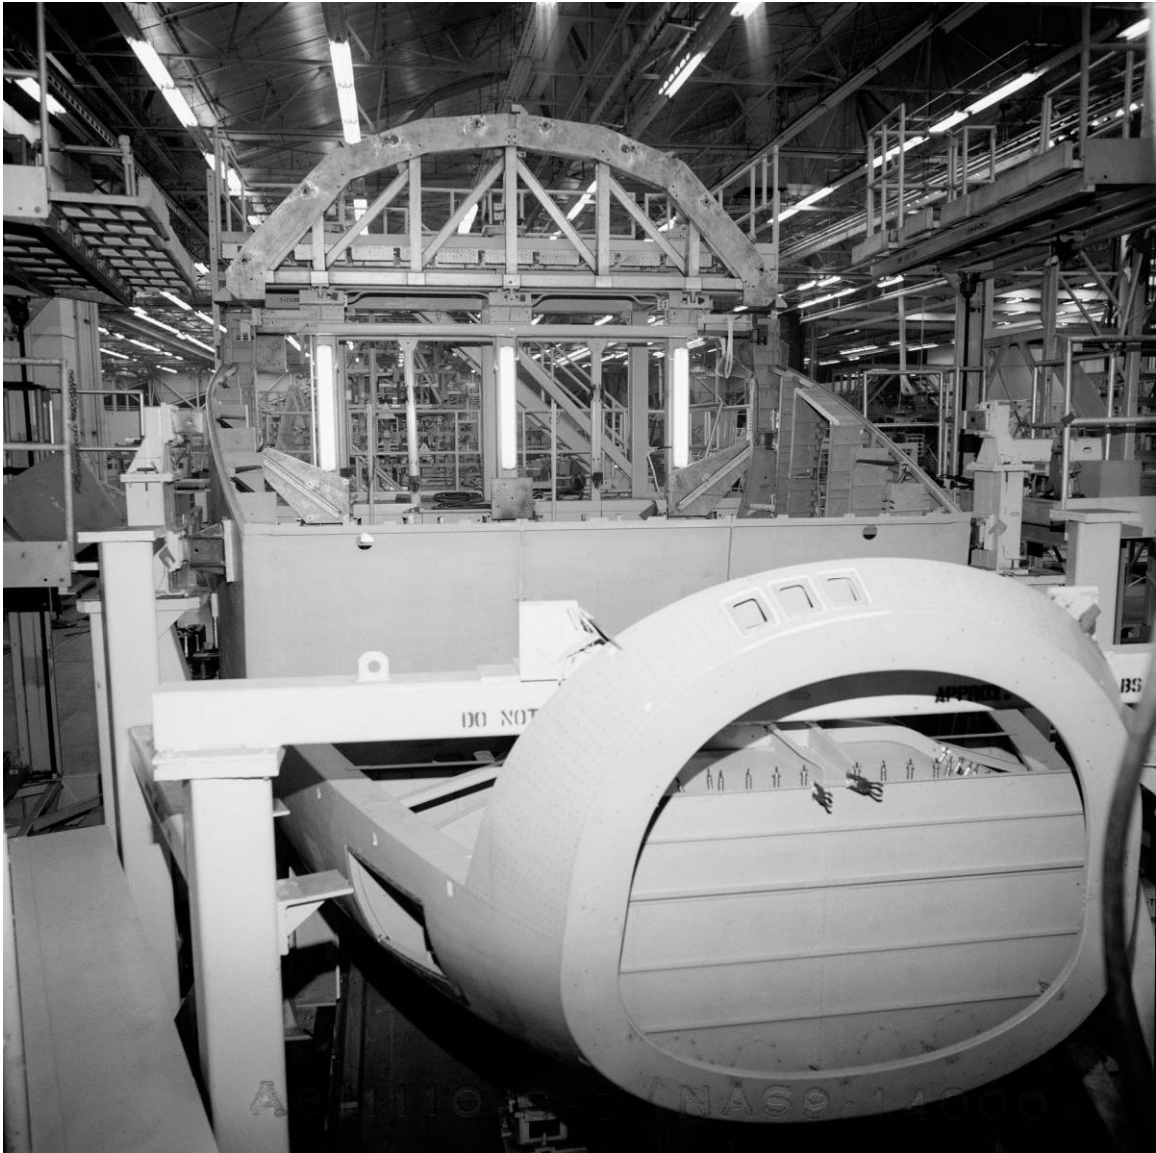
Figure B-2. Manufacturing of *Discovery's* lower forward fuselage, NAR Building 290, Downey, California, November 10, 1981.
Source: NASA, Johnson Space Center Image Repository, JSC2010-03198.

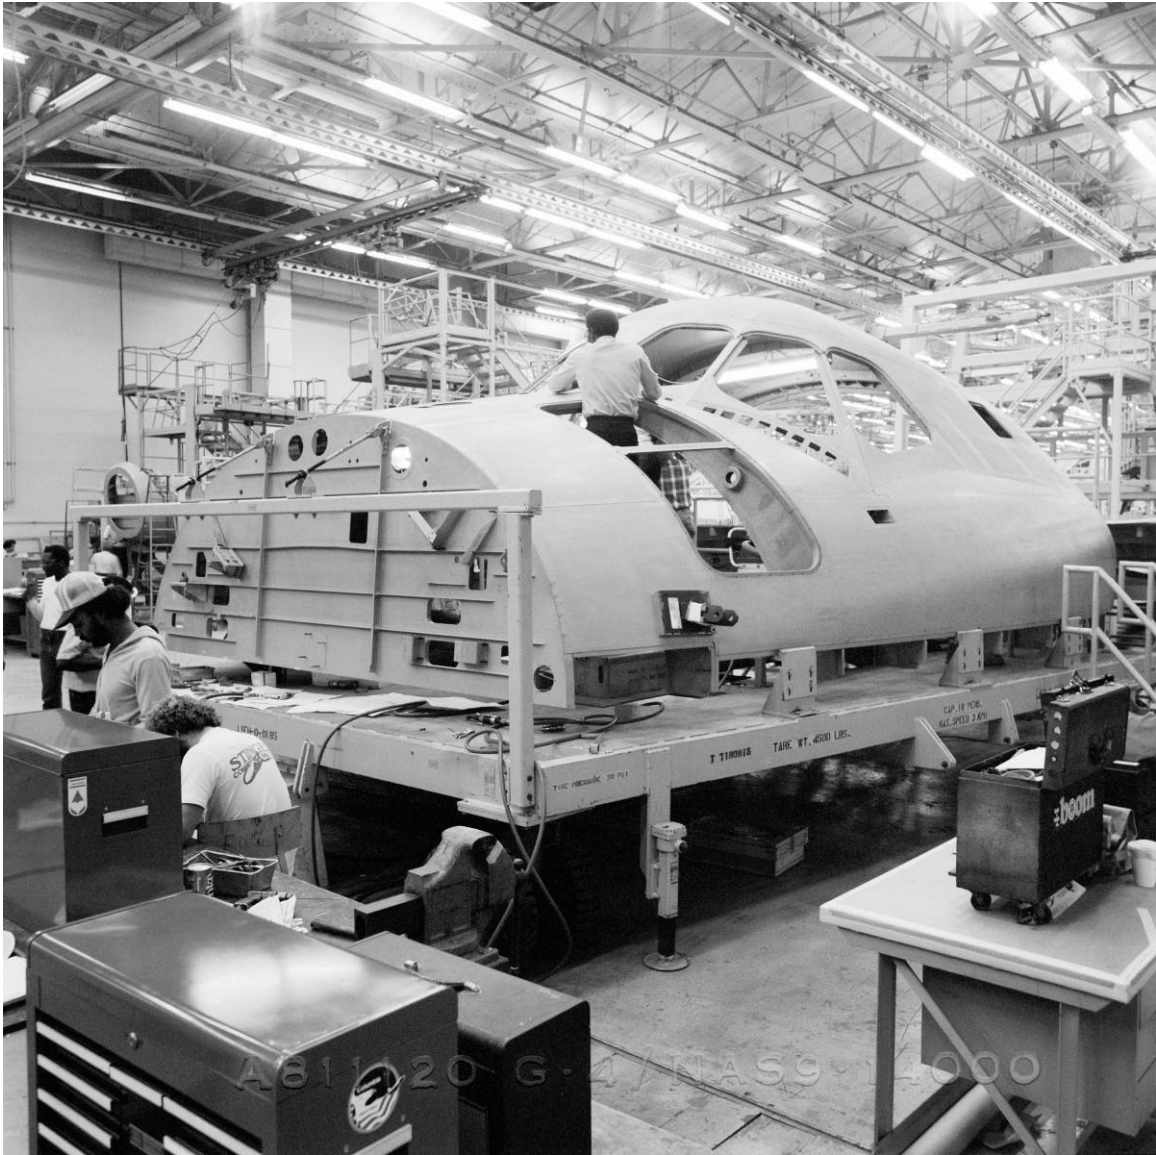
Figure B-4. Manufacturing of *Discovery's* upper forward fuselage, NAR Building 290, Downey, California, November 20, 1981.
Source: NASA, Johnson Space Center Image Repository, JSC2010-03204.

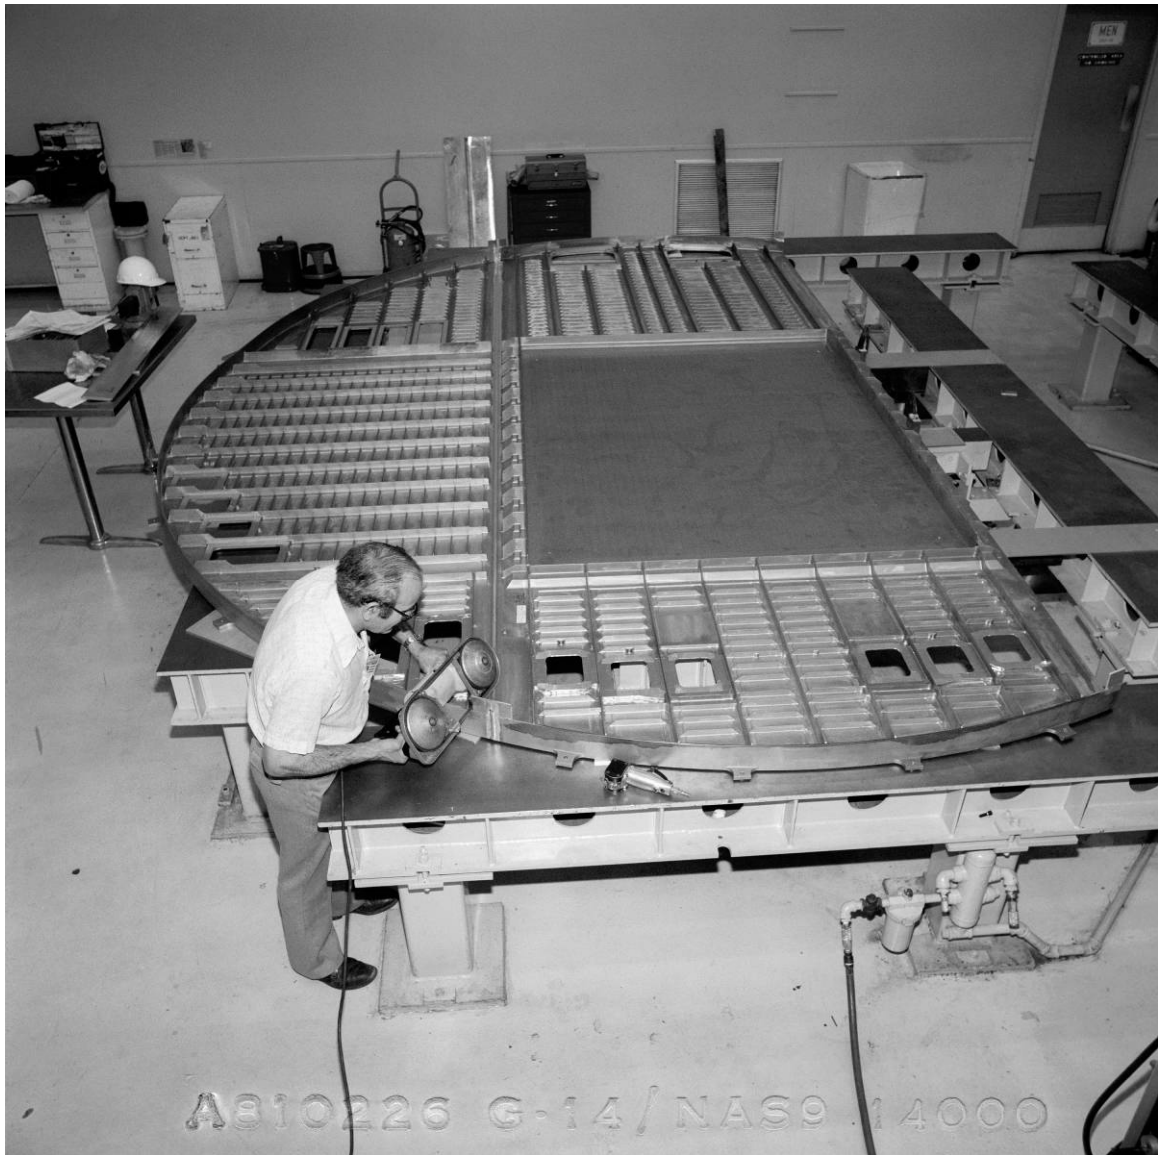
Figure B-5. Manufacturing of *Discovery's* crew module aft bulkhead, NAR Building 290, Downey, California, February 26, 1981.
Source: NASA, Johnson Space Center Image Repository, JSC2010-03081.

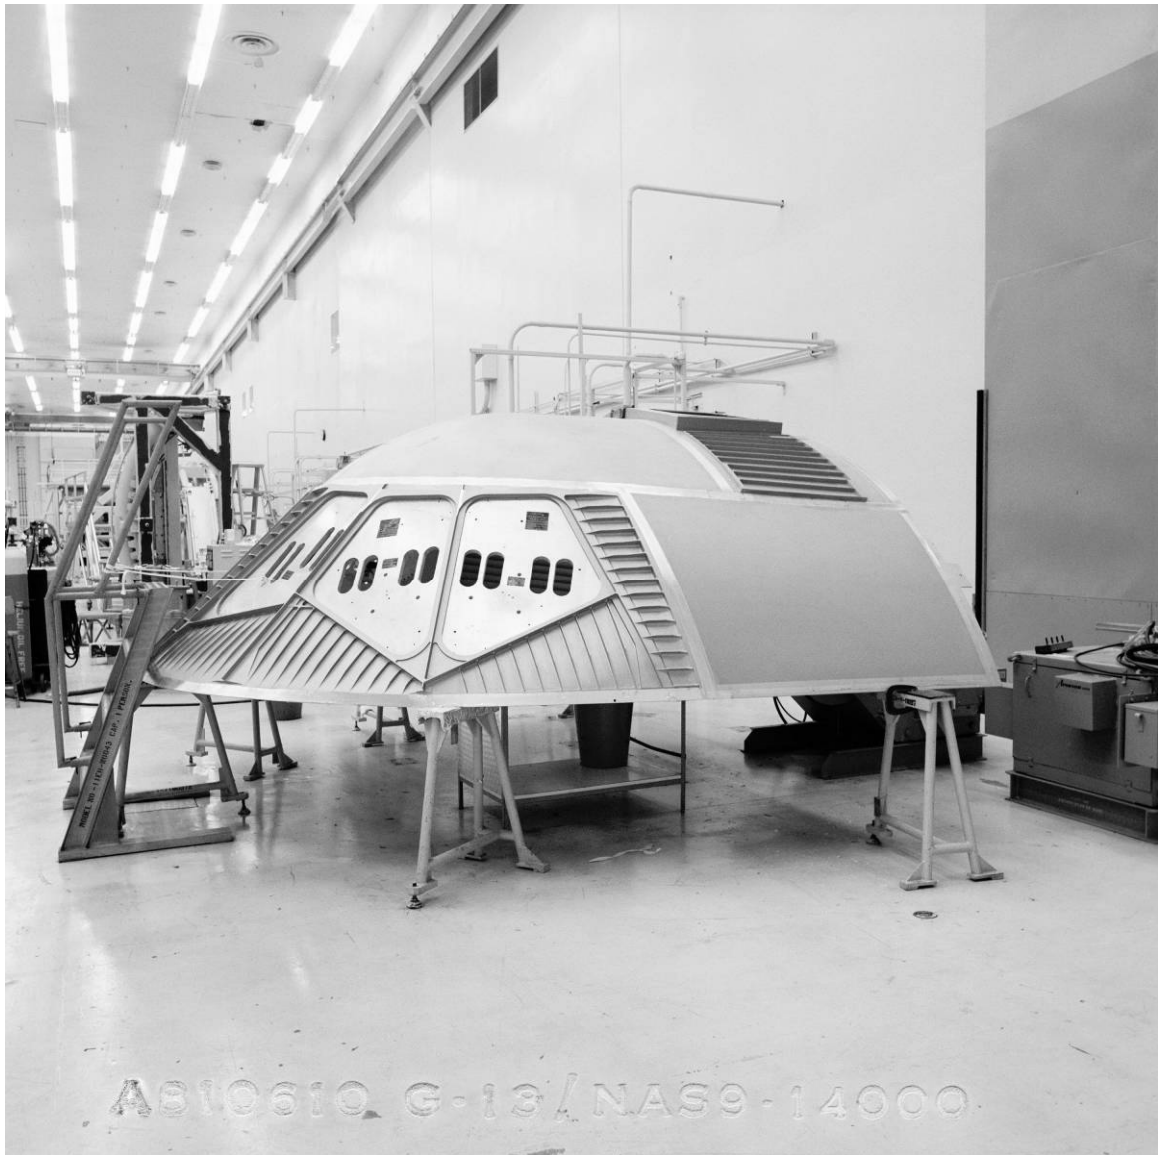
Figure B-6. Upper skin panel assembly for *Discovery's* crew module, NAR Building 290, Downey, California, June 10, 1981.
Source: NASA, Johnson Space Center Image Repository, JSC2010-03105.

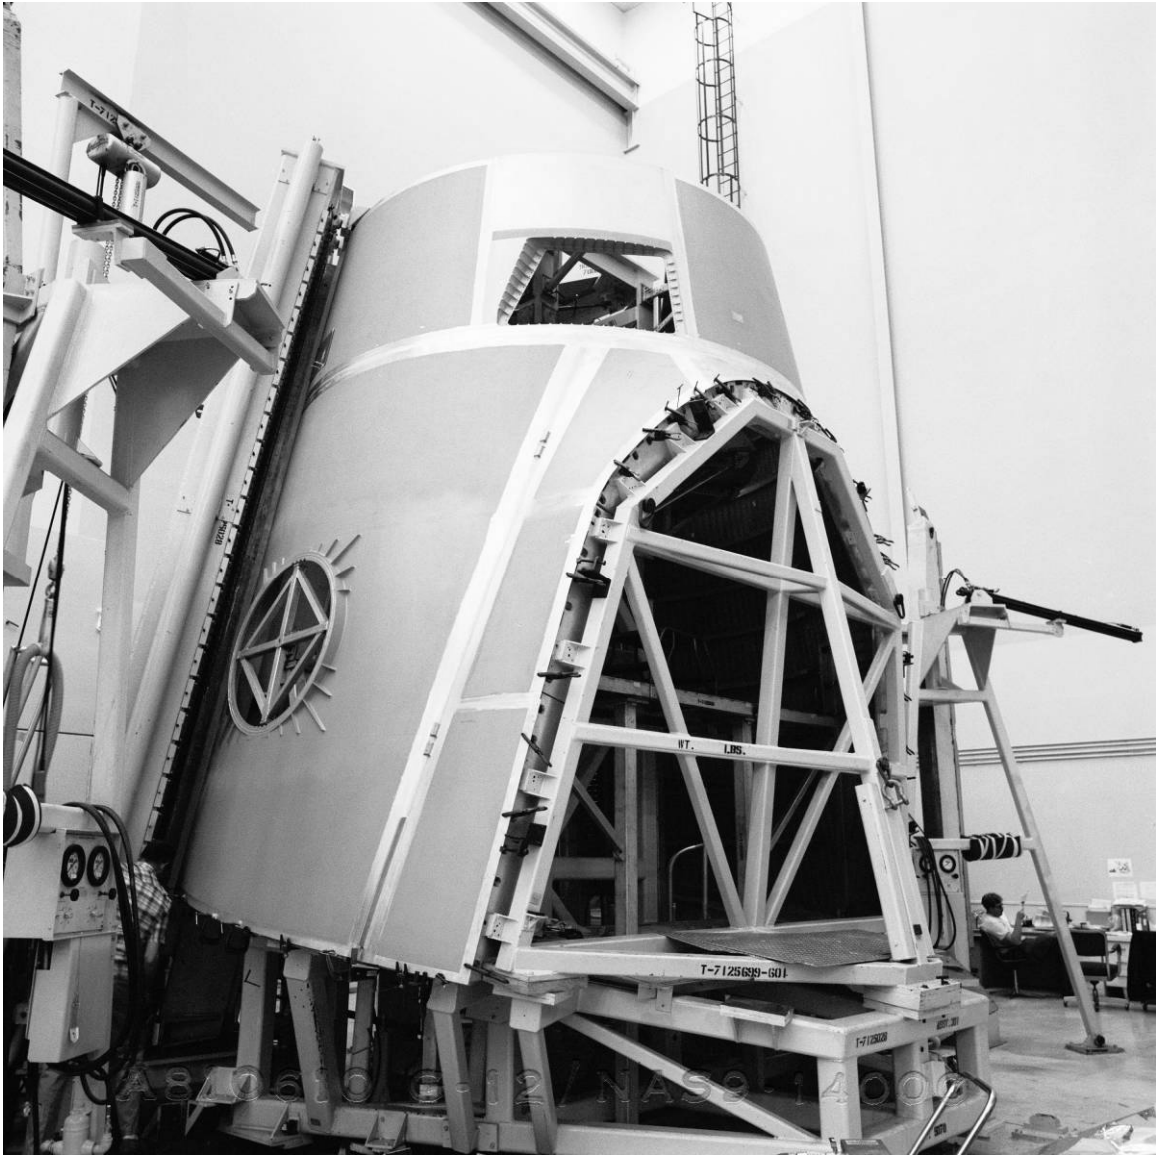
Figure B-7. Intermediate structure assembly for *Discovery's* crew module, NAR Building 290, Downey, California, June 10, 1981.
Source: NASA, Johnson Space Center Image Repository, JSC2010-03104.

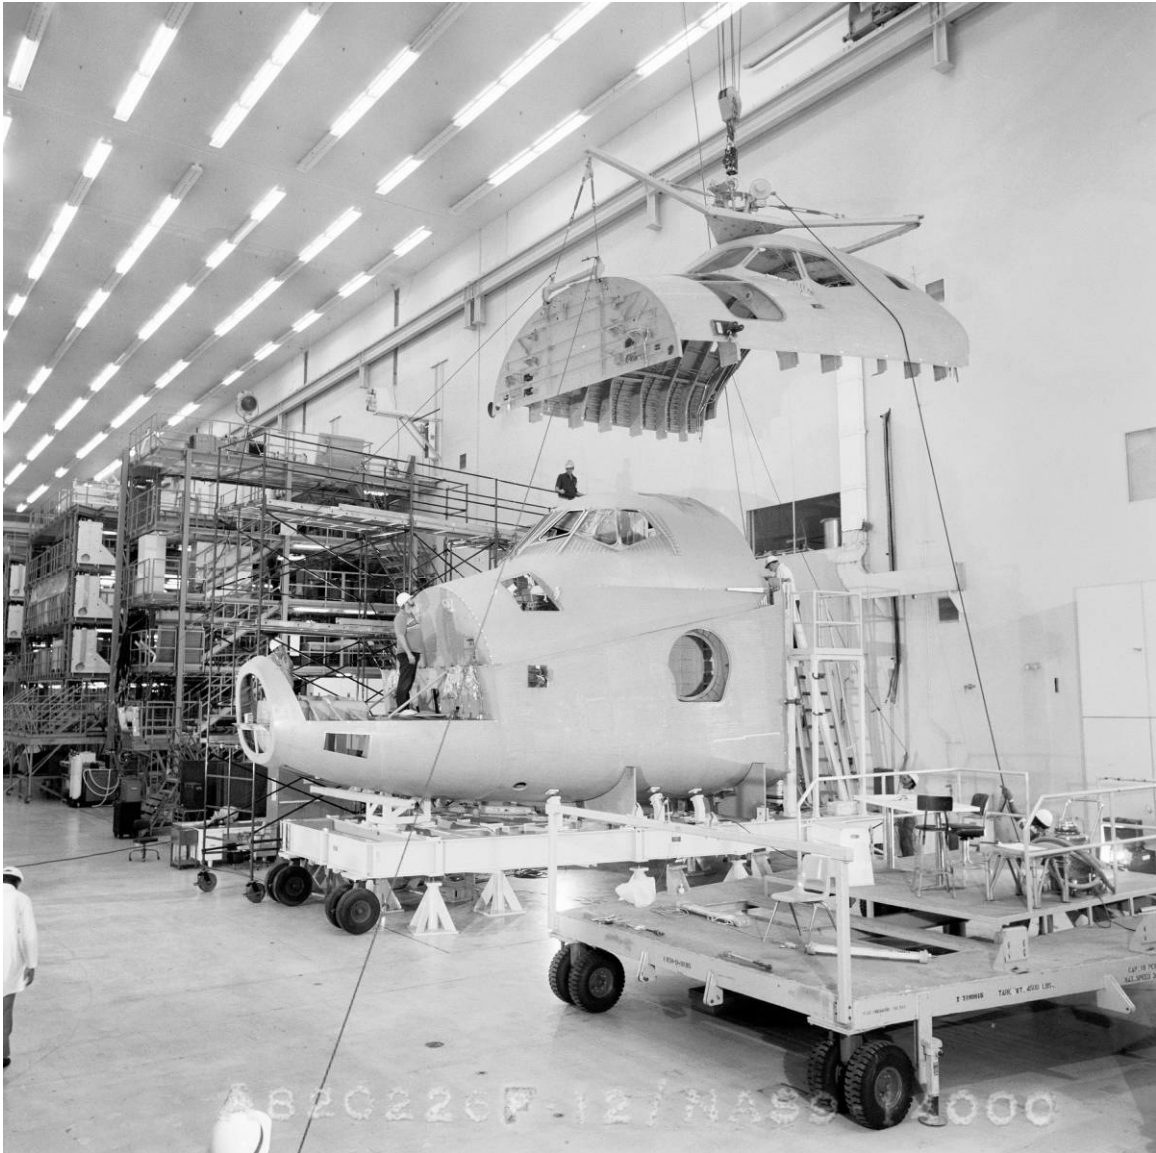
Figure B-10. Fit check of *Discovery's* crew module, lower forward fuselage, and upper forward fuselage, NAR Building 290, Downey, California, February 26, 1982.
Source: NASA, Johnson Space Center Image Repository, JSC2010-03237.

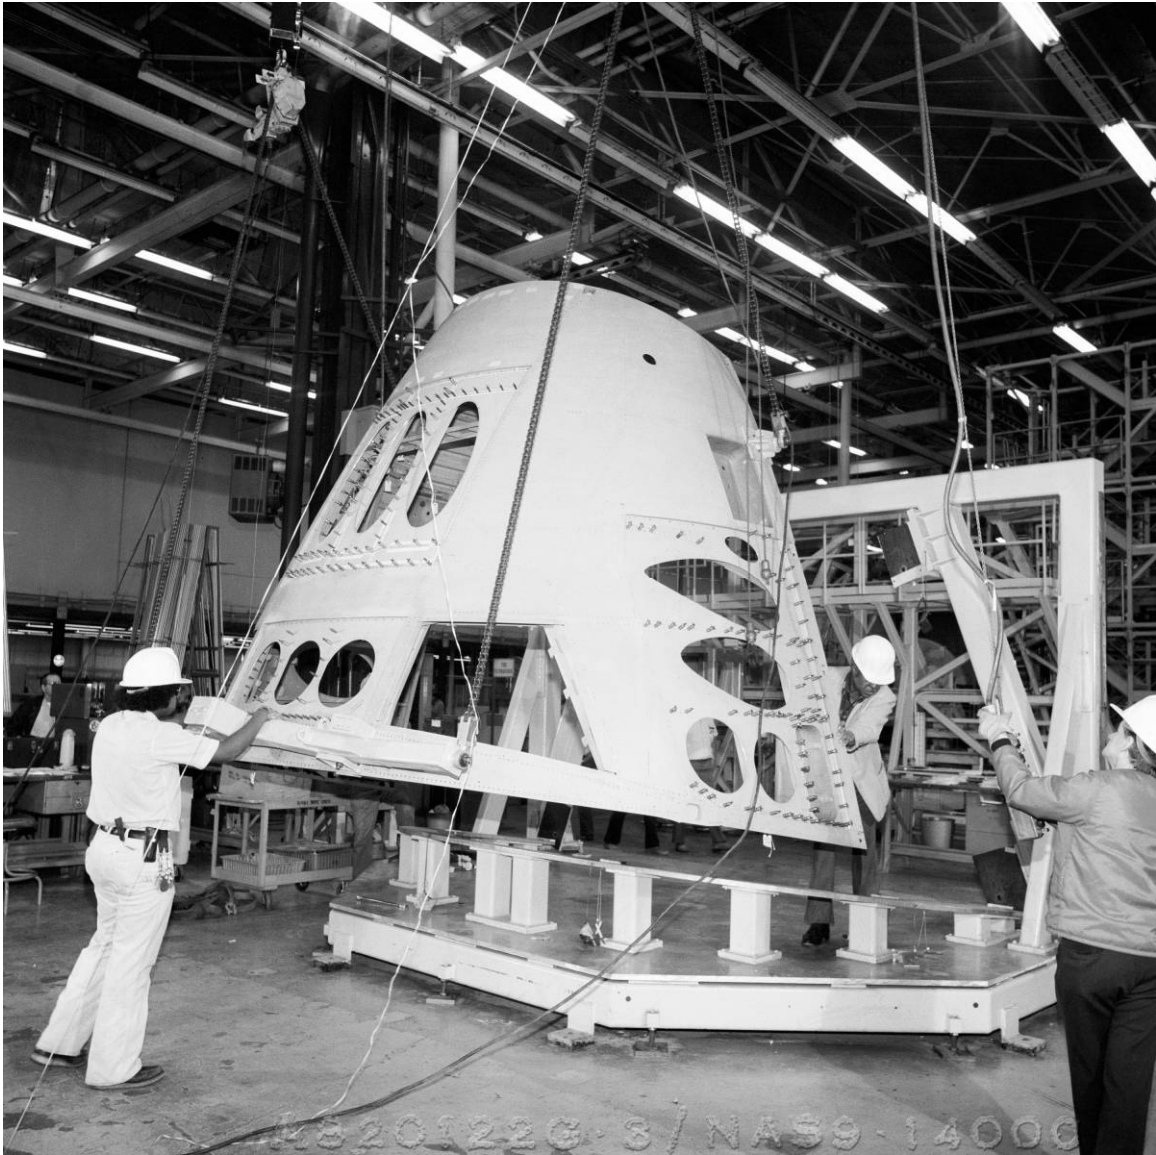
Figure B-12. Manufacturing of *Discovery's* FRCS module, NAR Building 1, Downey, California, August 26, 1981.
Source: NASA, Johnson Space Center Image Repository, JSC2010-03142.

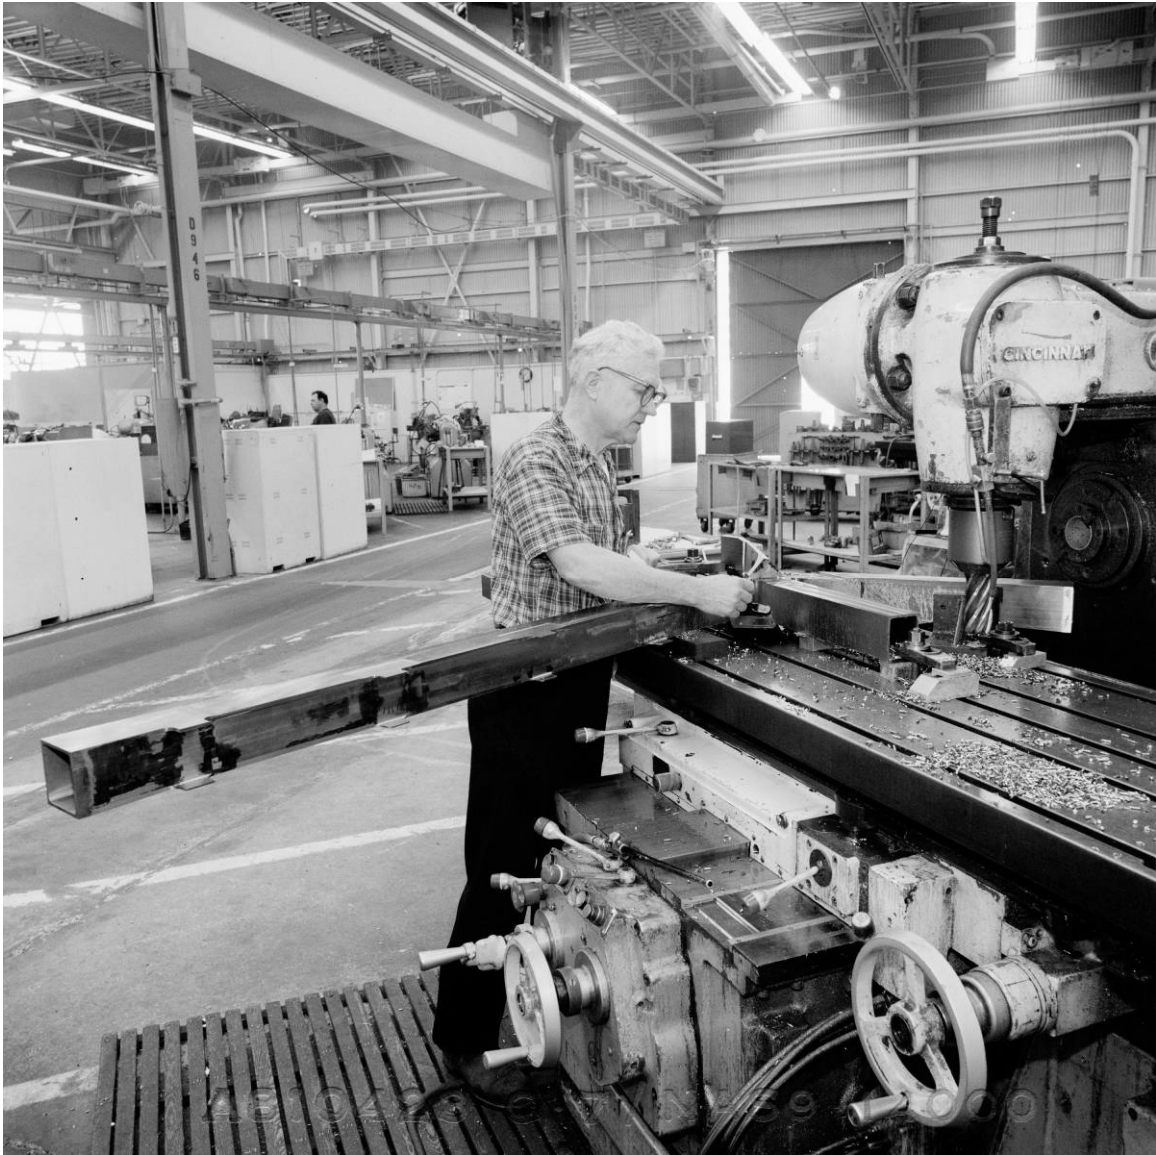
Figure B-15. Manufacturing of a vertical truss for the thrust structure of *Discovery's* aft fuselage, NAR Building 1, Downey, California, April 23, 1981.
Source: NASA, Johnson Space Center Image Repository, JSC2010-03093.

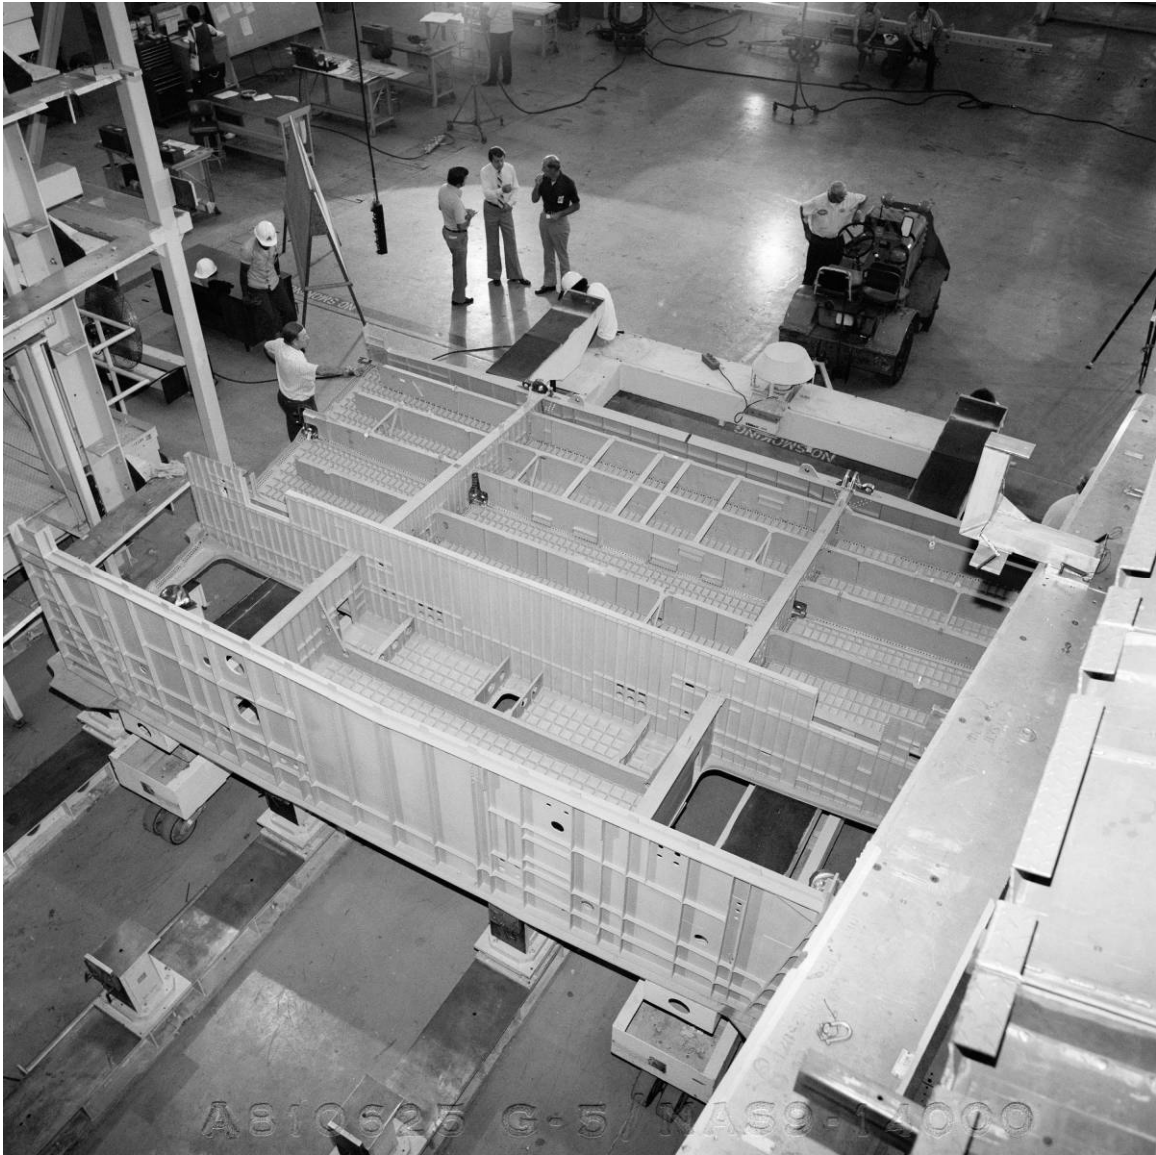
Figure B-16. Manufacturing of the lower structure assembly for *Discovery's* aft fuselage, NAR Building 1, Downey, California, June 25, 1981.
Source: NASA, Johnson Space Center Image Repository, JSC2010-03110.

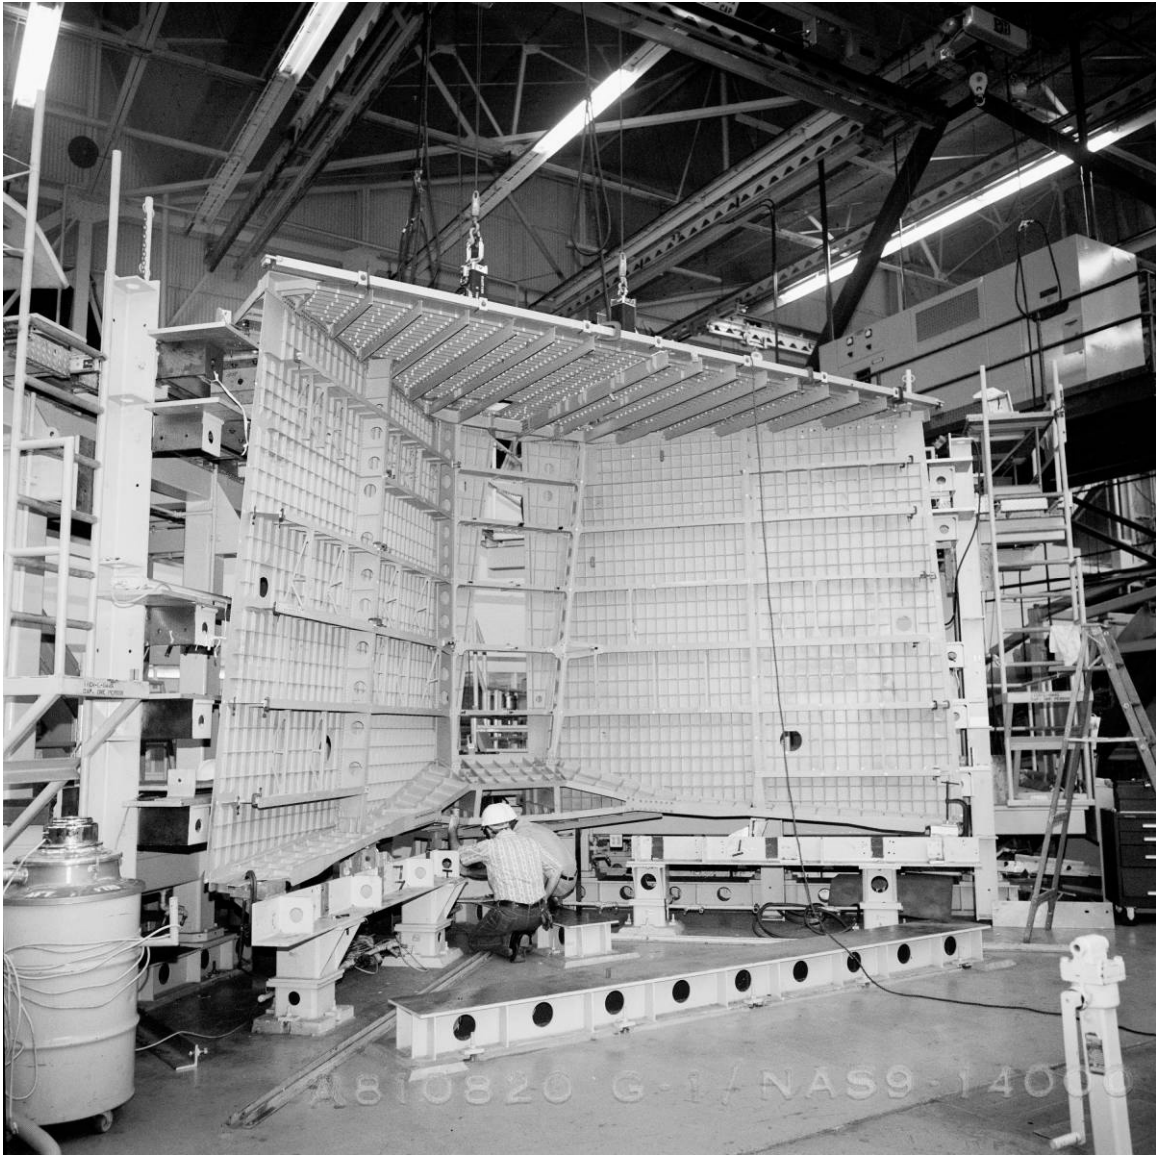
Figure B-17. Manufacturing of the upper structure assembly for *Discovery's* aft fuselage, NAR Building 1, Downey, California, August 20, 1981.
Source: NASA, Johnson Space Center Image Repository, JSC2010-03139.

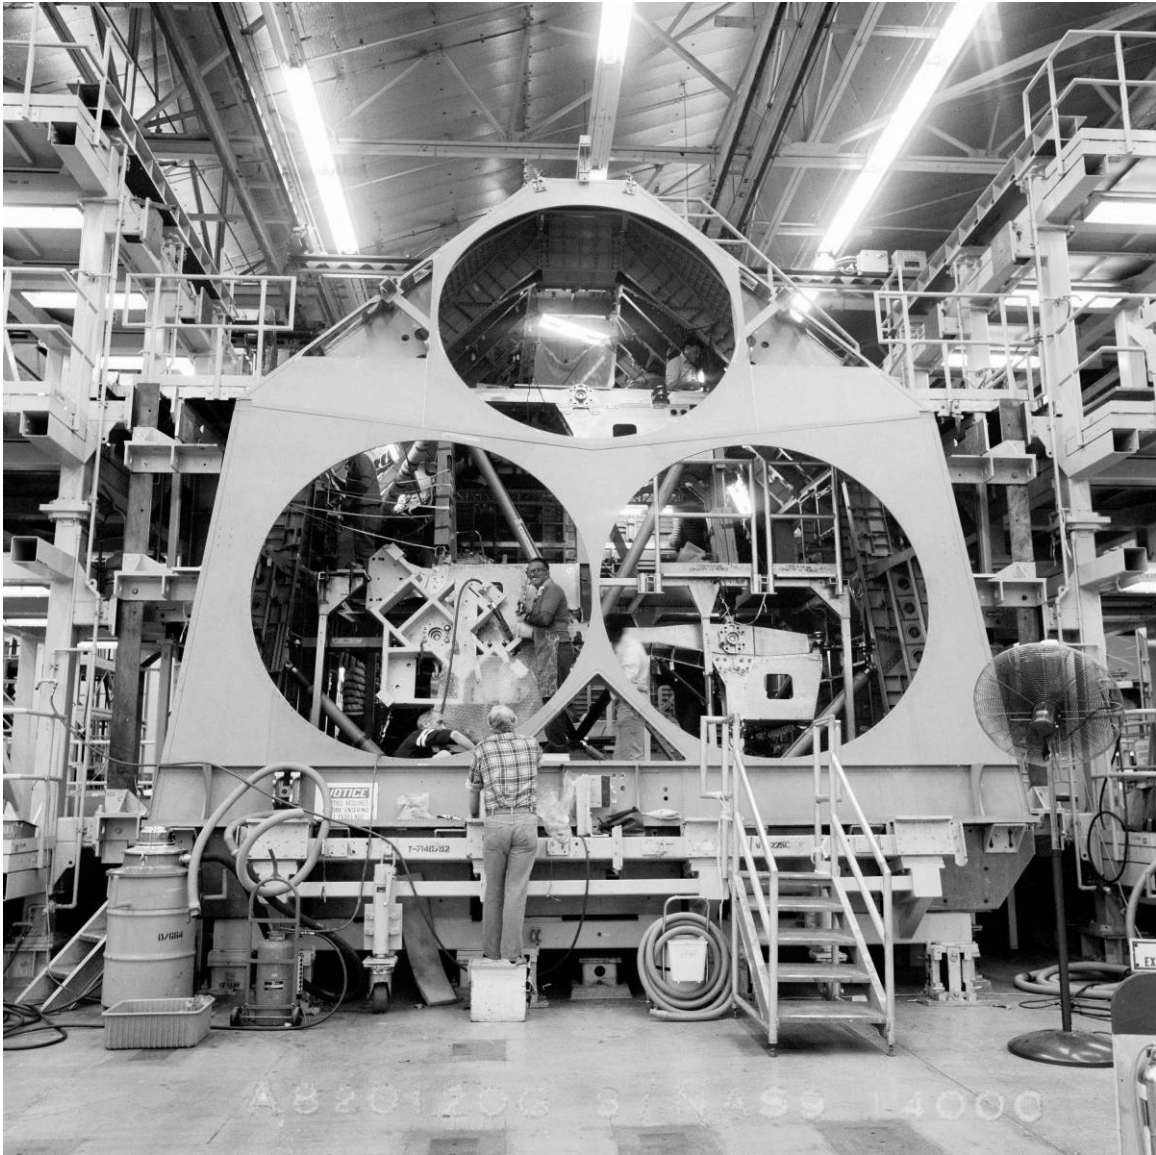
Figure B-18. Installation of aft heat shield to *Discovery's* aft fuselage, NAR Building 1, Downey, California, January 20, 1982.
Source: NASA, Johnson Space Center Image Repository, JSC2010-03226.

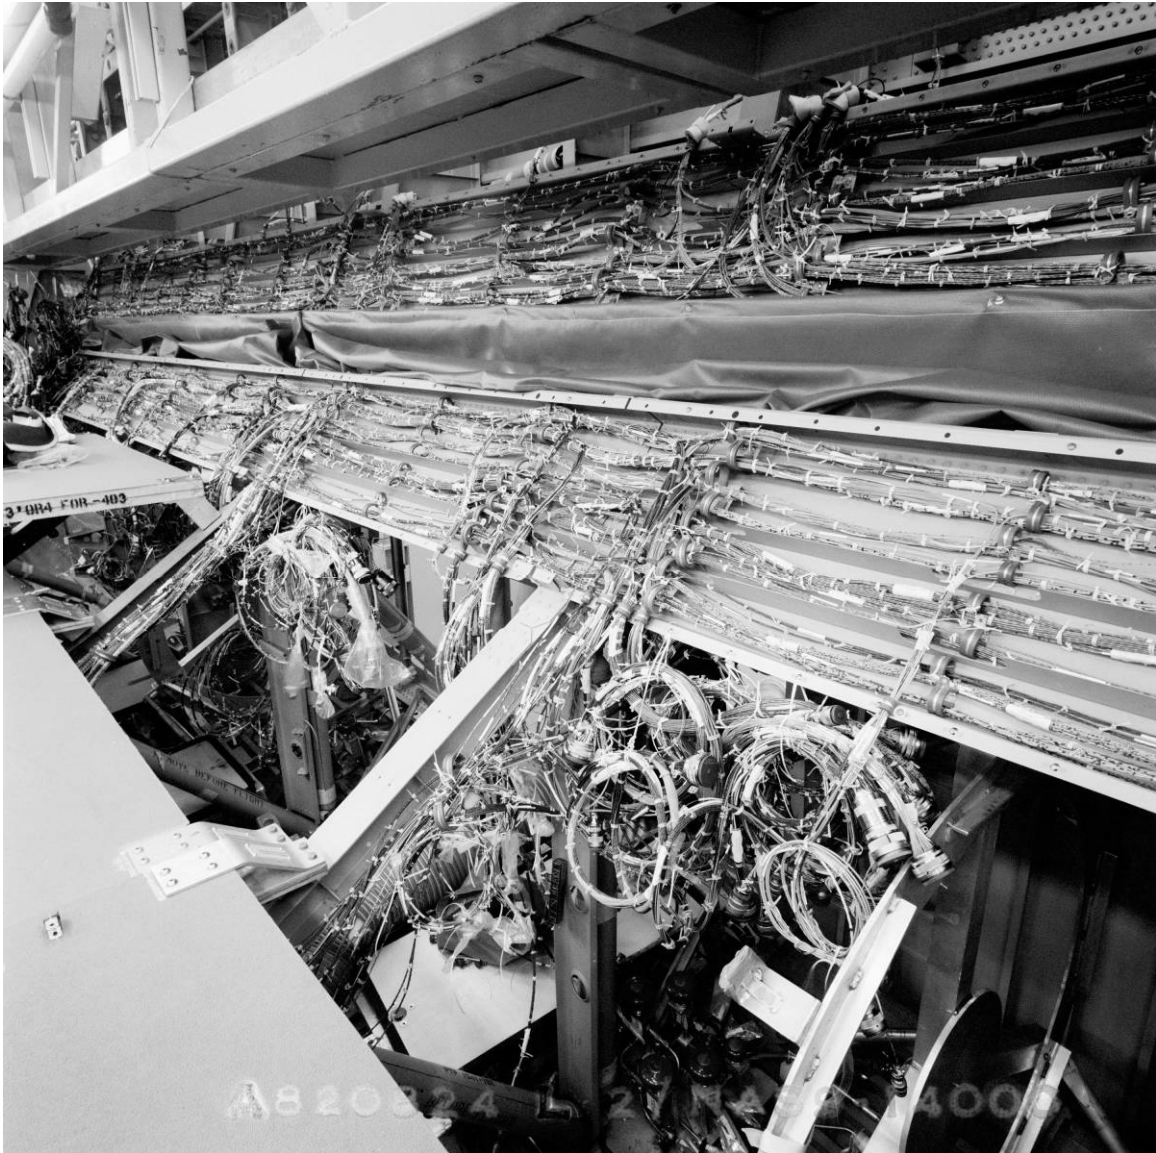
Figure B-25. Starboard wire harness being installed in *Discovery's* midfuselage in High Bay 2, AFP 42, August 24, 1982.
Source: NASA, Johnson Space Center Image Repository, JSC2010-03330.
