SPACE TRANSPORTATION SYSTEM
Johnson Space Center, 2101 NASA Parkway
Houston
Harris County
Texas

HAER TX-116
HAER TX-116

SPACE TRANSPORTATION SYSTEM HAER No. TX-116

Report Prepared by: Joan Deming, Principal Investigator
Patricia Slovinac, Architectural Historian
Archaeological Consultants, Inc. (ACI)
8110 Blaikie Court, Suite A
Sarasota, Florida 34240

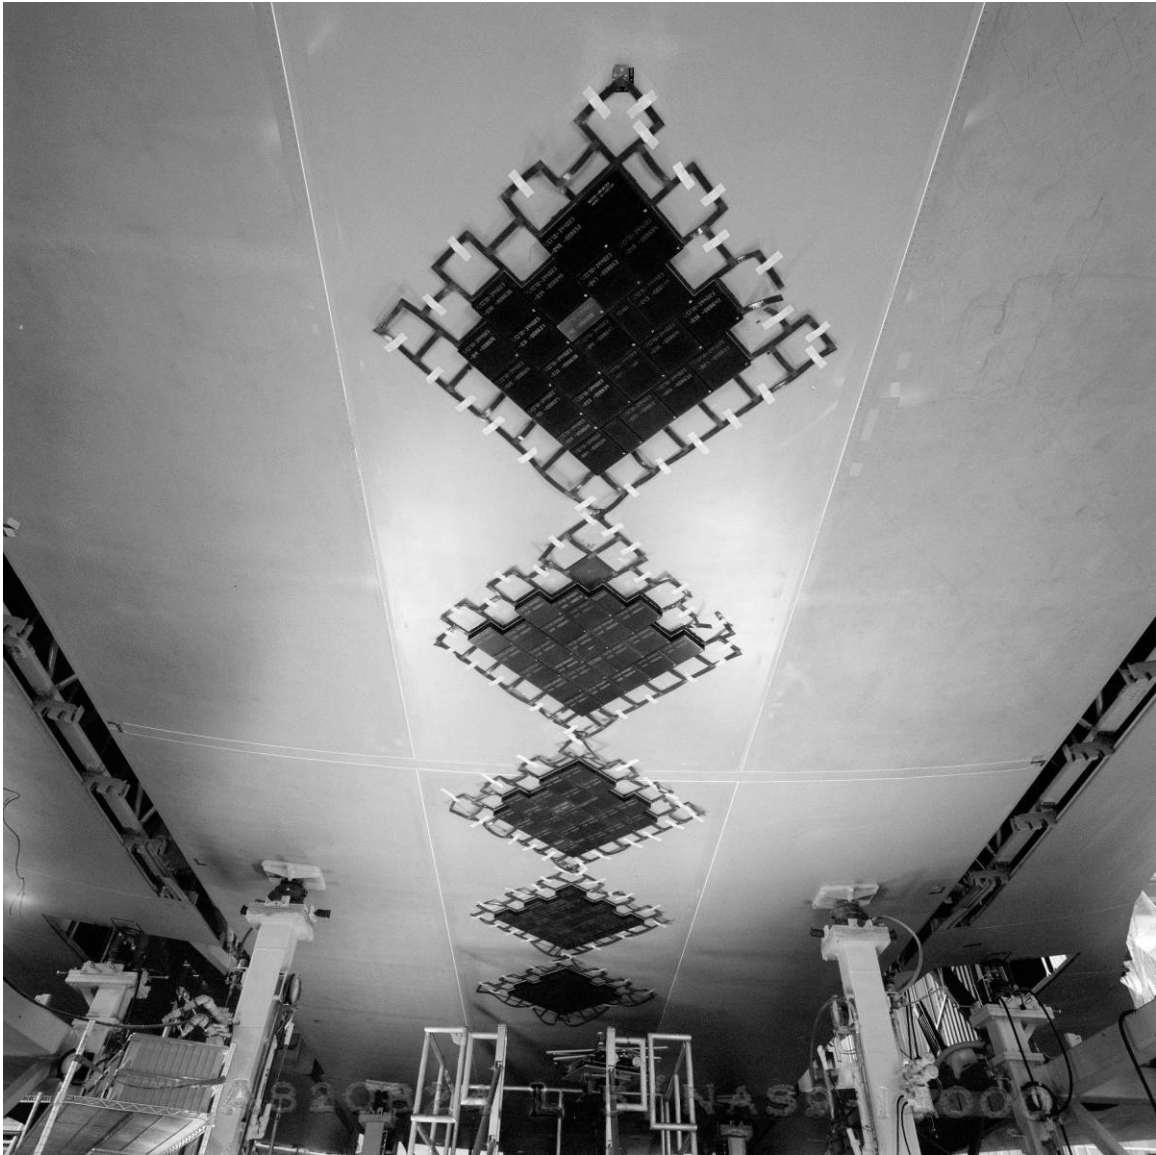
Figure B-26. HRSI tile being installed on the underside of *Discovery's* midfuselage in High Bay 2, AFP 42, August 24, 1982.
Source: NASA, Johnson Space Center Image Repository, JSC2010-03331.

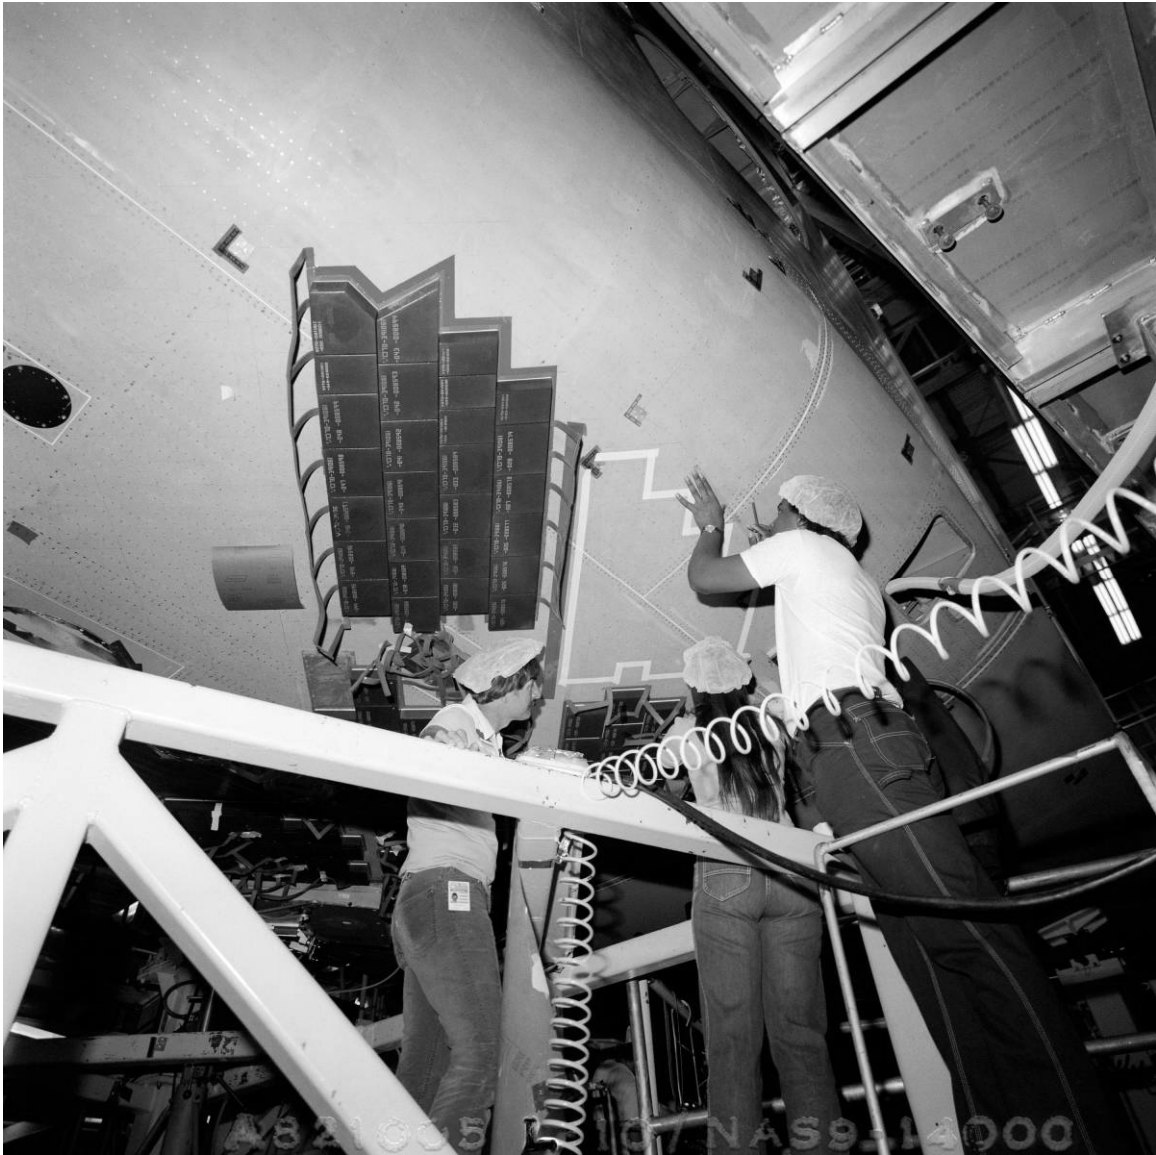
Figure B-28. HRSI installation on the underside of *Discovery's* lower forward fuselage in High Bay 2, AFP 42, October 5, 1982.
Source: NASA, Johnson Space Center Image Repository, JSC2010-03346.

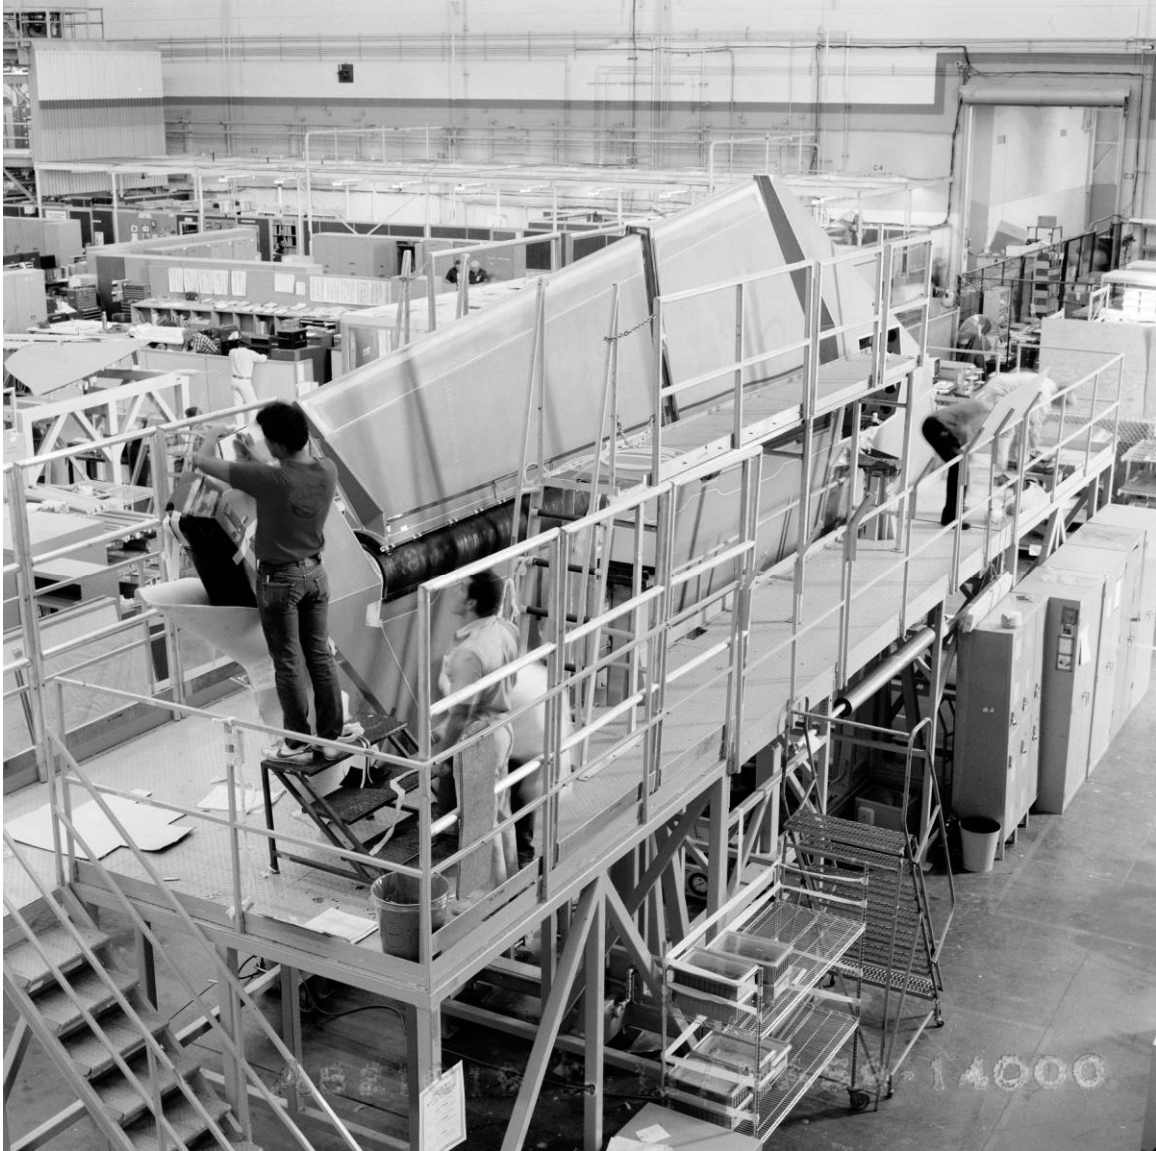
Figure B-30. Installation of TPS on *Discovery's* vertical stabilizer, AFP 42, October 19, 1982.
Source: NASA, Johnson Space Center Image Repository, JSC2010-03353.

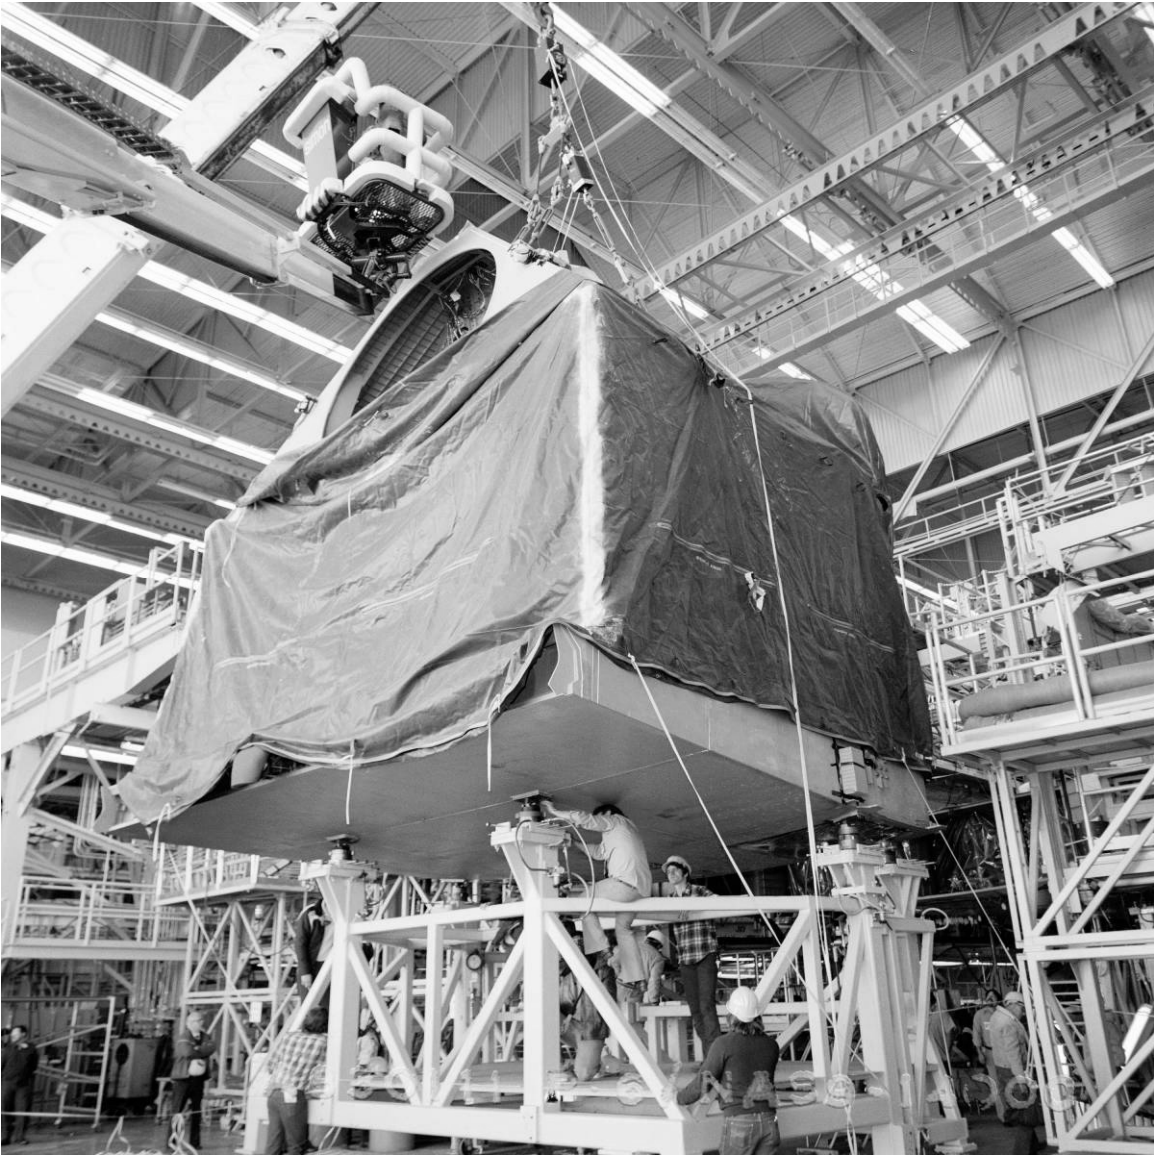
Figure B-35. Installation of *Discovery's* port side main landing gear in High Bay 2, AFP 42, January 8, 1983.

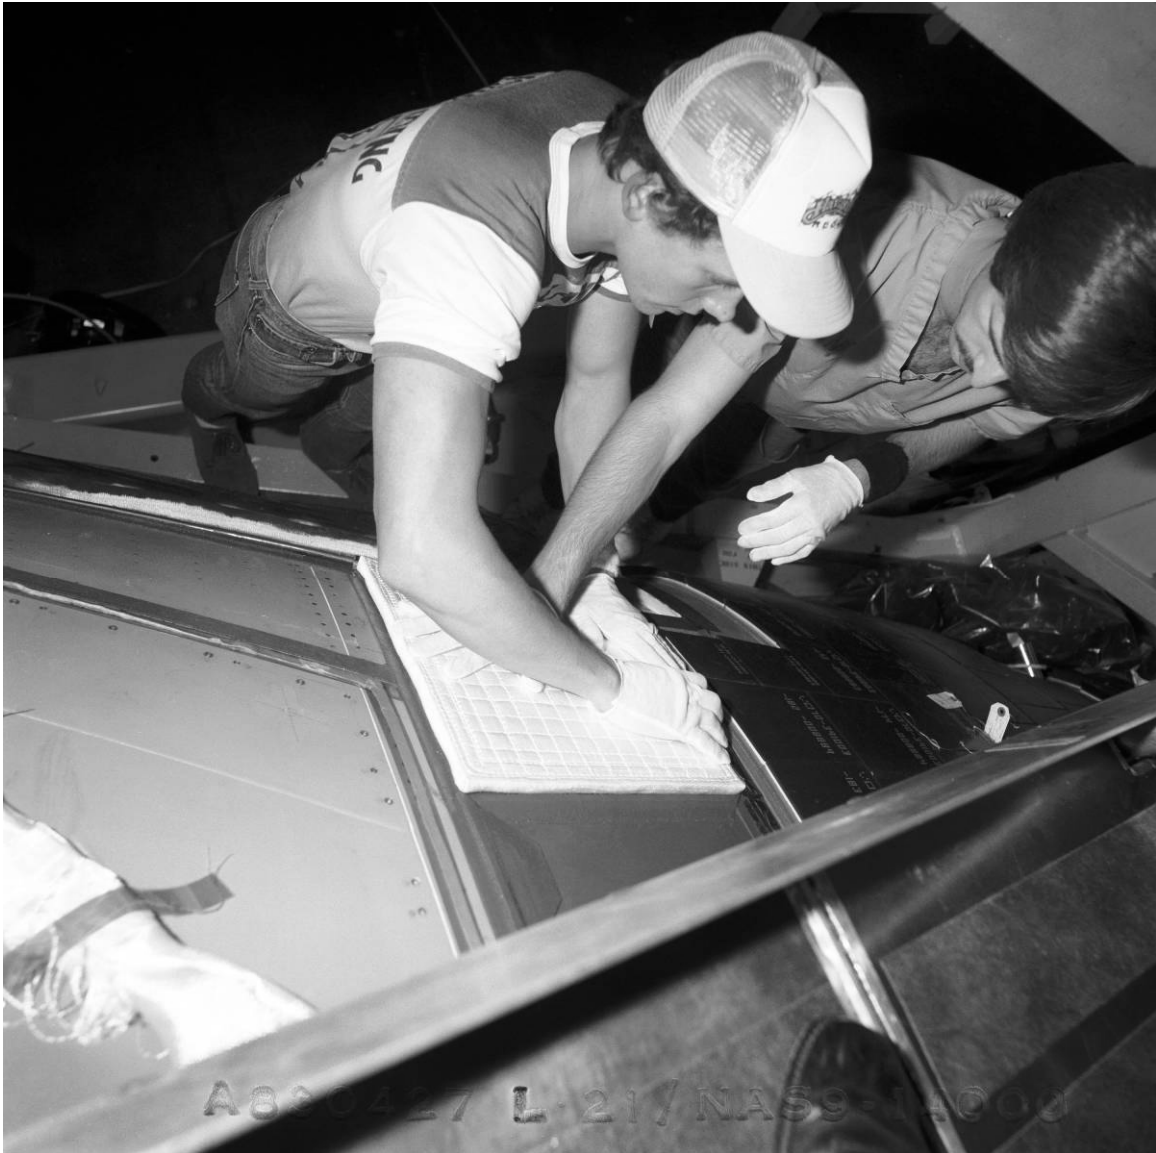
Figure B-49. Installation of AFRSI on *Discovery's* FRCS module in High Bay 2, AFP 42, April 27, 1983.
Source: NASA, Johnson Space Center Image Repository, JSC2010-03445.

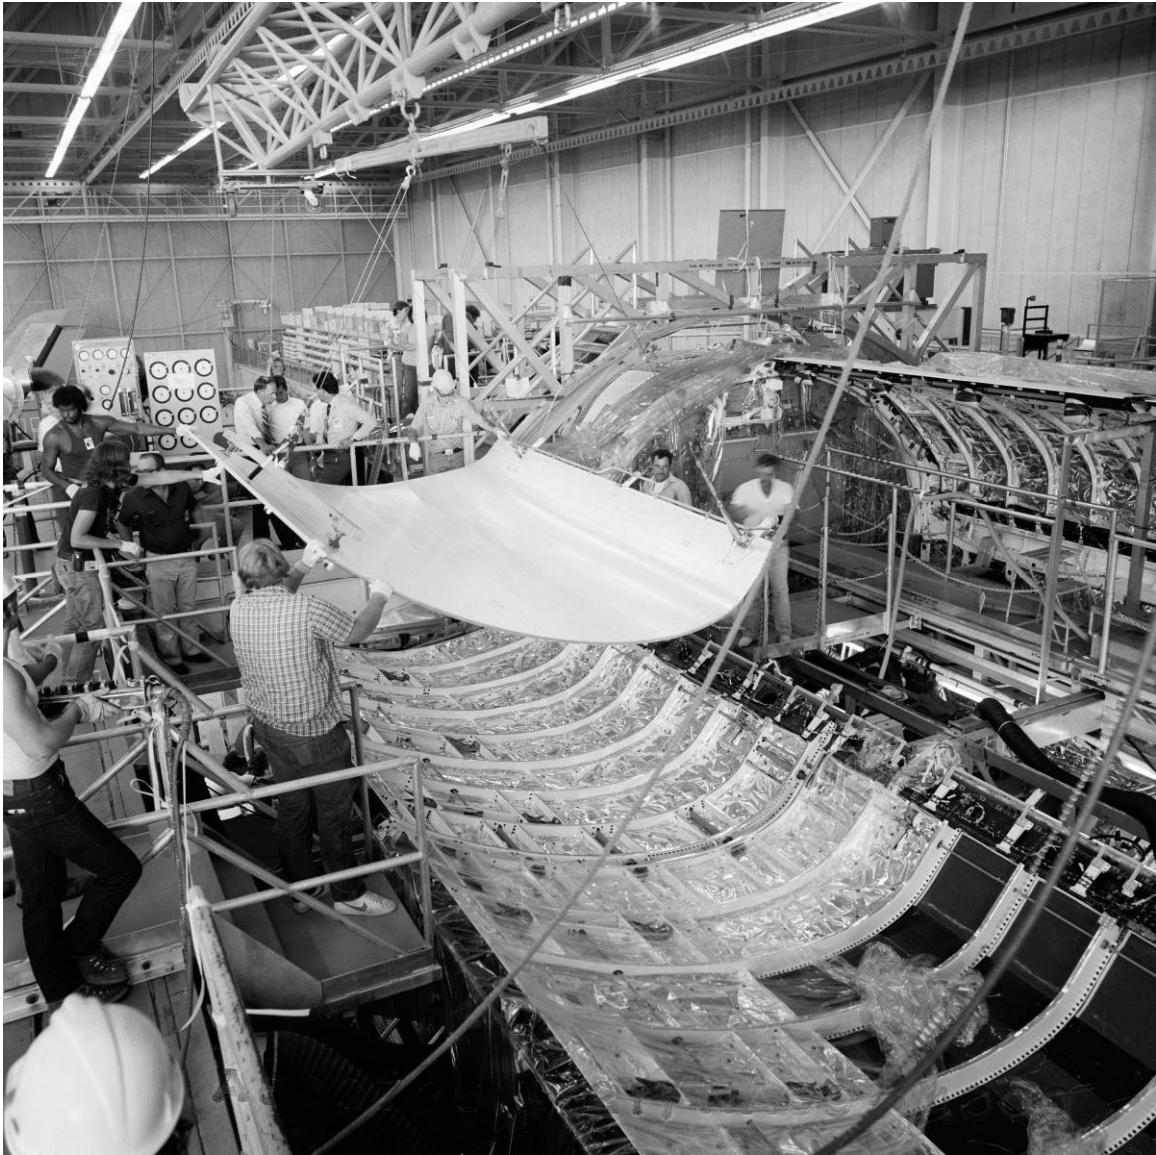
Figure B-54. Installation of the forward radiator panel on *Discovery's* port payload bay door in High Bay 2, AFP 42, July 26, 1983.
Source: NASA, Johnson Space Center Image Repository, JSC2010-03484.

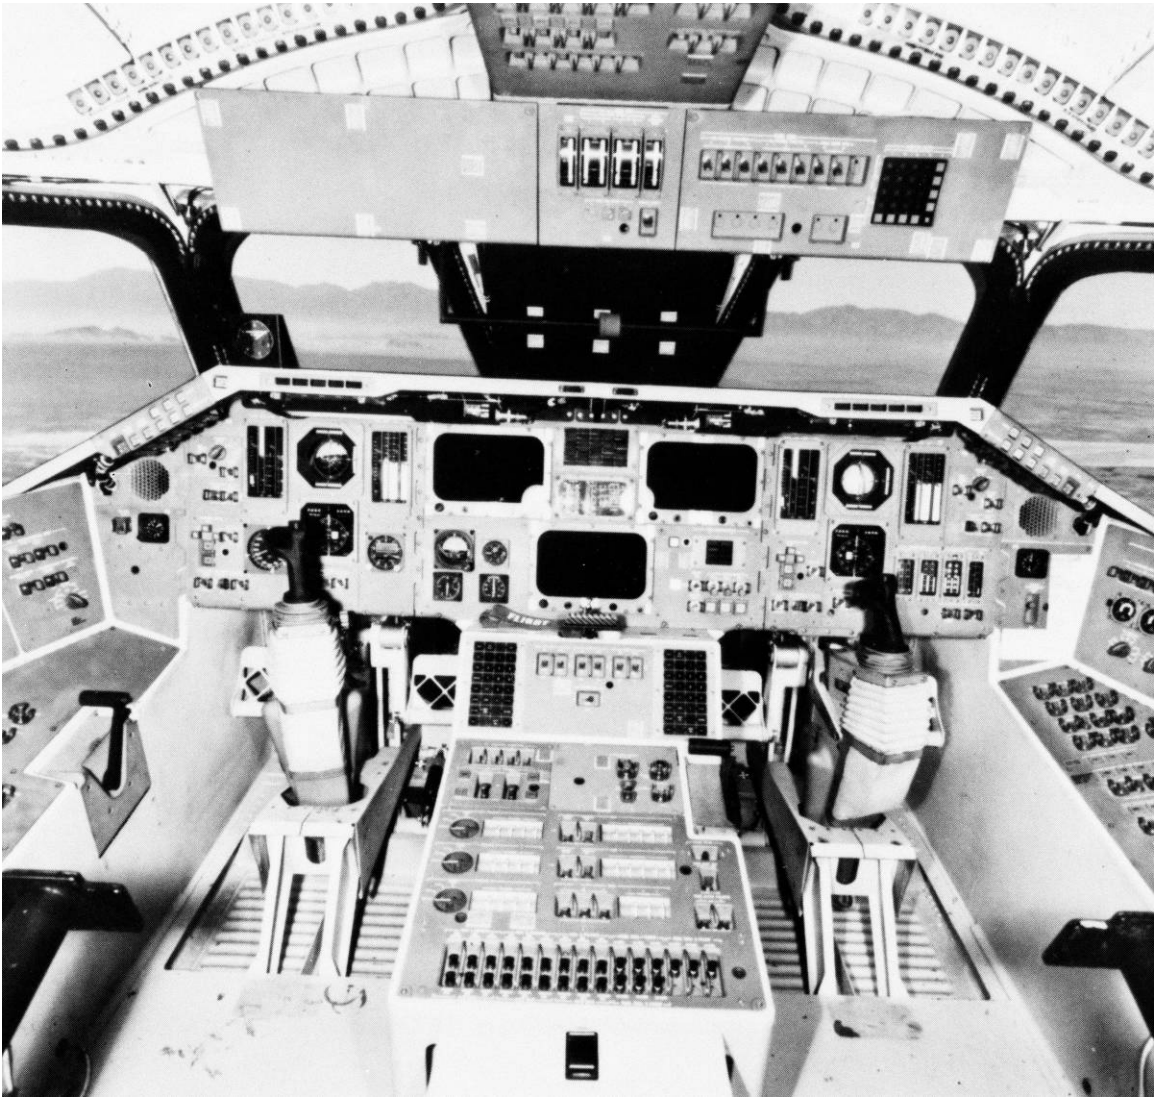
Figure B-78. Photograph of the original orbiter flight deck, 1978.
Source: NASA Johnson Space Center, Image Repository, S78-23470.

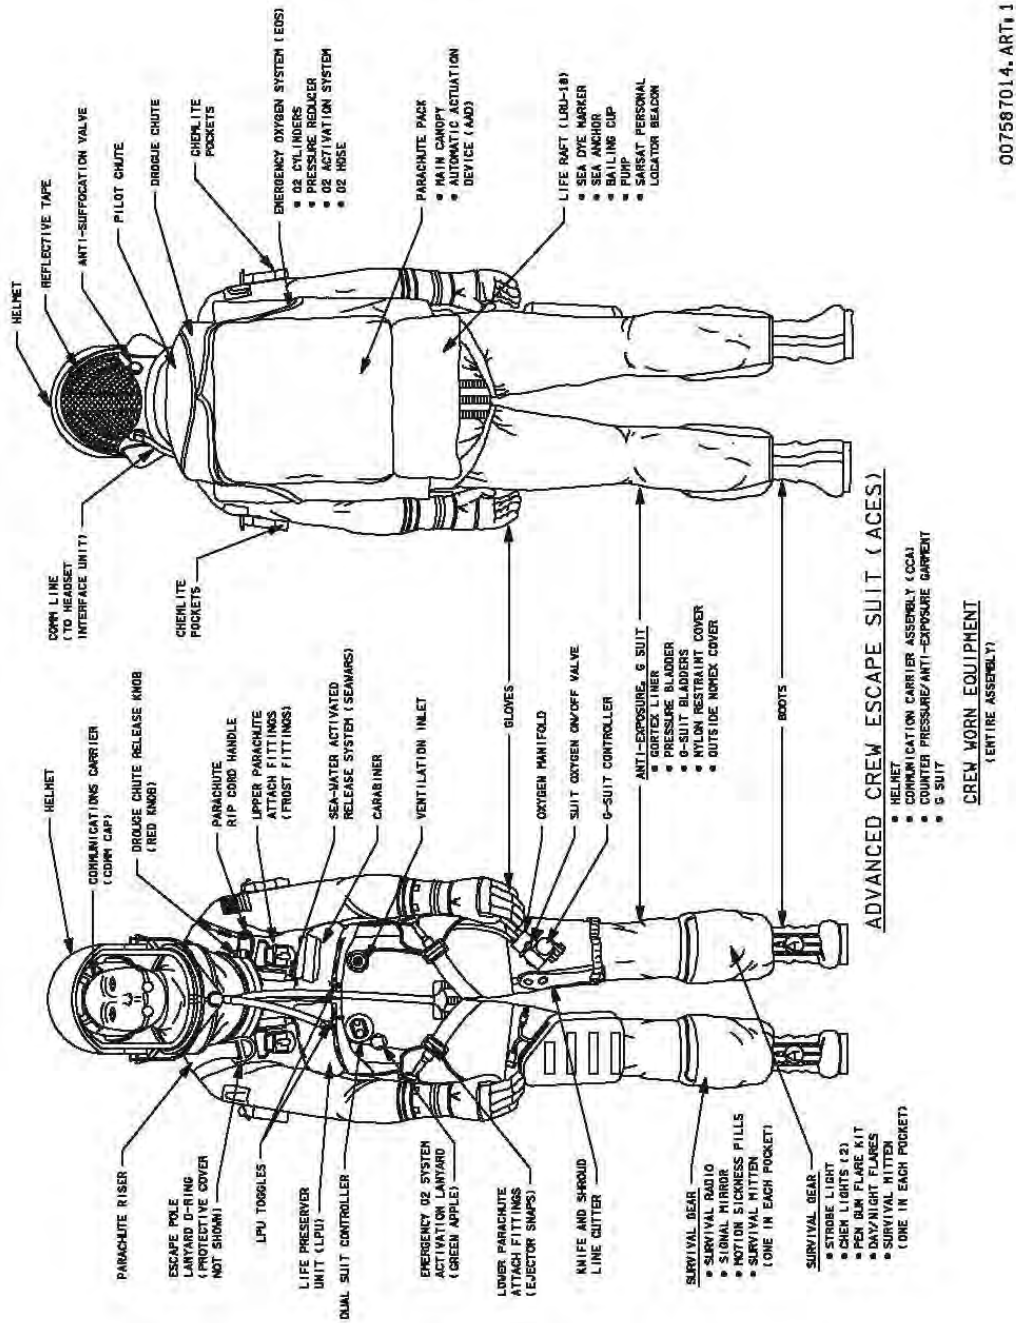
Figure B-144. Diagram of the advanced crew escape suit.
 Source: USA. Shuttle Crew Operations Manual, 2.10-5.

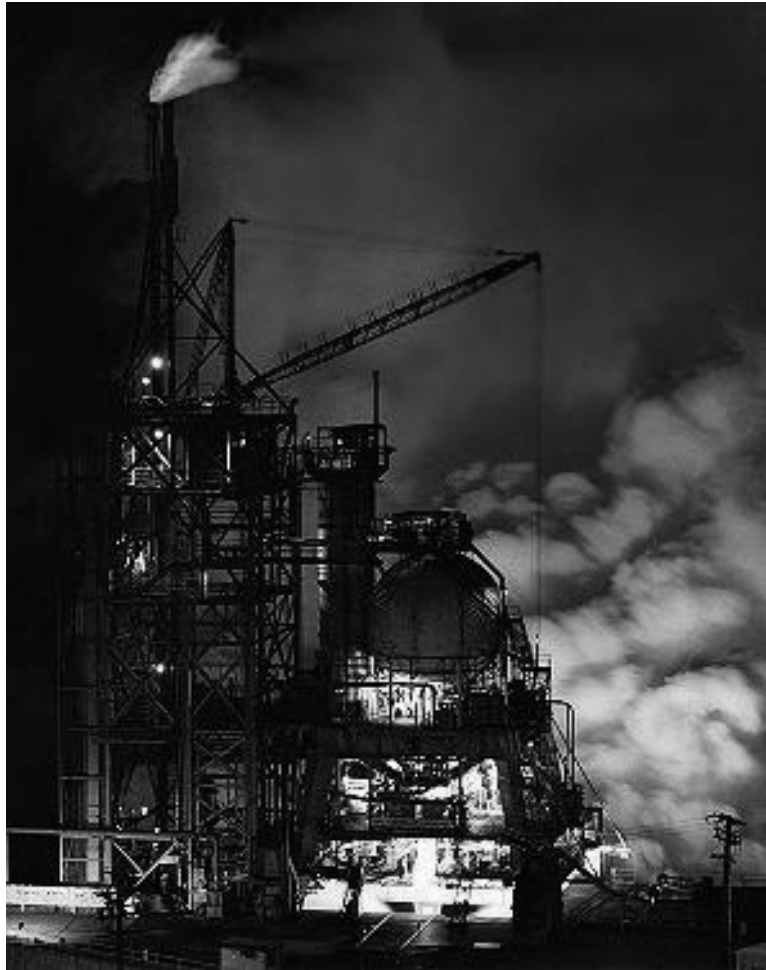
Figure C-3. Testing of SSME Solid Wall Hot Gas Manifold installed in Coca I Test Stand, SSFL,
direction and date unknown.

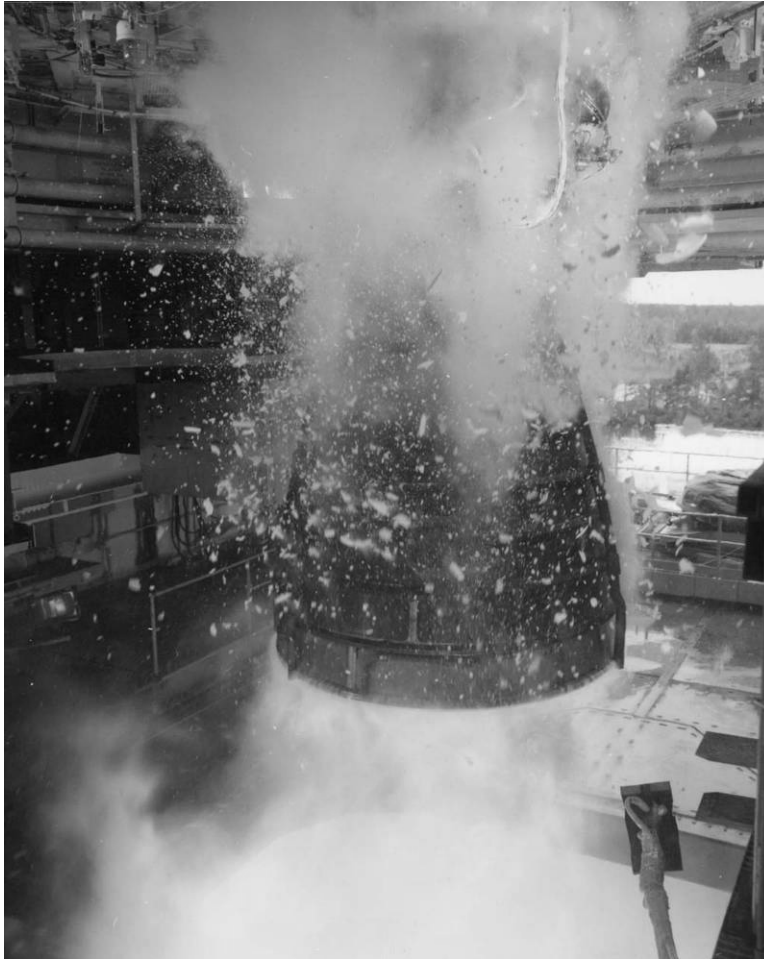
Figure C-14. Close-up view of a SSME test, direction unknown, 1994.
Source: John C. Stennis Space Center, SIRS, 94-engine, accessed at
<http://www.ssc.nasa.gov/sirs/scripts/xmlWelcome.pl>.

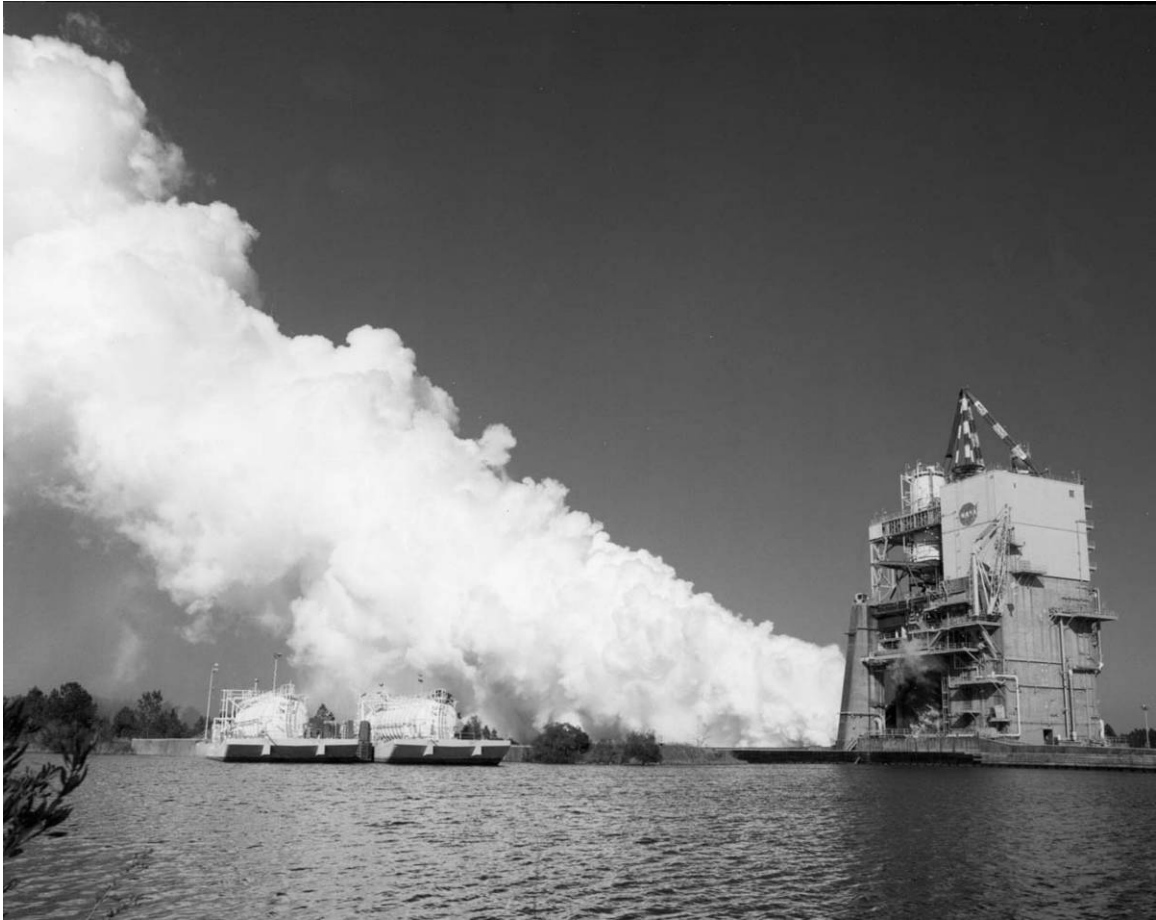
Figure C-16. A “Return to Flight,” Phase II SSME undergoing testing on Stand A-1, camera facing northeast, 1988.

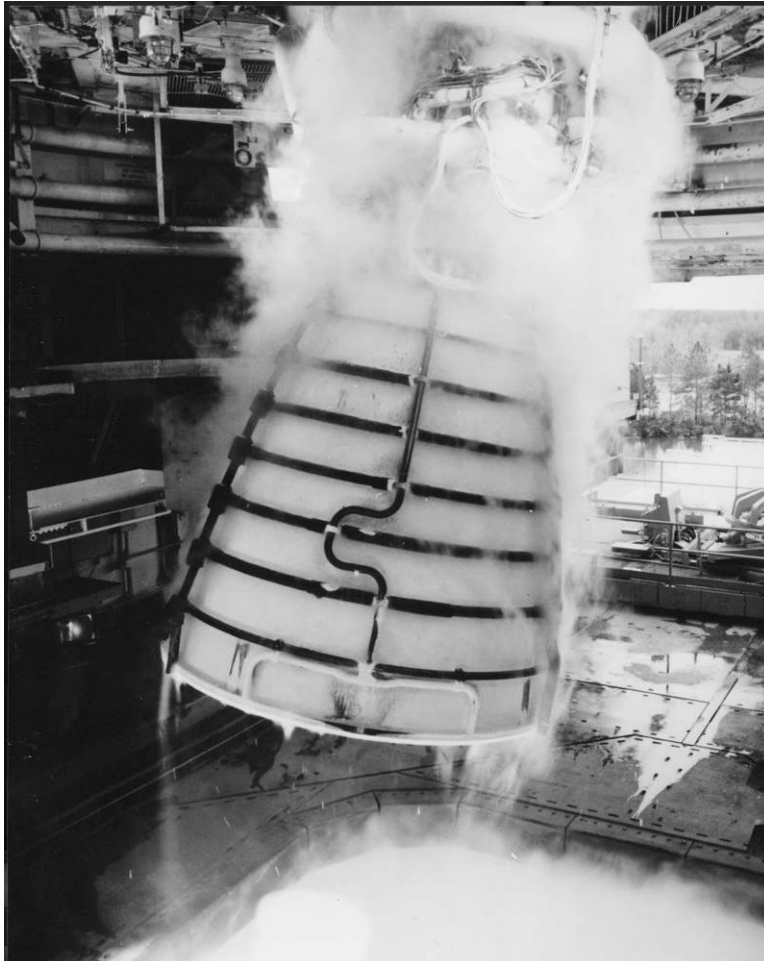
Figure C-17. A Block I SSME undergoing testing on Stand A-1, direction unknown, 1995.
Source: John C. Stennis Space Center, SIRS, 95-088-1, accessed at
<http://www.ssc.nasa.gov/sirs/scripts/xmlWelcome.pl>.

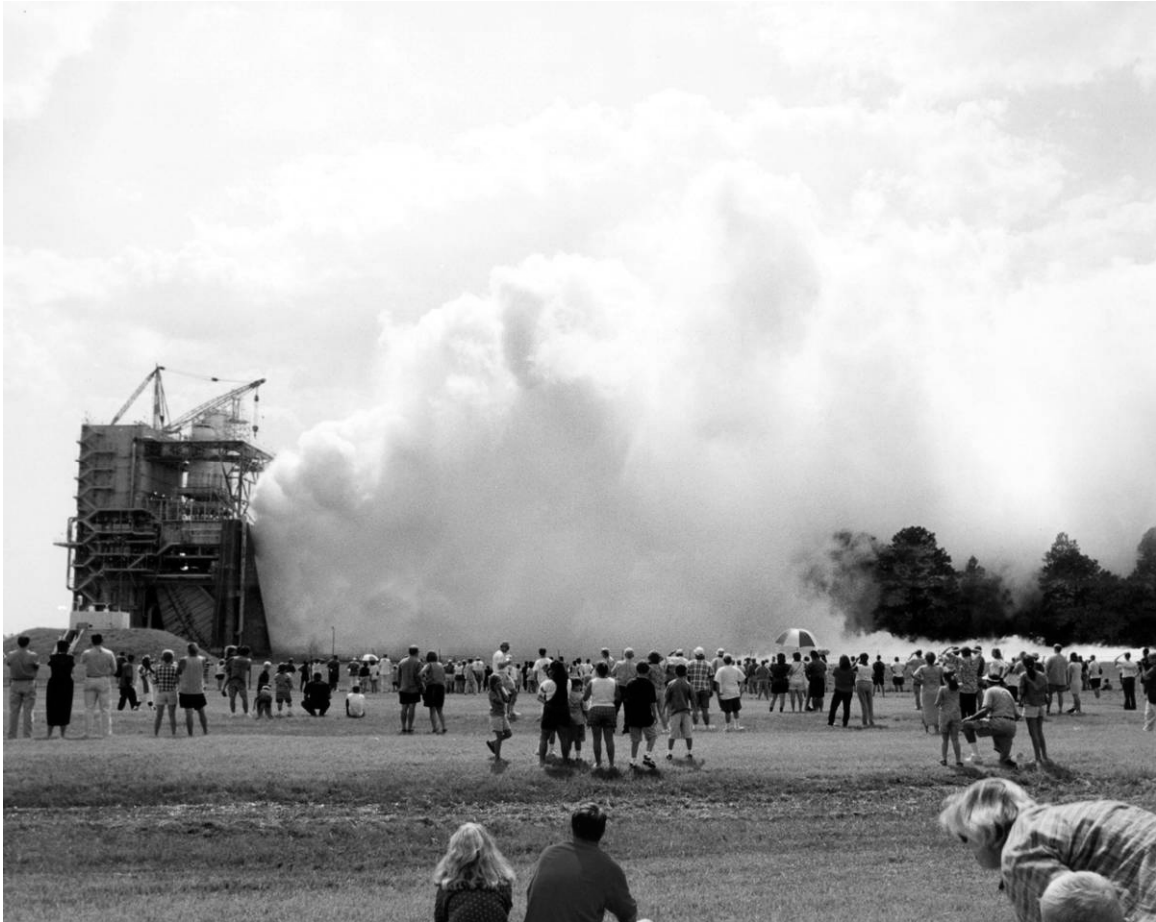
Figure C-18. A Block II SSME undergoing flight certification testing on Stand A-2, camera facing west, July 25, 2000.

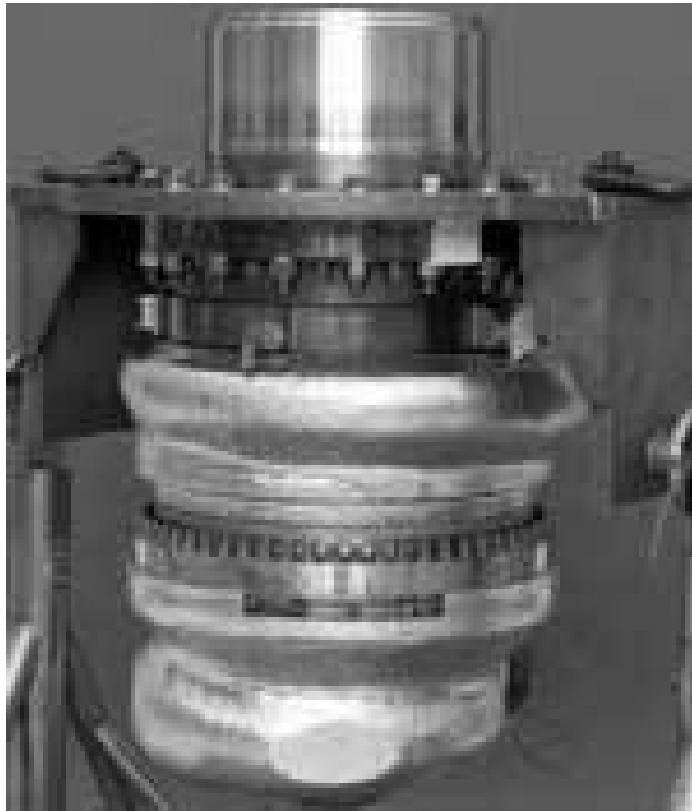
Figure C-22. SSME High Pressure Fuel Turbopump.
Source: George C. Marshall Space Flight Center.

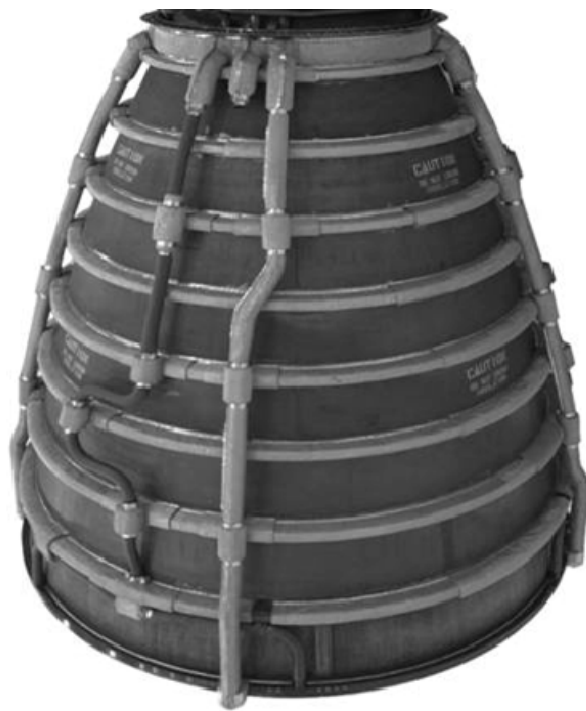
Figure C-24. SSME Nozzle.
Source: George C. Marshall Space Flight Center.

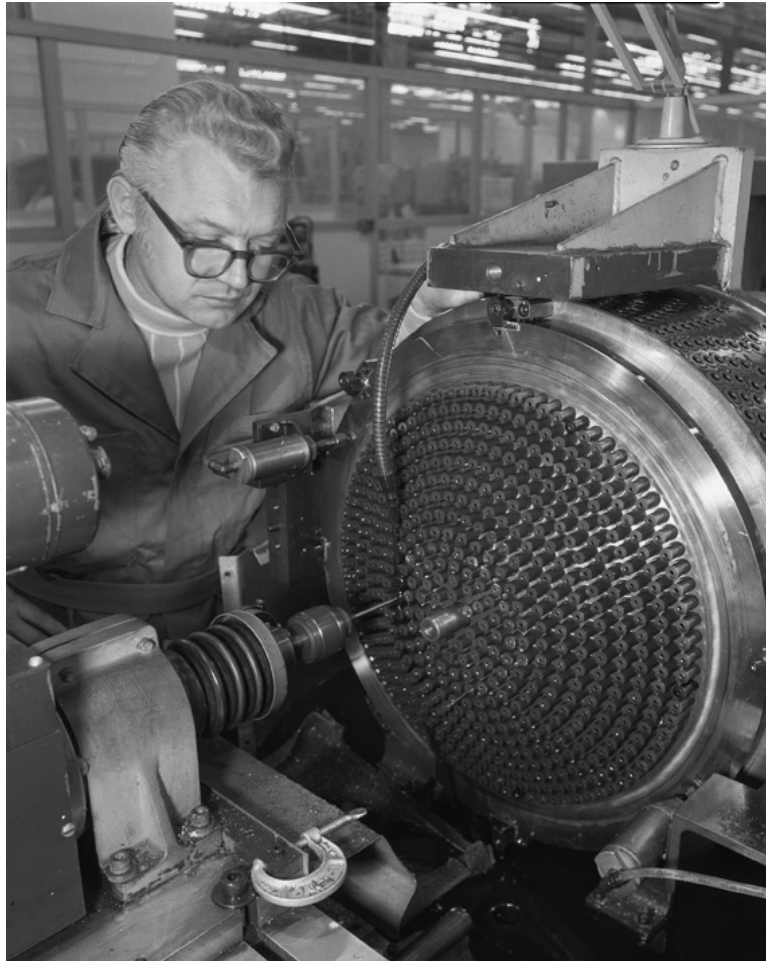
Figure C-25. A technician reams holes into the SSME main injector body at Rocketdyne's Canoga Park, California, facility, direction unknown, August 1, 1978.
Source: George C. Marshall Space Flight Center, Marshall Image Exchange (MIX), 7779474, accessed at <http://mix.msfc.nasa.gov/>.

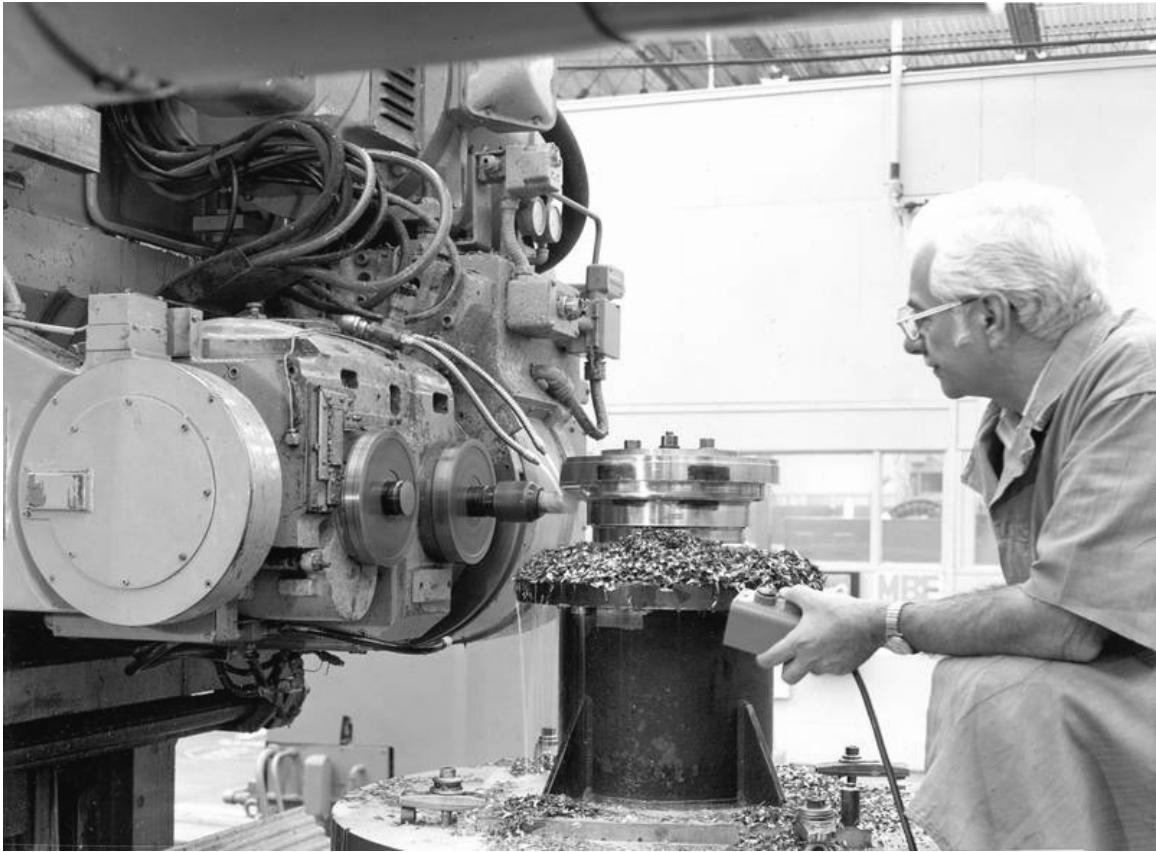
Figure C-26. A technician machining a SSME Oxidizer Preburner Body on the 5-Axis Omni Mill, Canoga Park, 1973.

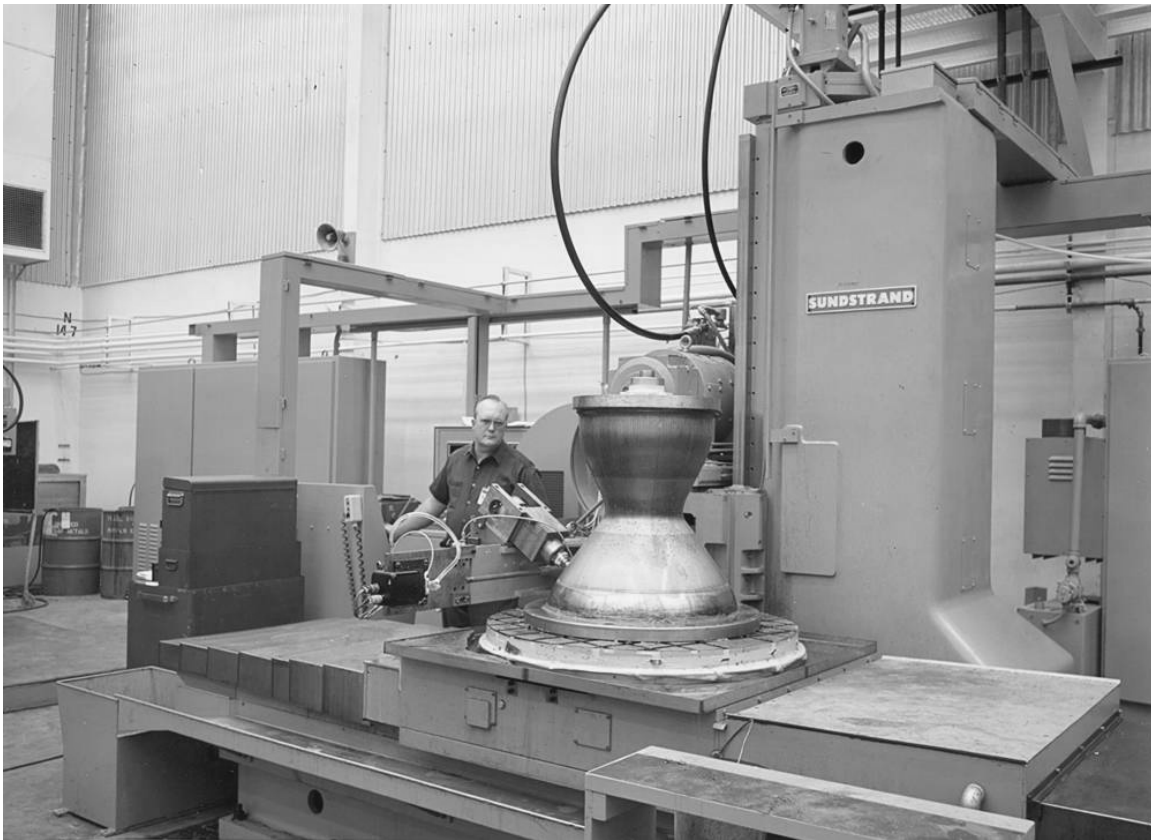
Figure C-28. Milling of the 390 Inlet Slots around the outer periphery of the Main Combustion Chamber of the SSME, on a Sundstrand Numerical Controlled Mill.
Source: *History of the Air Force Plant Representative Office Rockwell International Corporation Rocketdyne Division 1 January – 30 June 1974.*

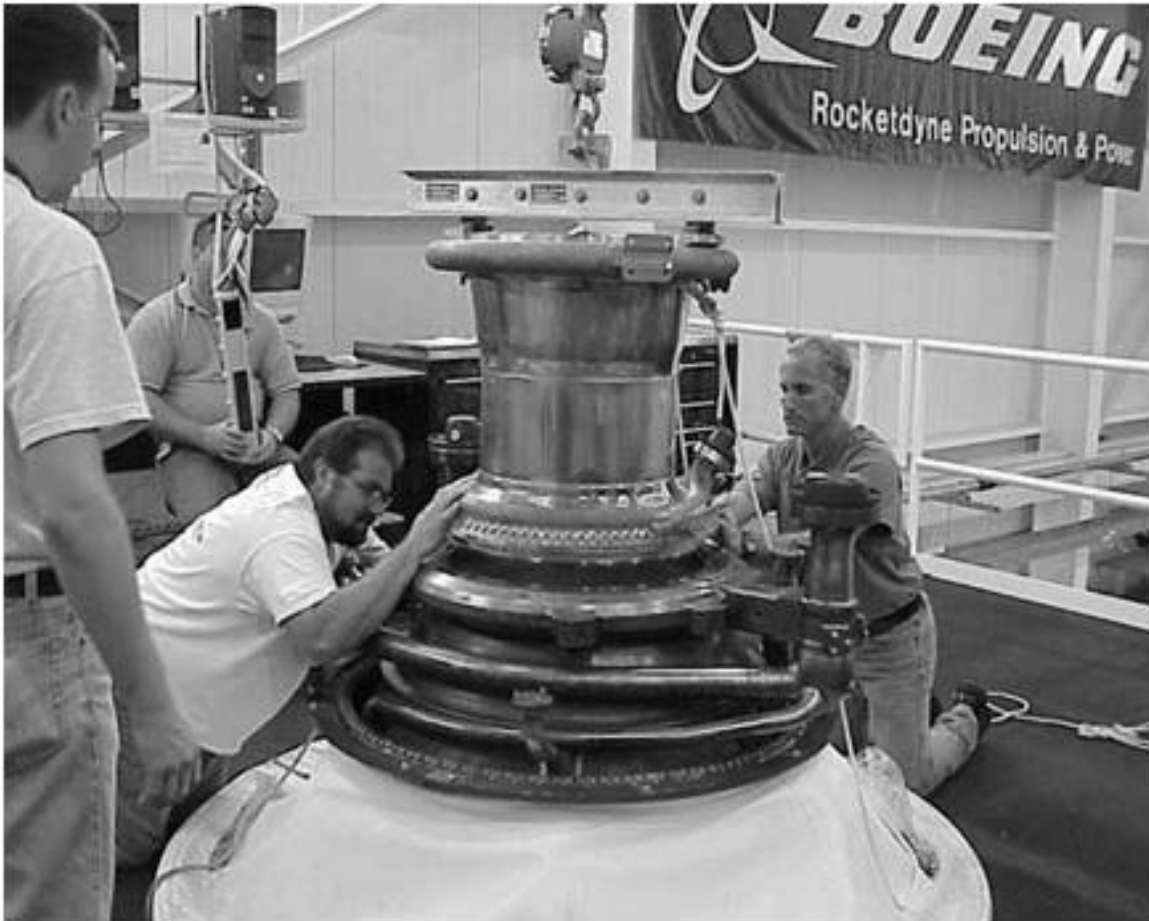
Figure C-31. Technicians attach the Main Combustion Chamber to the Nozzle in the SSMEPF at Kennedy Space Center, camera facing northeast, date unknown.
Source: George C. Marshall Space Flight Center.

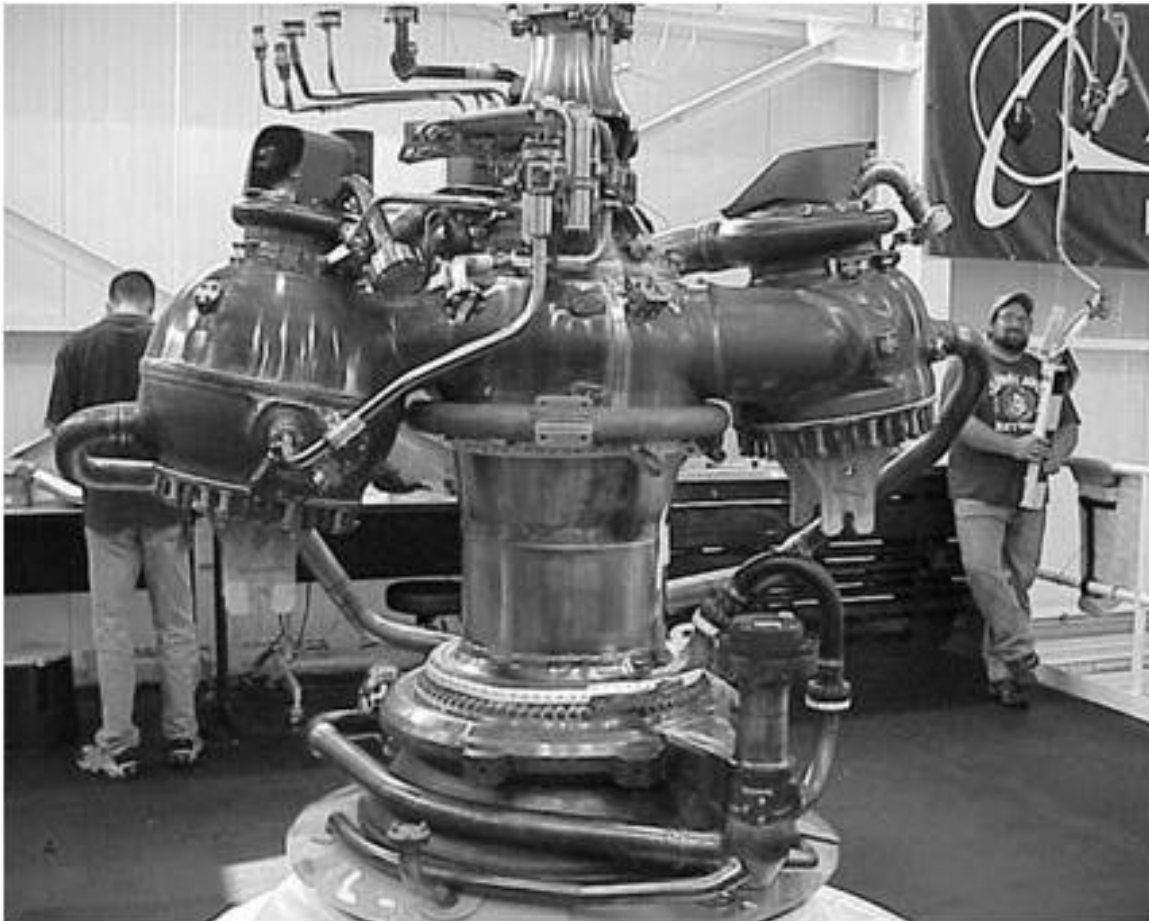
Figure C-32. Attachment of the Powerhead to the Main Combustion Chamber, SSMEPF, camera facing northeast, date unknown.

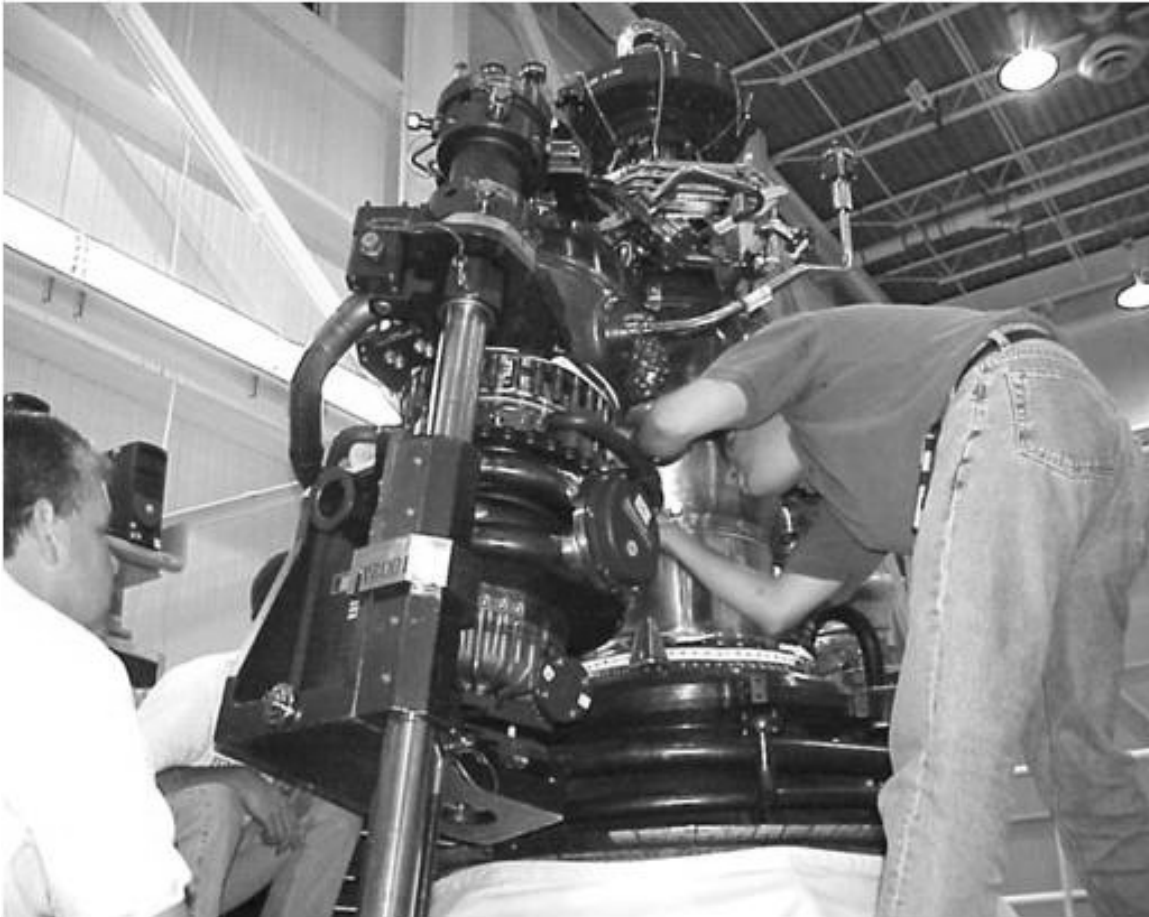
Figure C-33. A technician attaches the High Pressure Oxidizer Turbopump to the SSME, SSMEPF, camera facing northeast, date unknown.
Source: George C. Marshall Space Flight Center.
