SPACE TRANSPORTATION SYSTEM
Johnson Space Center, 2101 NASA Parkway
Houston
Harris County
Texas

HAER TX-116
HAER TX-116

SPACE TRANSPORTATION SYSTEM HAER No. TX-116

Report Prepared by: Joan Deming, Principal Investigator
Patricia Slovinac, Architectural Historian
Archaeological Consultants, Inc. (ACI)
8110 Blaikie Court, Suite A
Sarasota, Florida 34240

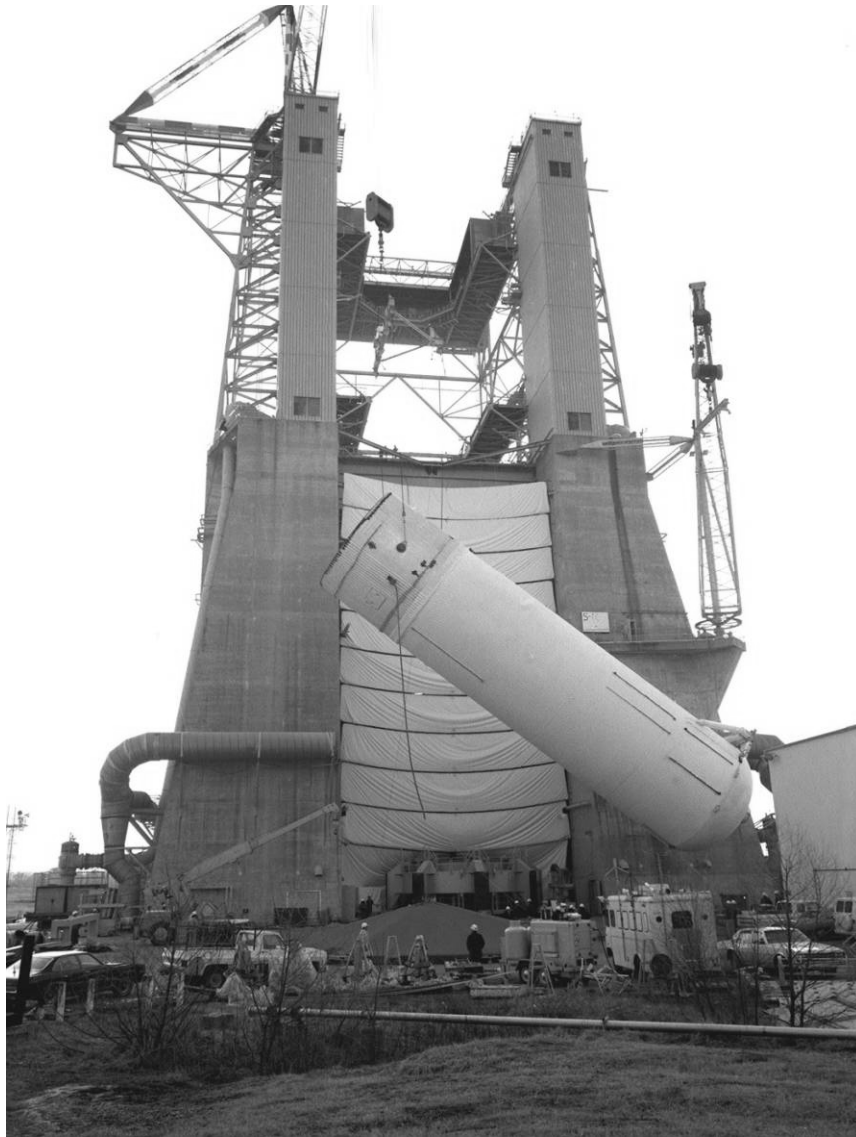
Figure D-1. Liquid hydrogen tank of the ET is installed into the S-1C Test Stand at MSFC for a structural test, March 1, 1978.

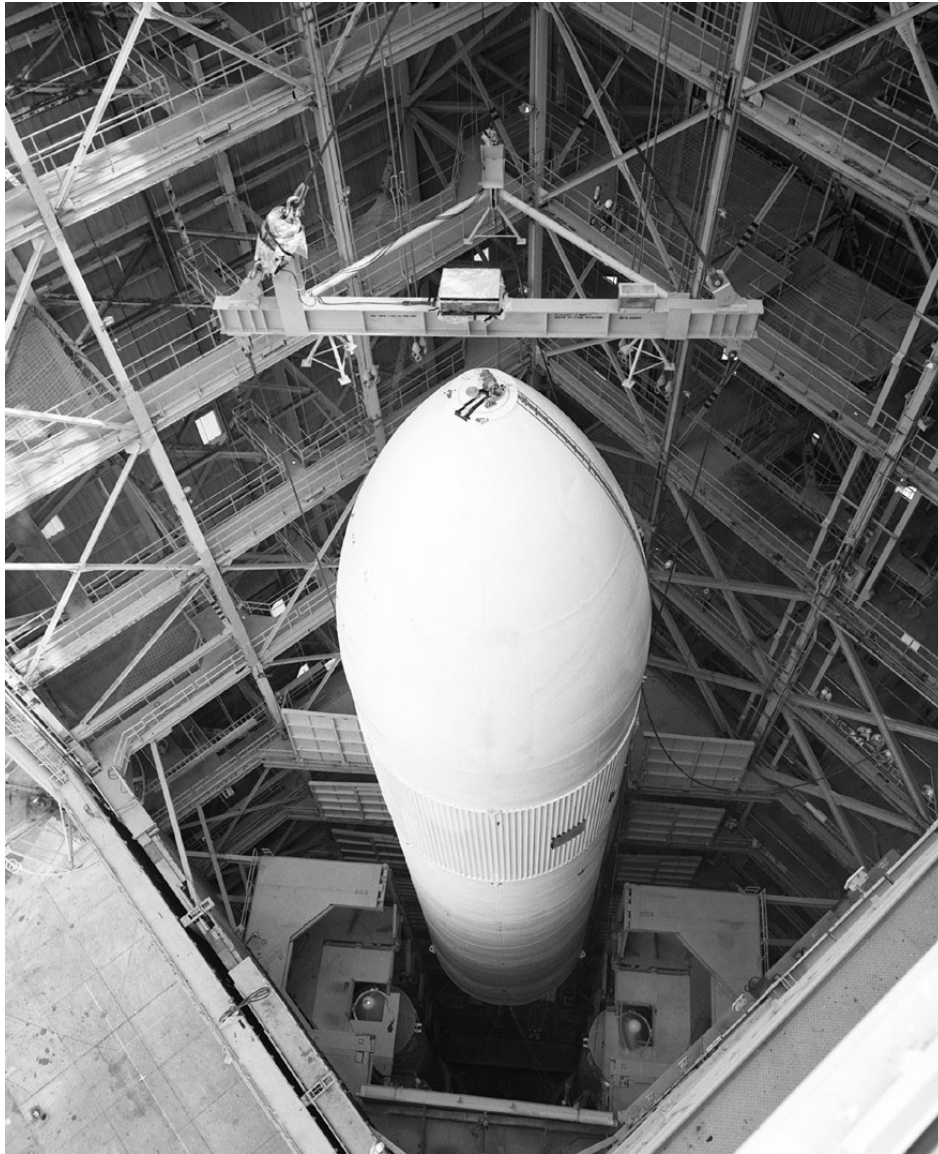
Figure D-4. Installation of ET into the Dynamic Test Stand (Building 4550) at MSFC for Mated Vertical Ground Vibration Test, September 29, 1978.

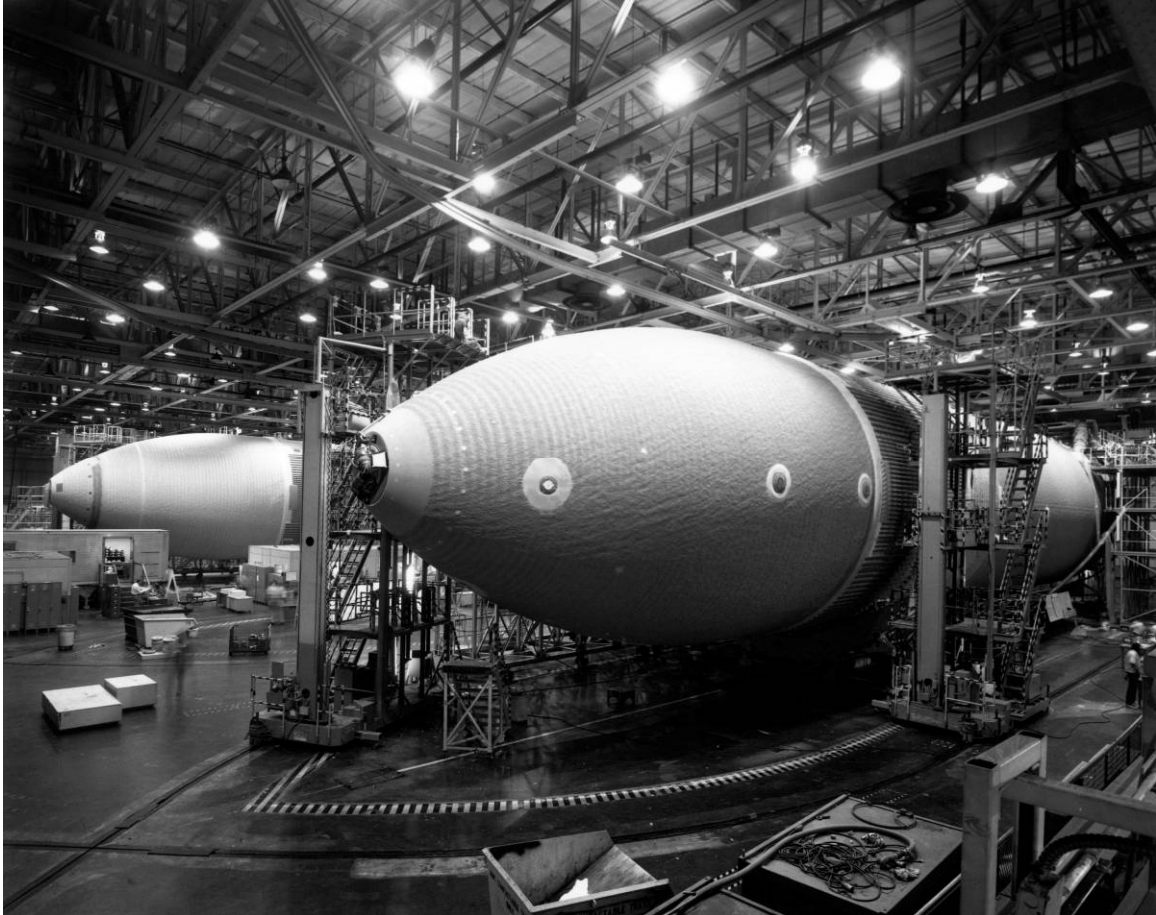
Figure D-5. A Standard Weight Tank (foreground) and a Lightweight Tank (rear) in final assembly at MAF, date unknown.

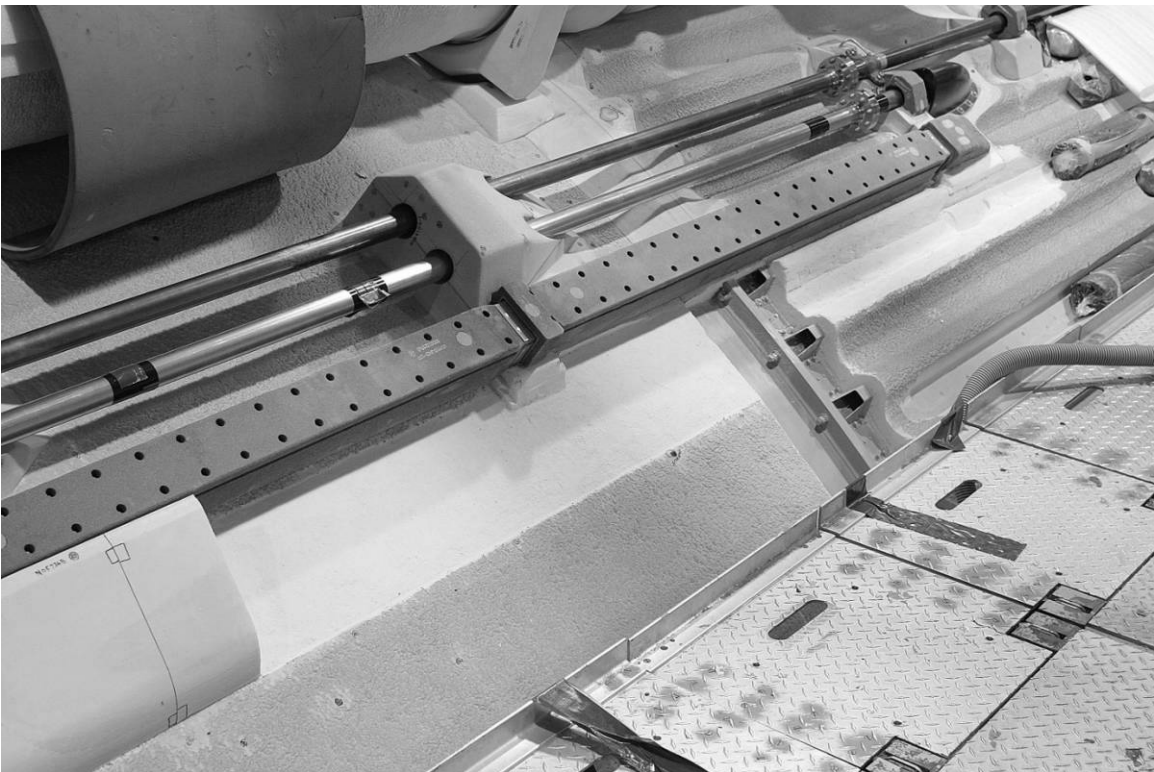
Figure D-11. PAL Ramp, August 12, 2004.

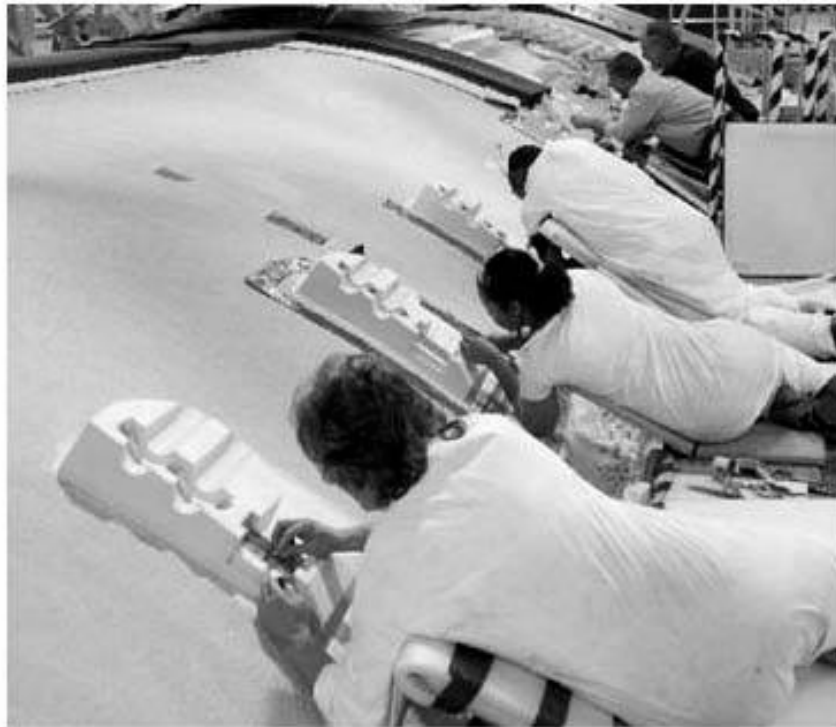
Figure D-12. Lockheed Martin technicians installing ice/frost ramps.
Source: NASA, *NASA Facts: Space Shuttle External Tank ET-128, STS-124*, 2; accessed at http://www.nasa.gov/centers/marshall/pdf/228641main_8-368946_%282%29.pdf.

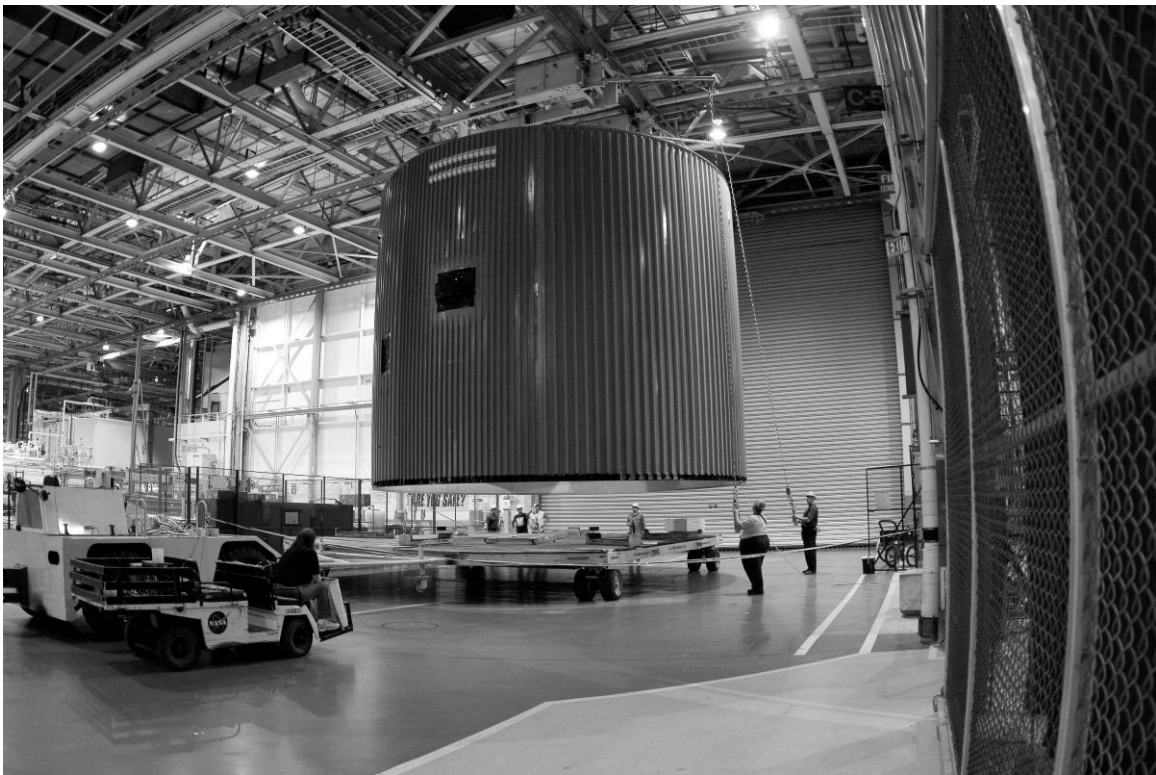
Figure D-23. View of the intertank for ET-138.
Source: NASA, Johnson Space Center, Imagery Online, jsc2010e009713.

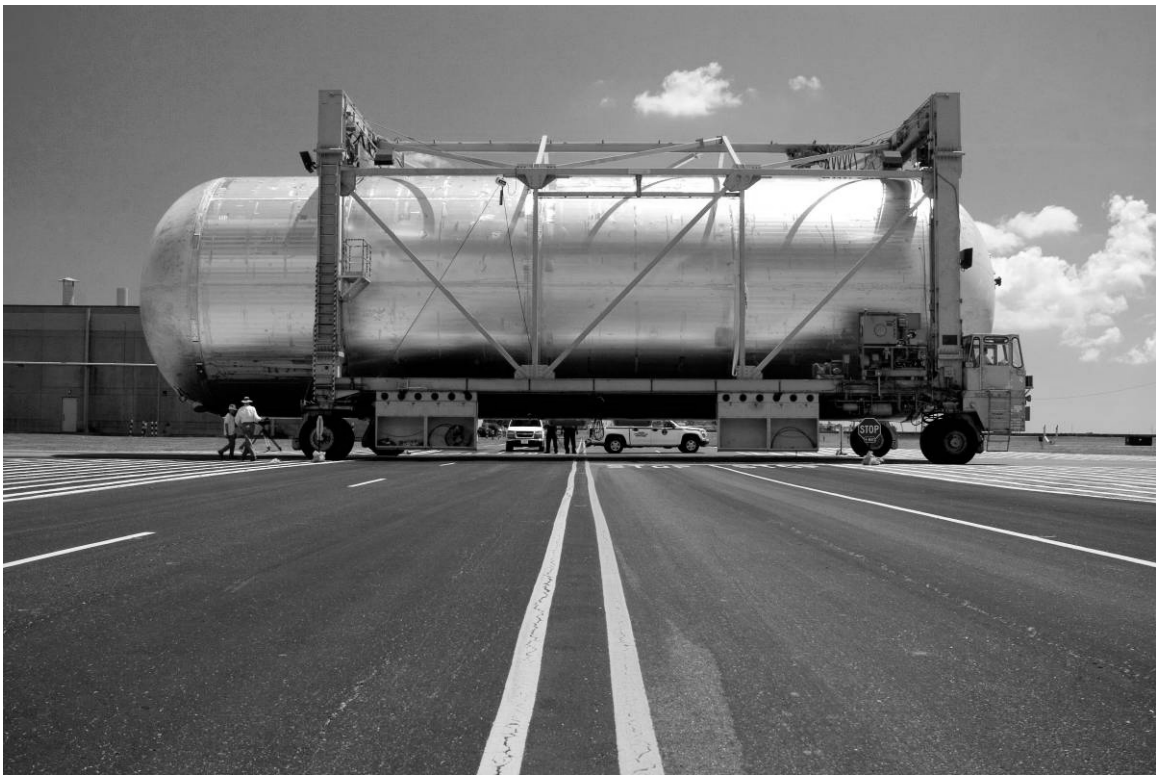
Figure D-25. The liquid hydrogen tank for ET-138 at MAF, May 30, 2009.
Source: NASA, Johnson Space Center, Imagery Online, jsc2010e009748.

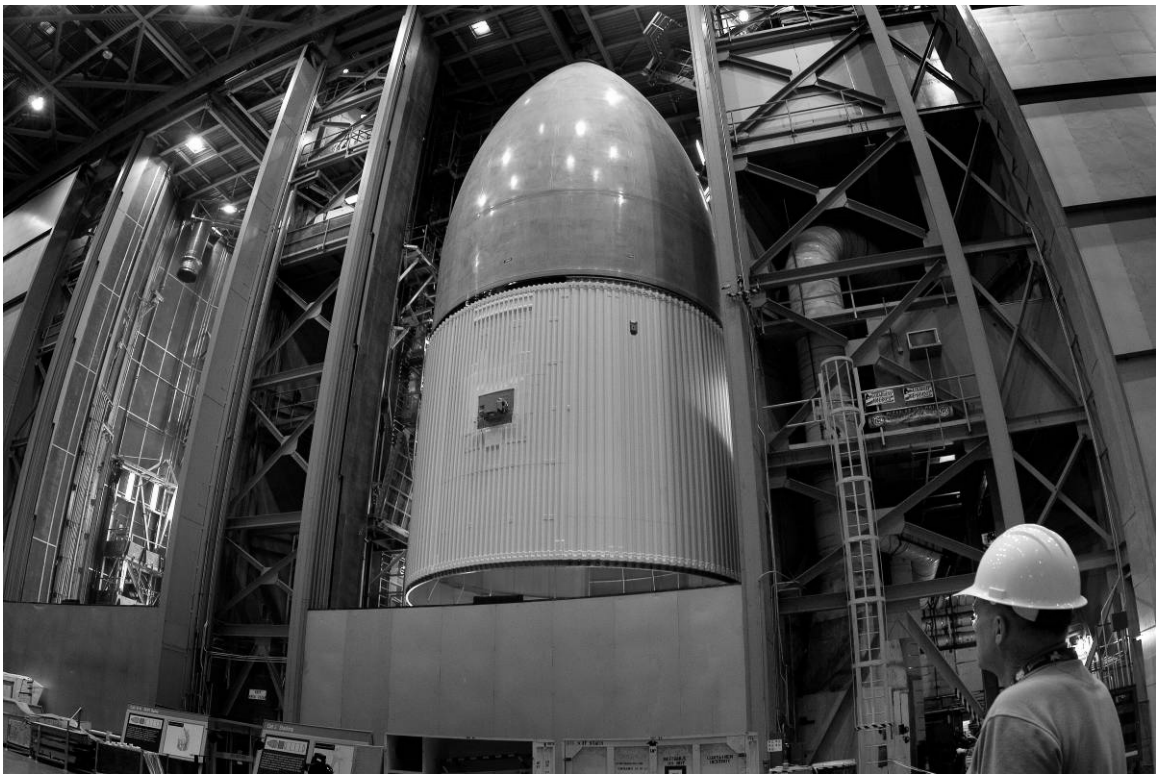
Figure D-33. LO2/intertank combination for ET-138 in Cell H at MAF,
November 12, 2009.
Source: NASA, Johnson Space Center, Imagery Online, jsc2010e009722.

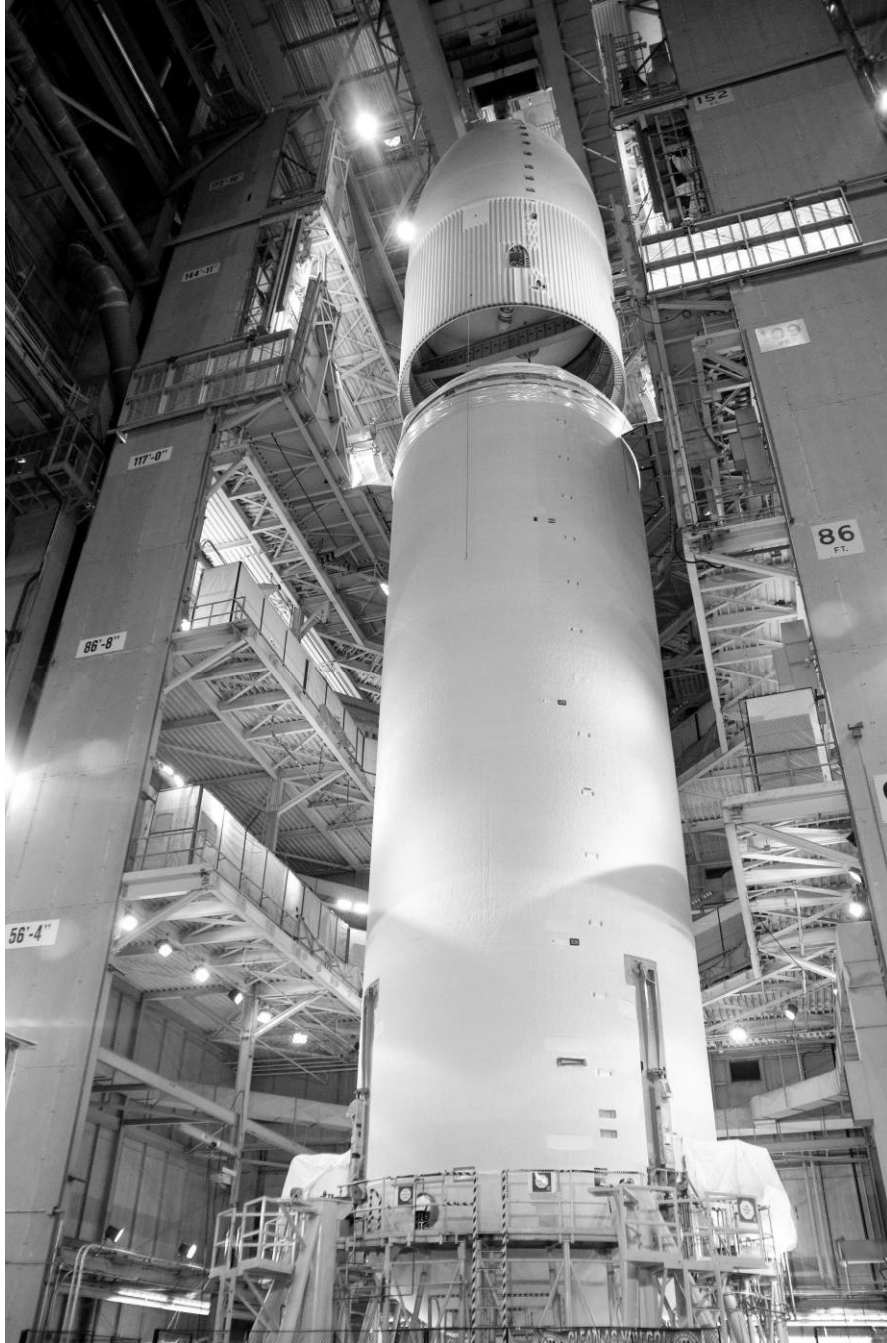
Figure D-34. LO2/intertank combination being moved to Cell A at MAF for stacking on top of the LH2 tank to complete ET-133, February 4, 2009.

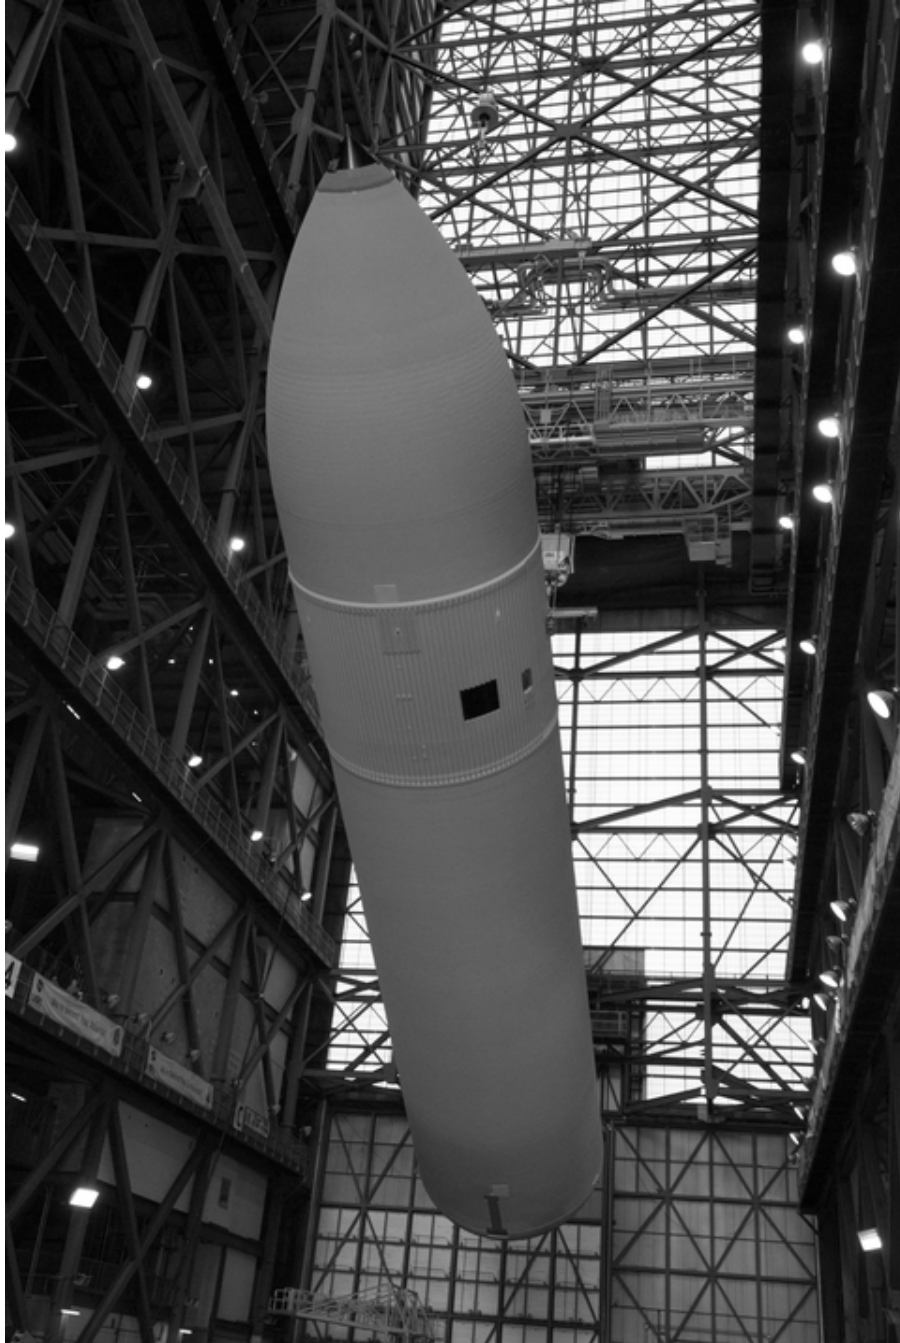
Figure D-41. ET-135 being rotated to vertical in KSC's VAB for placement into a test cell,
January 6, 2010.

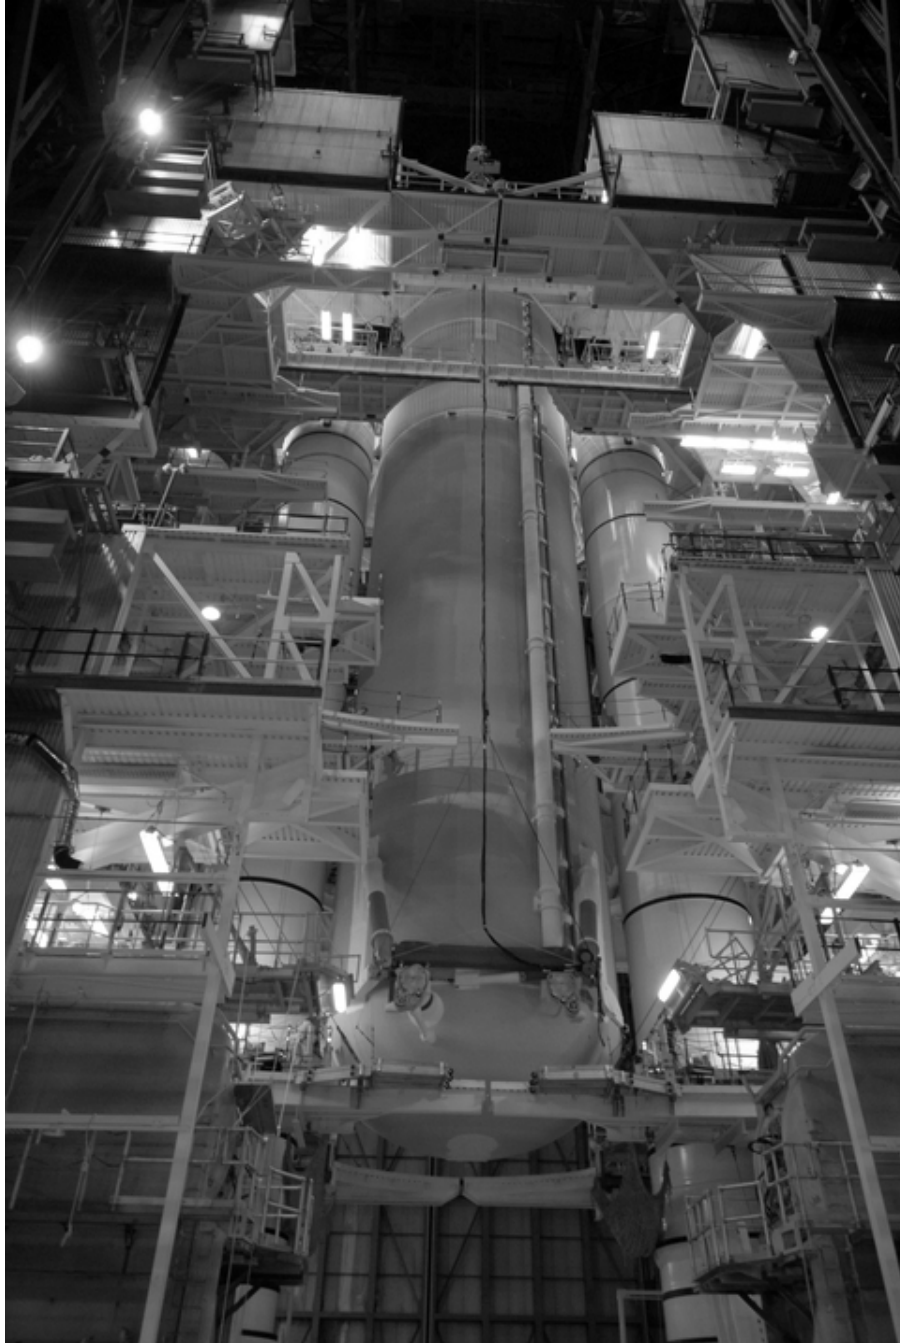
Figure D-43. ET-29 being lowered between the SRBs in KSC's VAB for mating,
August 28, 2008.

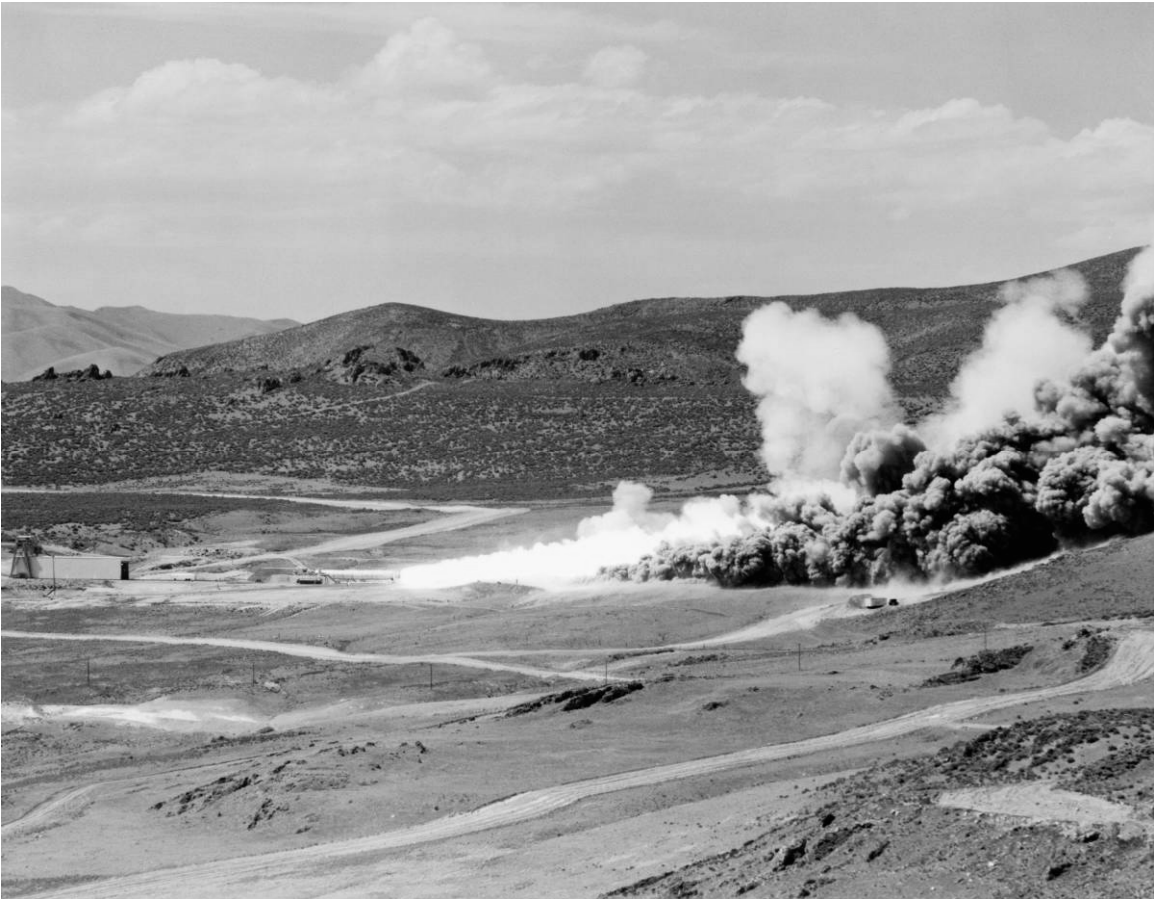
Figure No. E-1. SRB Development Motor-1 (DM-1) in test stand at Morton Thiokol facility at Wasatch, Utah, July 18, 1977.

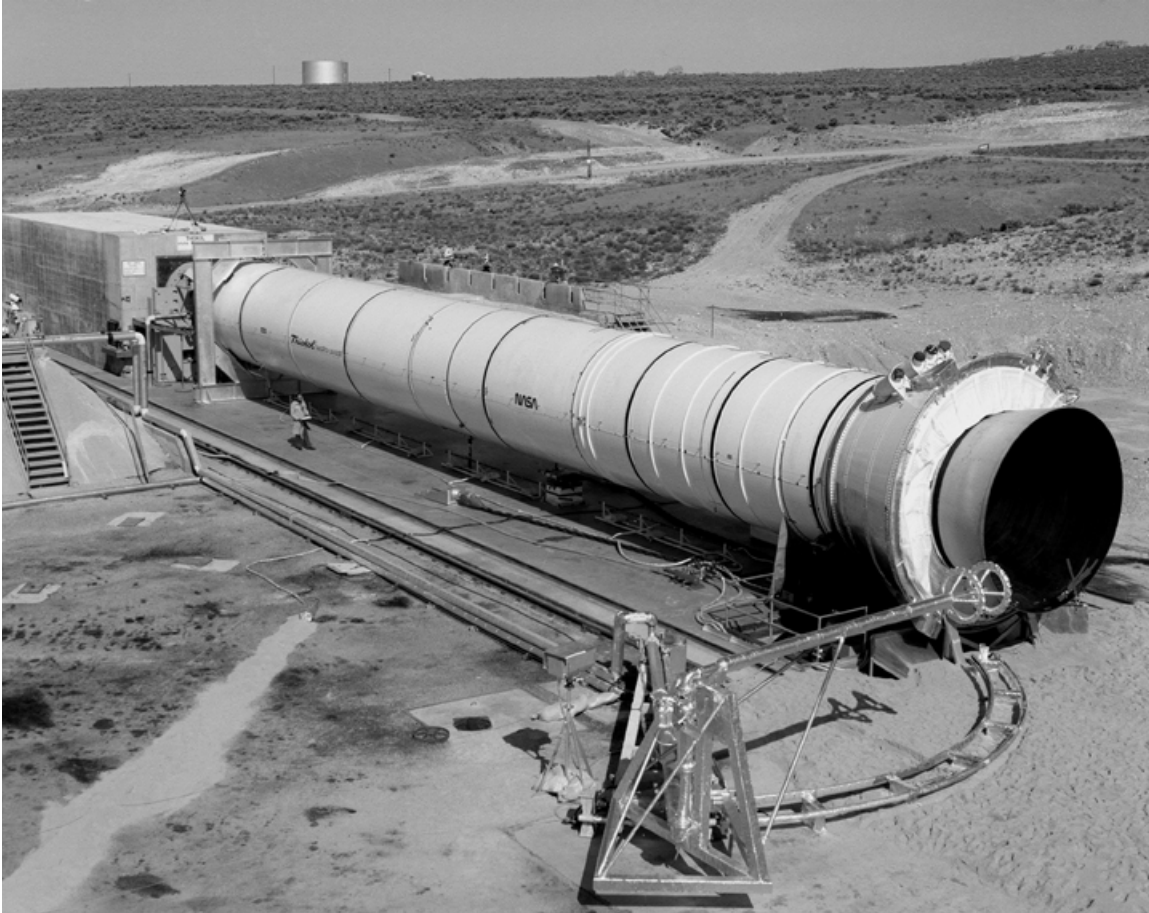
Figure No. E-2. SRB Qualification Motor-1 (QM-1) in test stand at Morton Thiokol facility at Wasatch, Utah, July 13, 1979.

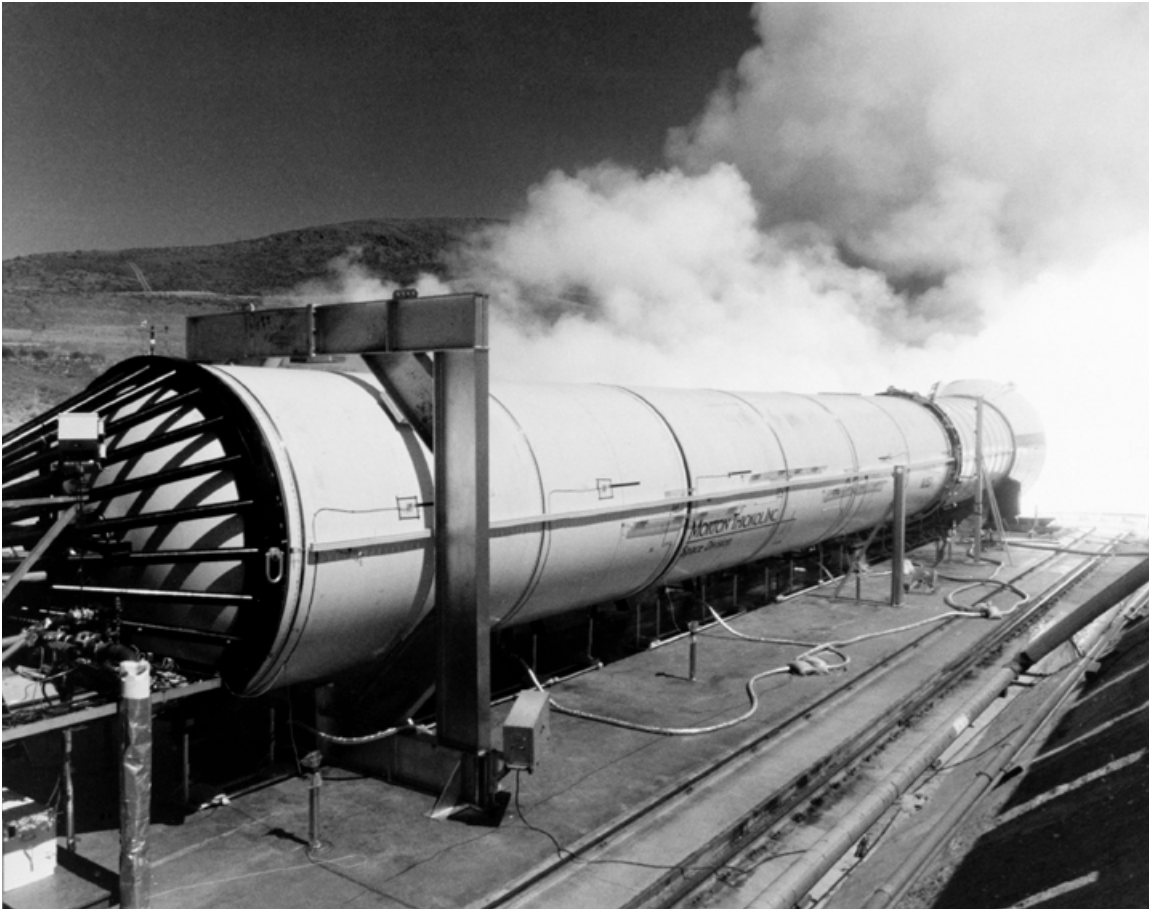
Figure No. E-3. Test firing of Development Motor-8 (DM-8) in test stand at Morton Thiokol's Wasatch, Utah, facility, August 27, 1987.

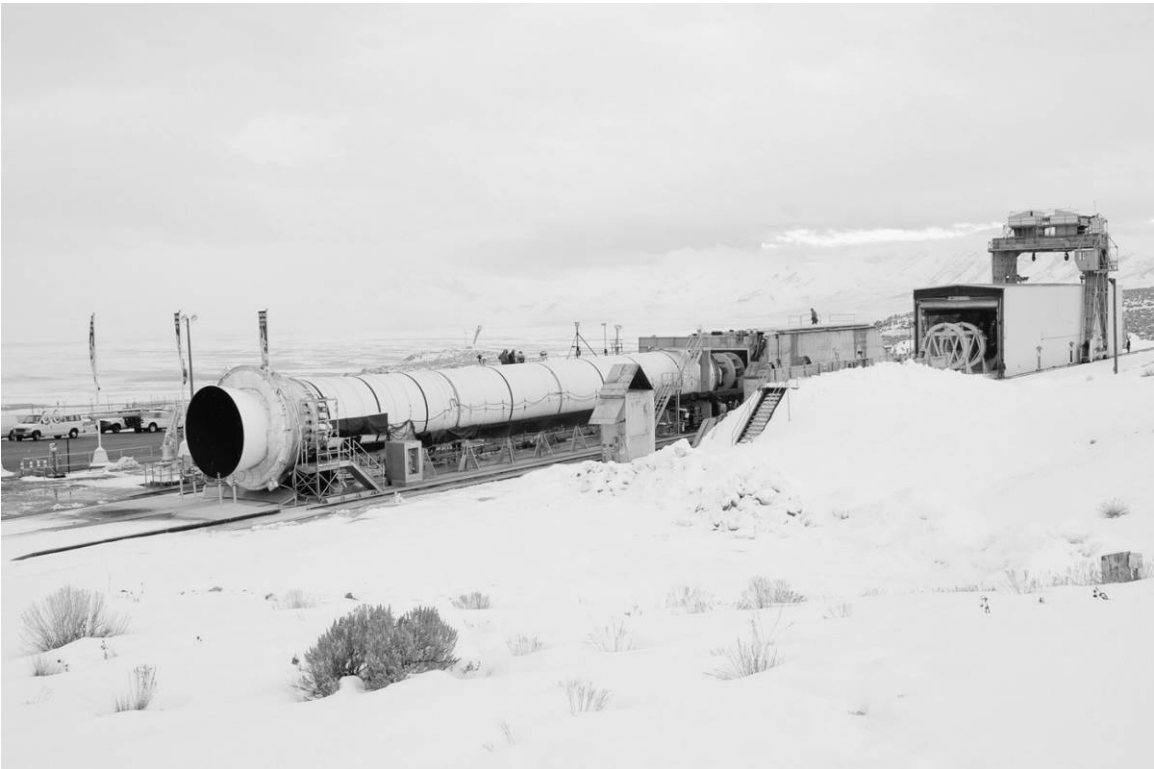
Figure No. E-4. Flight Support Motor (FSM)-17 test, February 25, 2010, at ATK in Promontory, Utah. This was the last RSRM test of the Space Shuttle program.
Source: NASA, accessed at http://www.nasa.gov/images/content/429987main_179307_002.jpg.

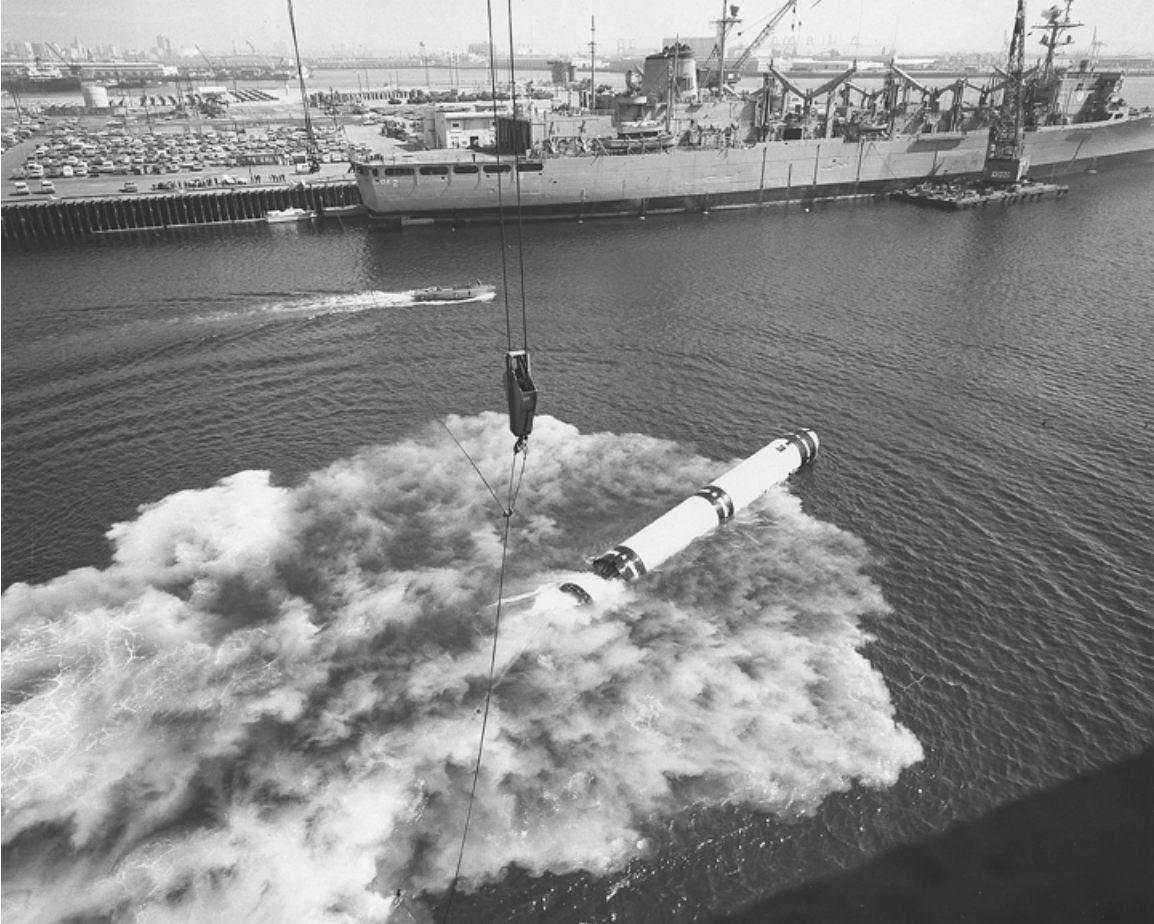
Figure No. E-5. Solid rocket booster drop tests at the Long Beach Naval Shipyard, California, 1973.

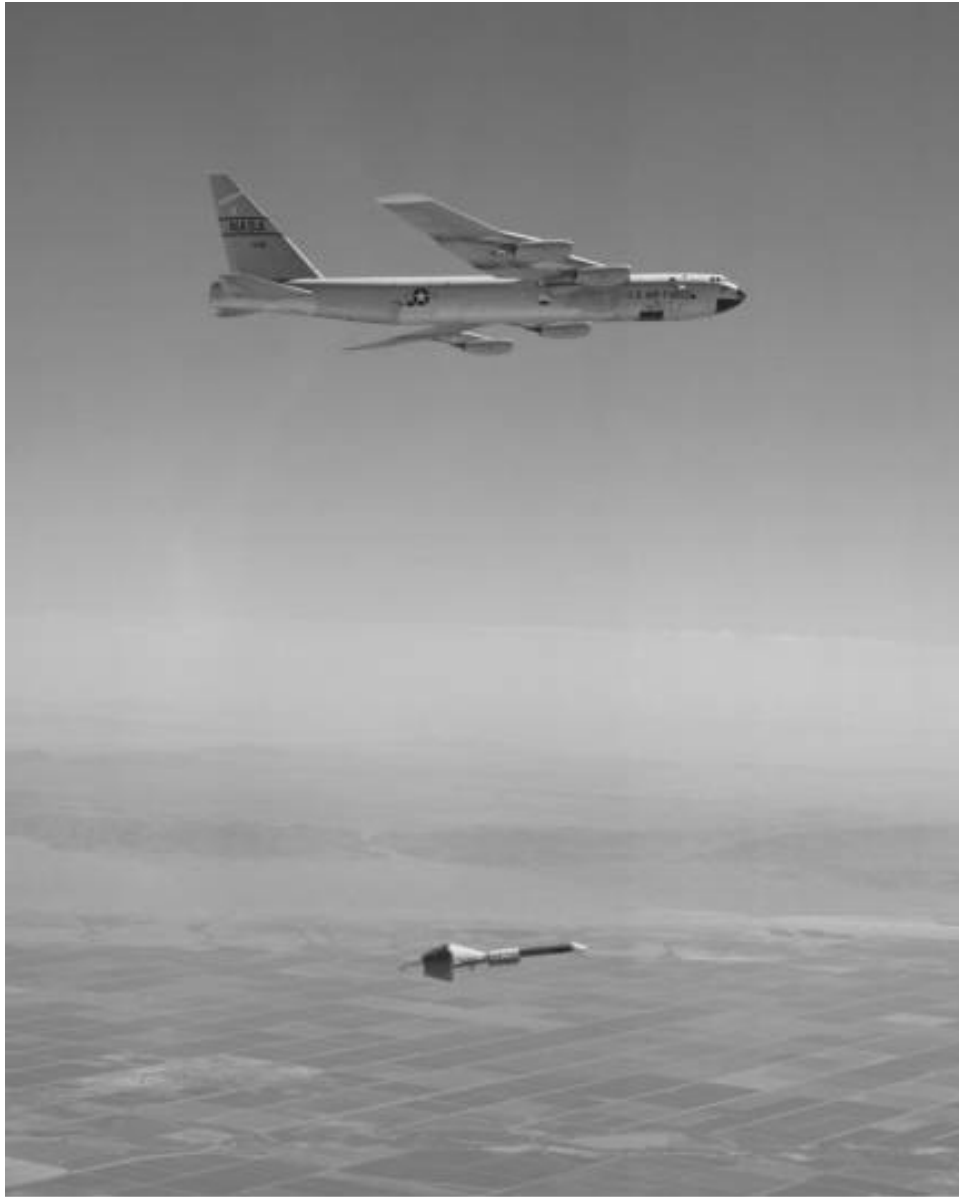
Figure No. E-8. Space Shuttle Solid Rocket Booster Drop Test Vehicle (SRB-DTV) first release from NB-52B, August 13, 1977.

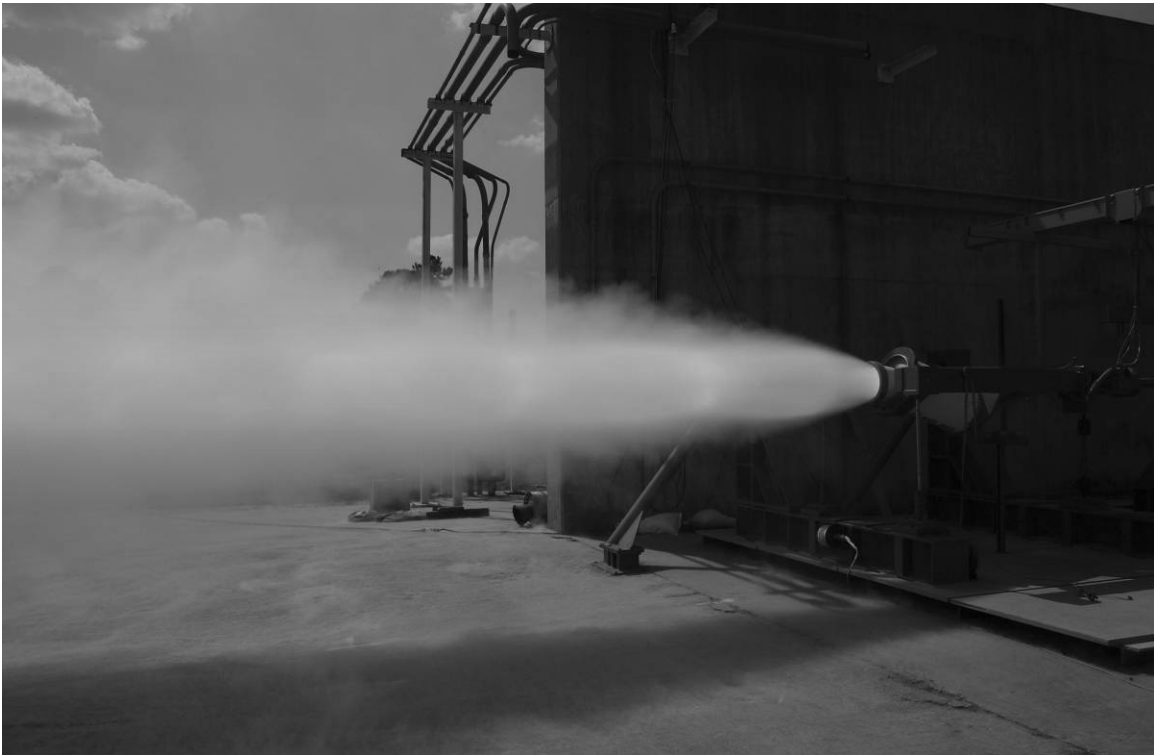
Figure No. E-10. Space Shuttle SRB separation motor test firing at Test Stand 116 at MSFC, March 28, 2007.

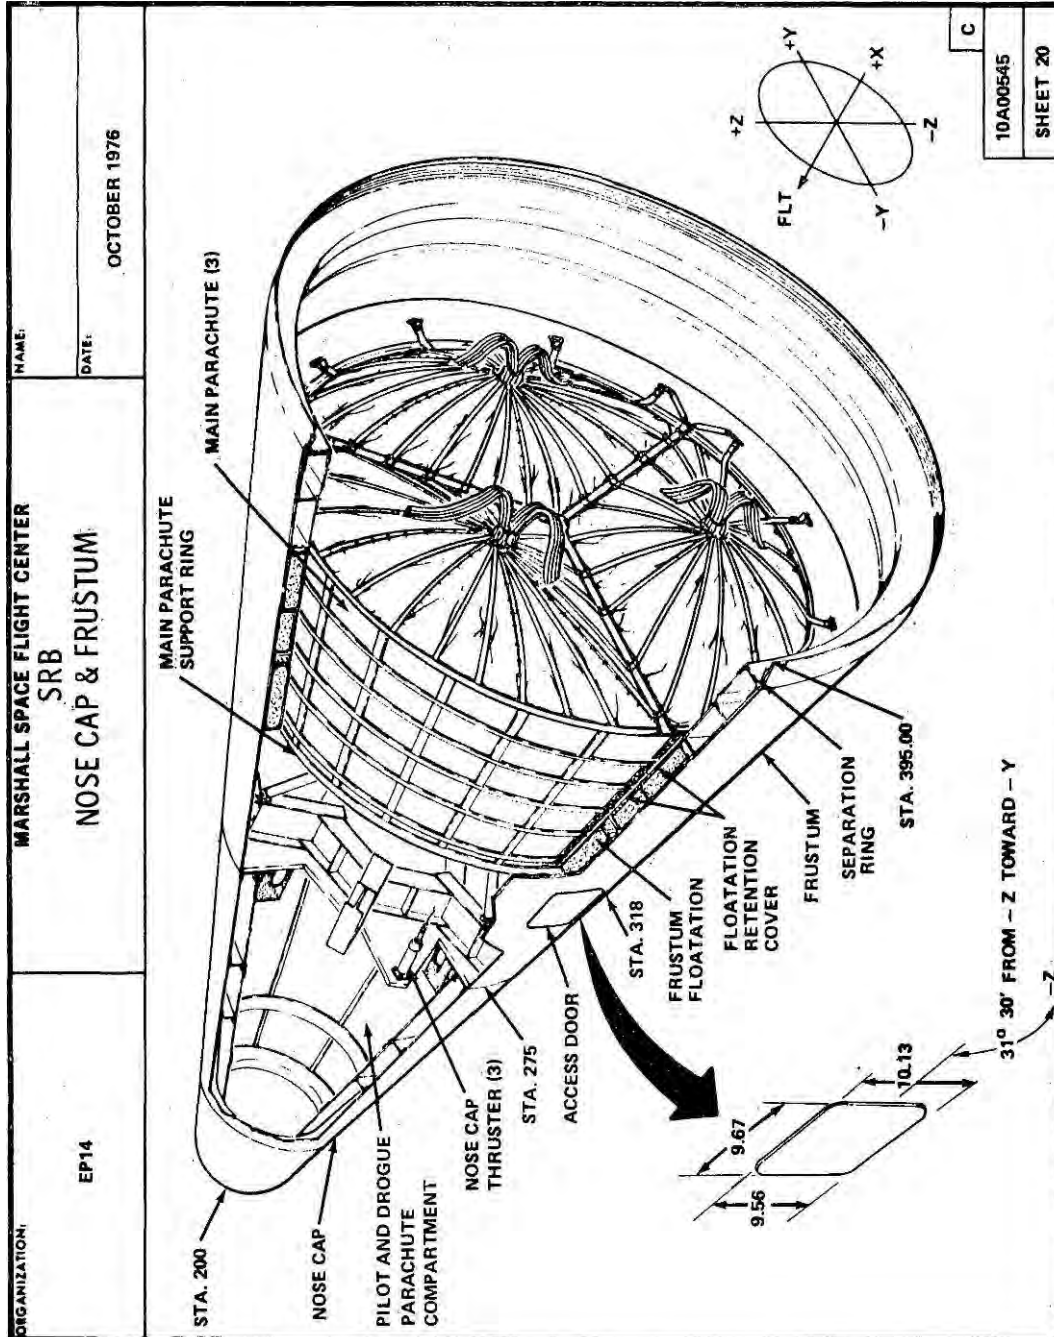
Figure No. E-14. Diagram of SRB nose cap and frustum.

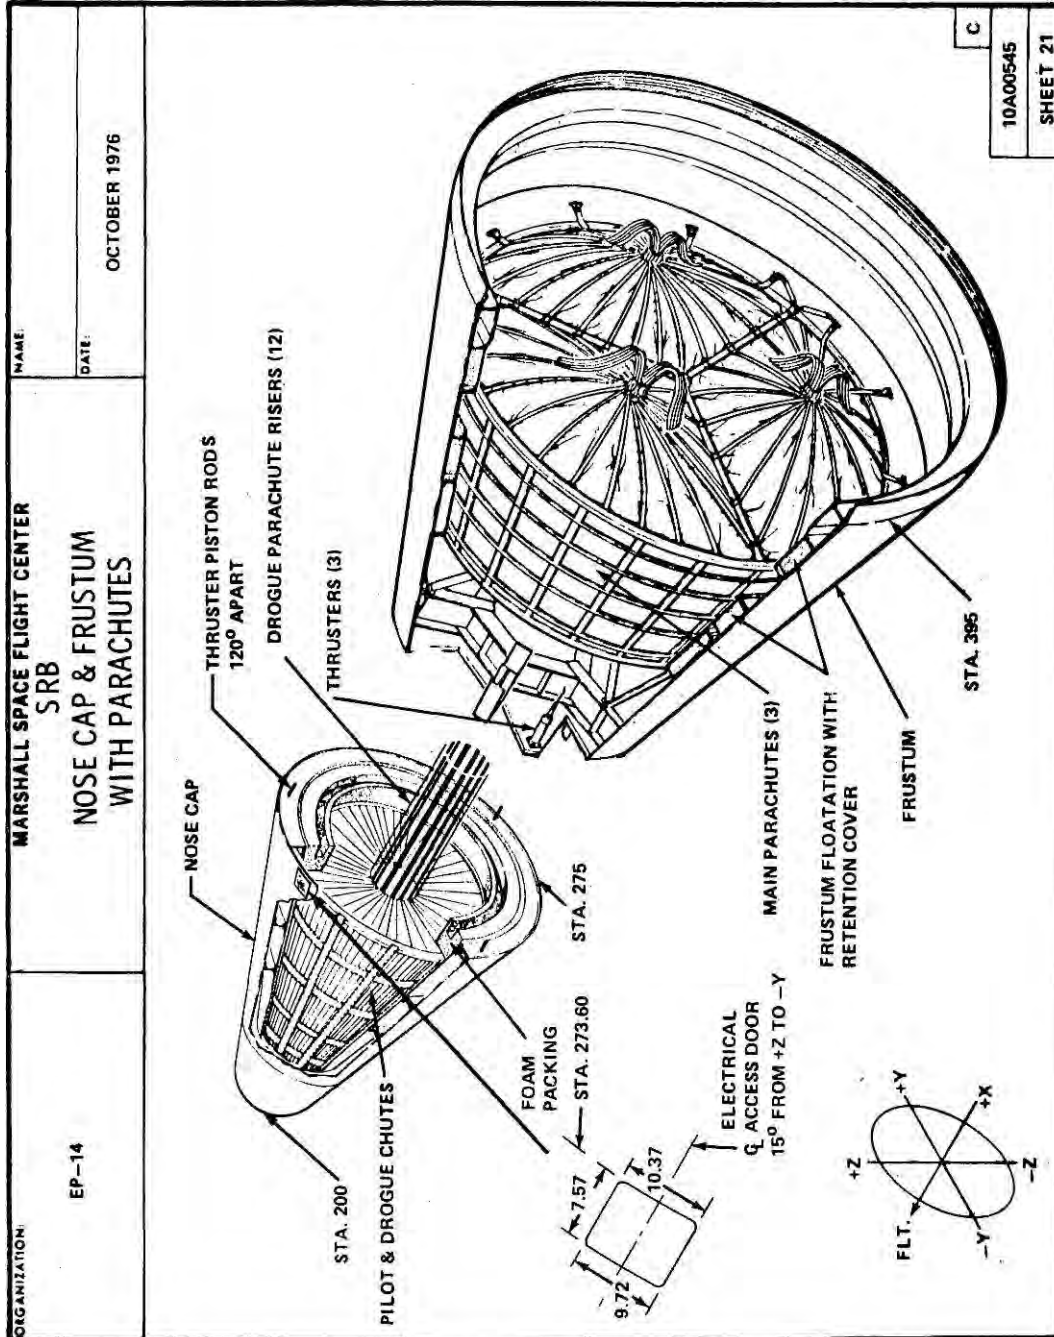
Figure No. E-15. Diagram of SRB nose cap (with parachute) and frustum.
 Source: Griner, et al., *Space Shuttle Solid Rocket Booster Pictorial Representations*, sheet 21.

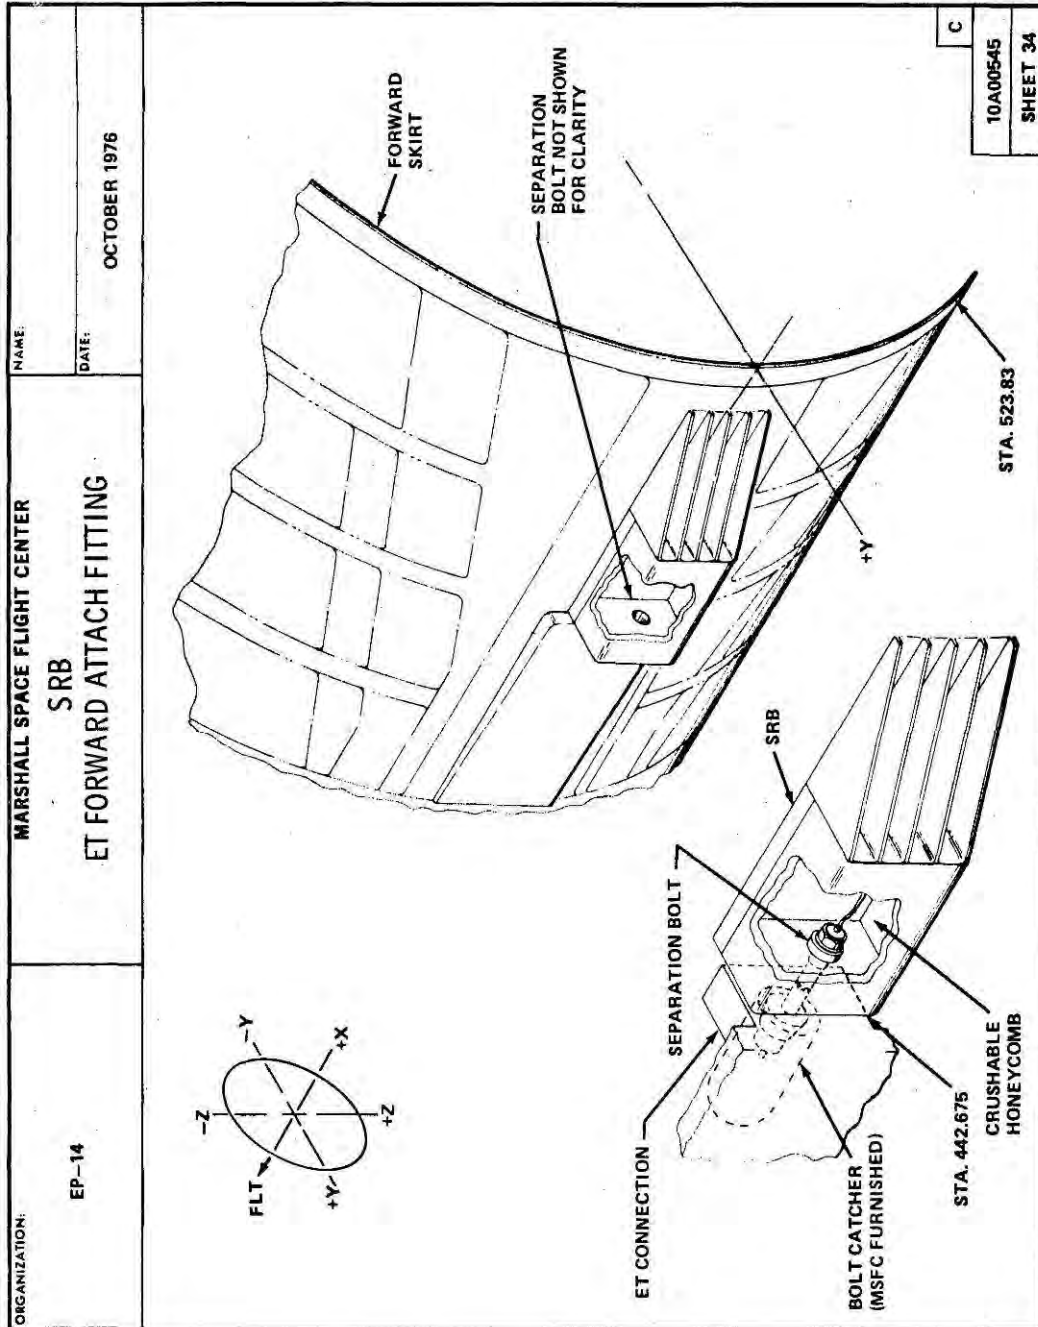
Figure No. E-17. Diagram of SRB/ET forward attach fitting.
 Source: Griner, et al., *Space Shuttle Solid Rocket Booster Pictorial Representations*, sheet 34.
