SPACE TRANSPORTATION SYSTEM
Johnson Space Center, 2101 NASA Parkway
Houston
Harris County
Texas

HAER TX-116
HAER TX-116

SPACE TRANSPORTATION SYSTEM HAER No. TX-116

Report Prepared by: Joan Deming, Principal Investigator
Patricia Slovinac, Architectural Historian
Archaeological Consultants, Inc. (ACI)
8110 Blaikie Court, Suite A
Sarasota, Florida 34240

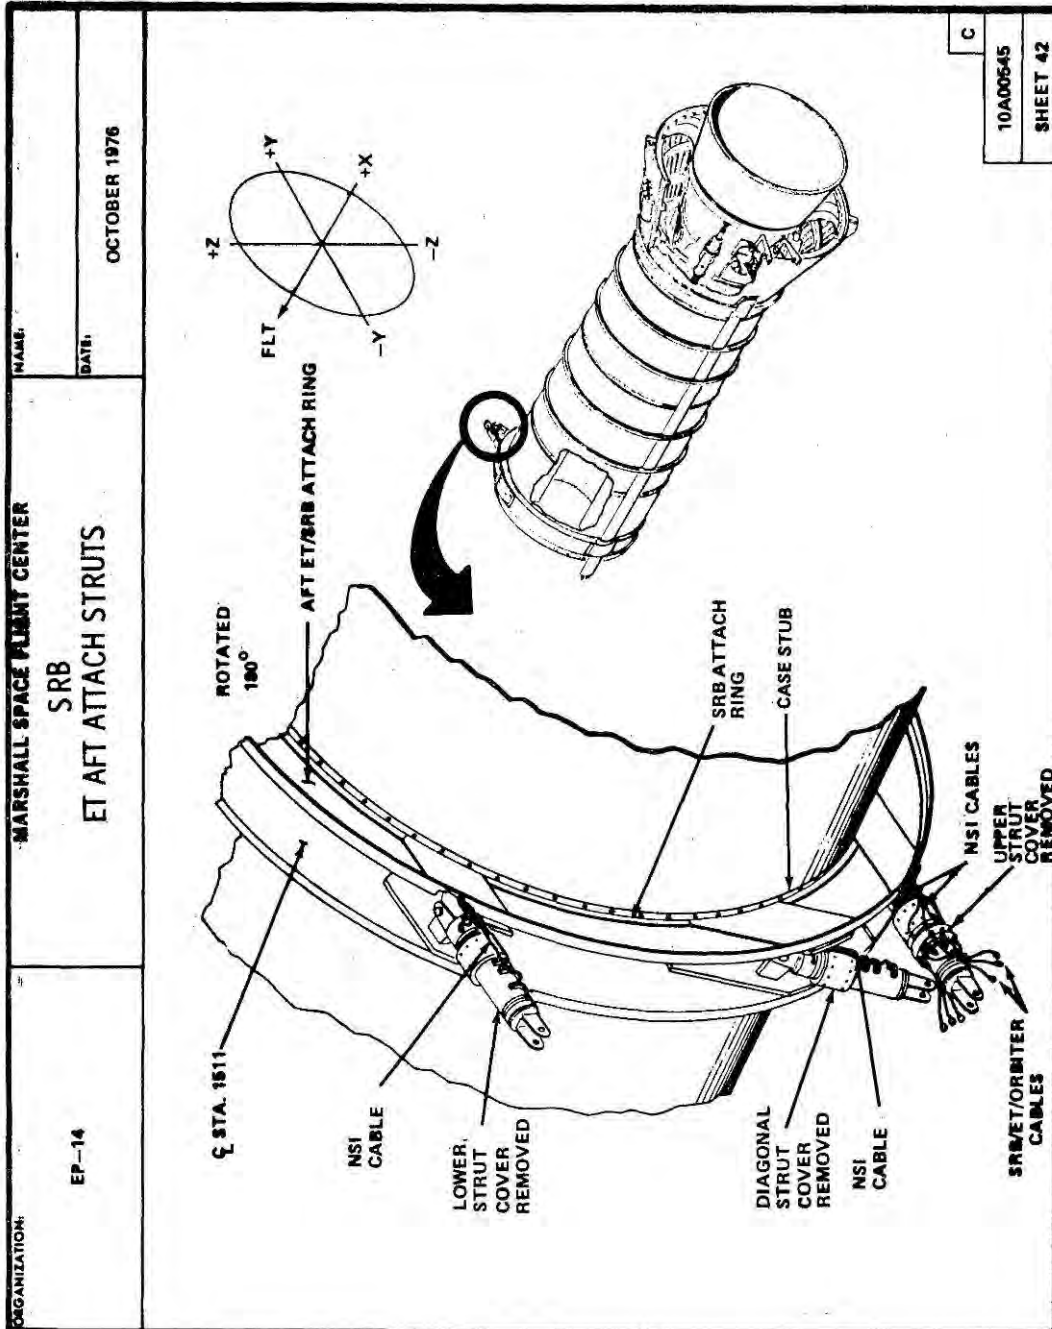
Figure No. E-18. Diagram of SRB/ET aft attach struts.

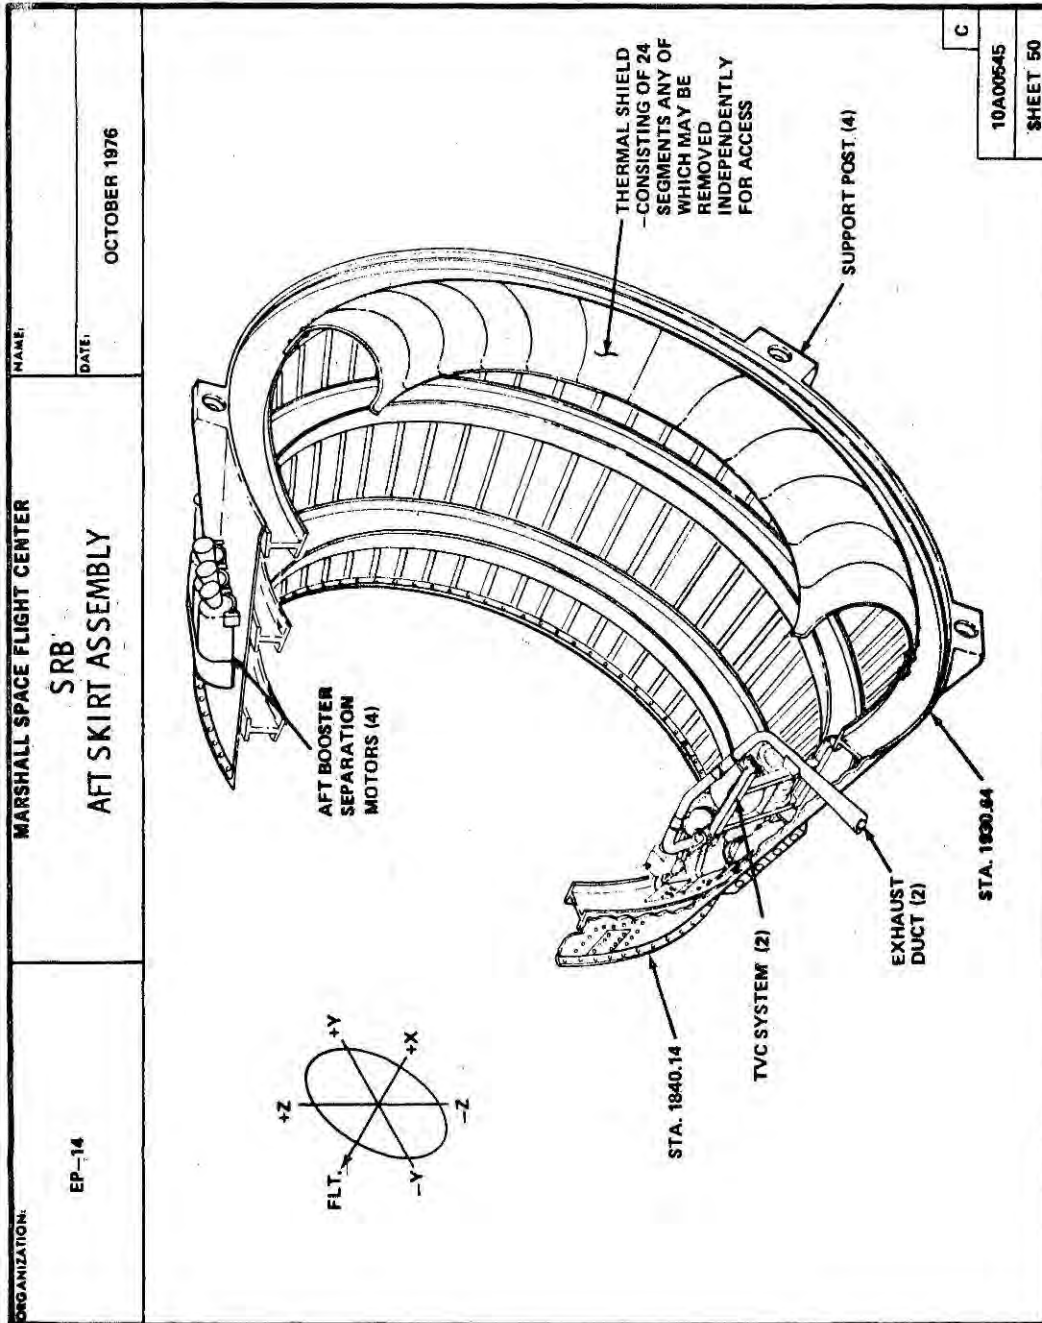
Figure No. E-20. Diagram of SRB aft skirt.

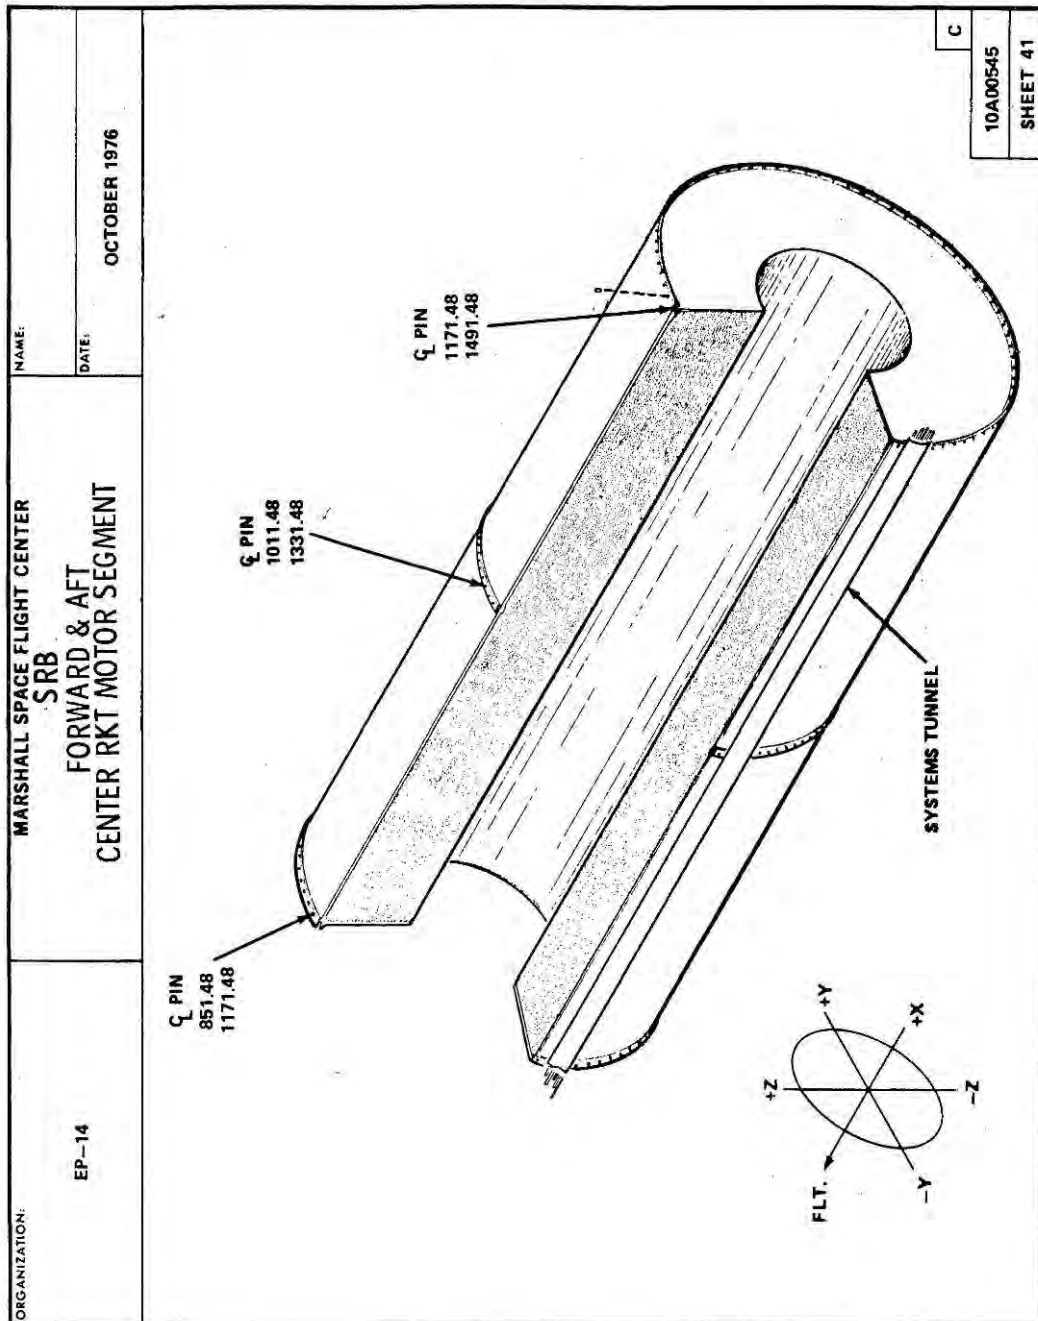
Figure No. E-22. Diagram of SRB center motor segments.
 Source: Griner, et al., *Space Shuttle Solid Rocket Booster Pictorial Representations*, sheet 41.

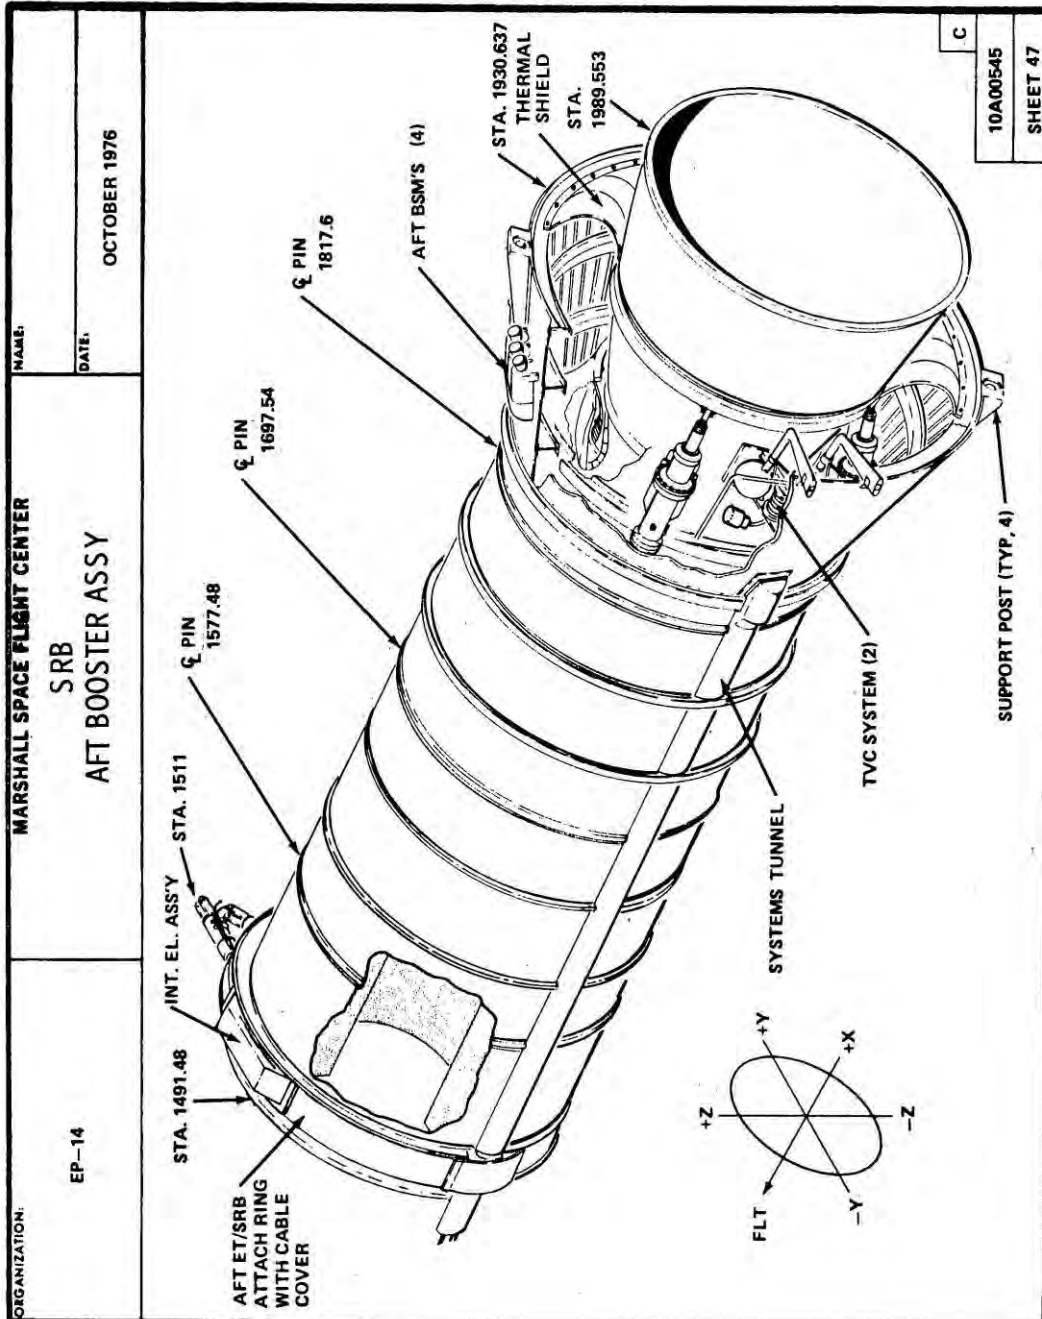
Figure No. E-24. Diagram of SRB aft booster assembly with skirt.
 Source: Griner, et al., *Space Shuttle Solid Rocket Booster Pictorial Representations*, sheet 47.

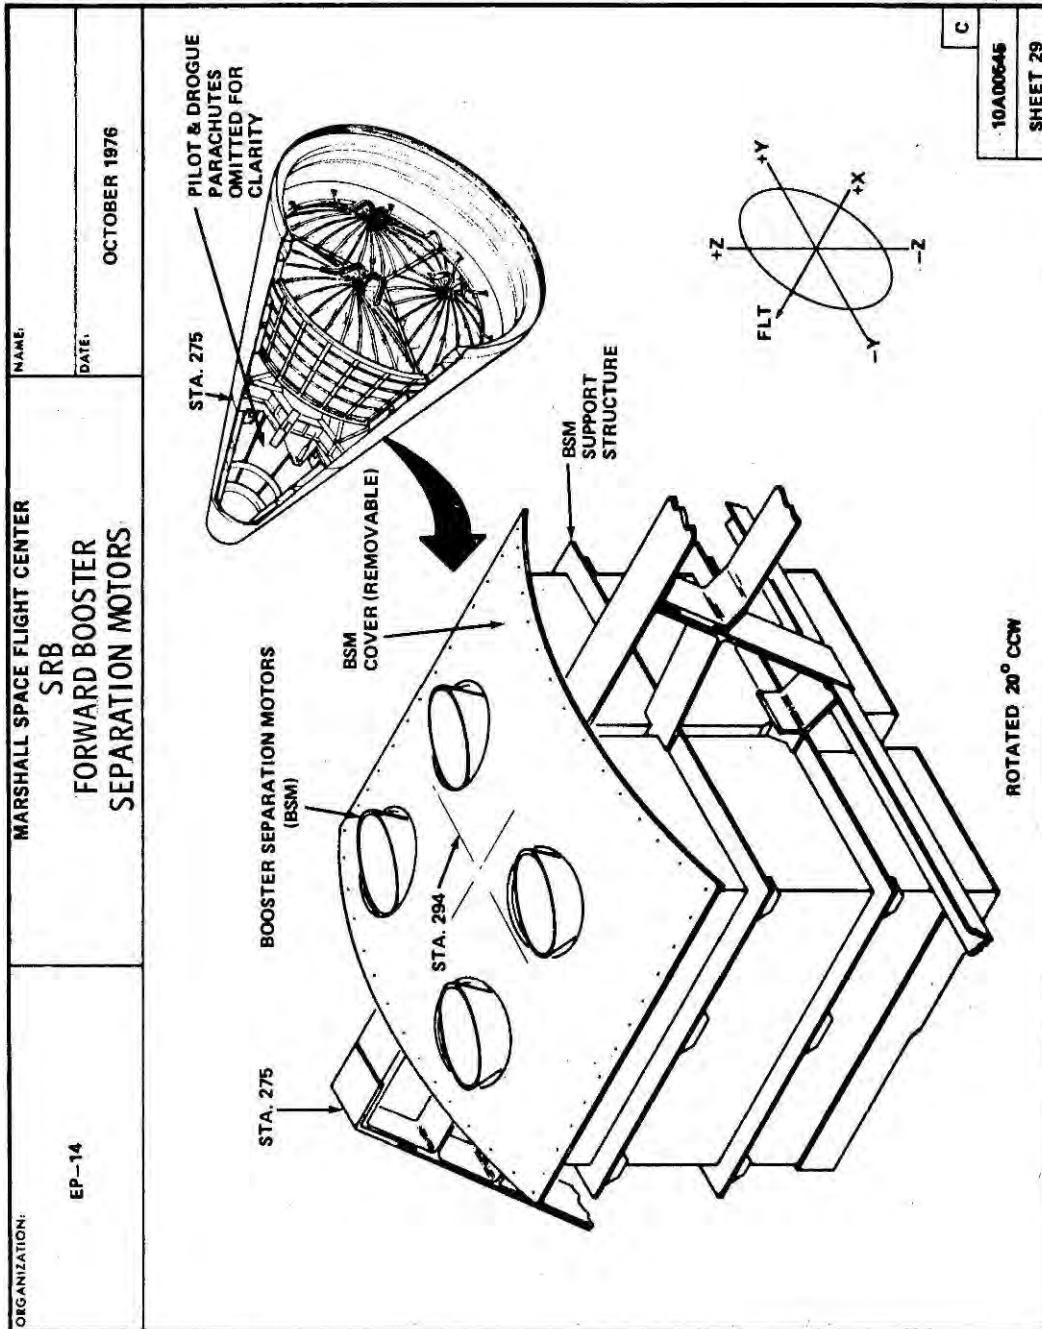
Figure No. E-25. Diagram of SRB forward booster separation motors.
Source: Griner, et al., *Space Shuttle Solid Rocket Booster Pictorial Representations*, sheet 29.

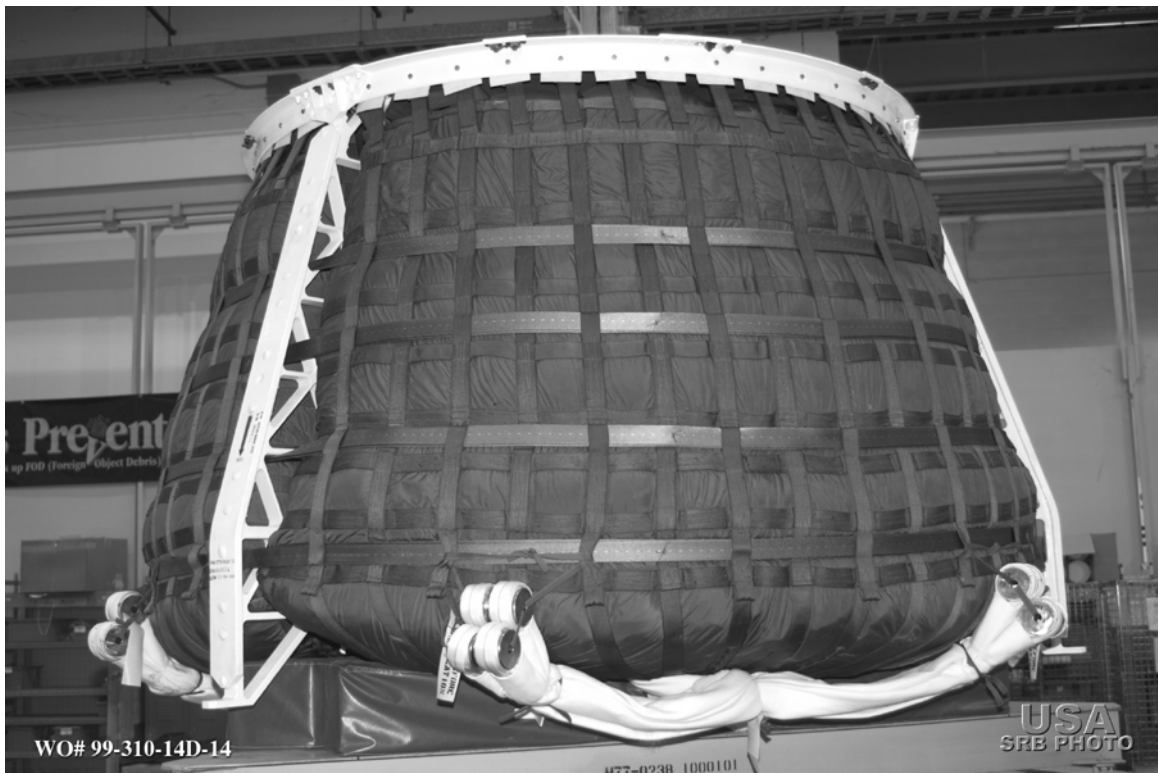
Figure No. E-28. SRB Parachute Assembly.
Source: USA, WO# 99-310-14D-14

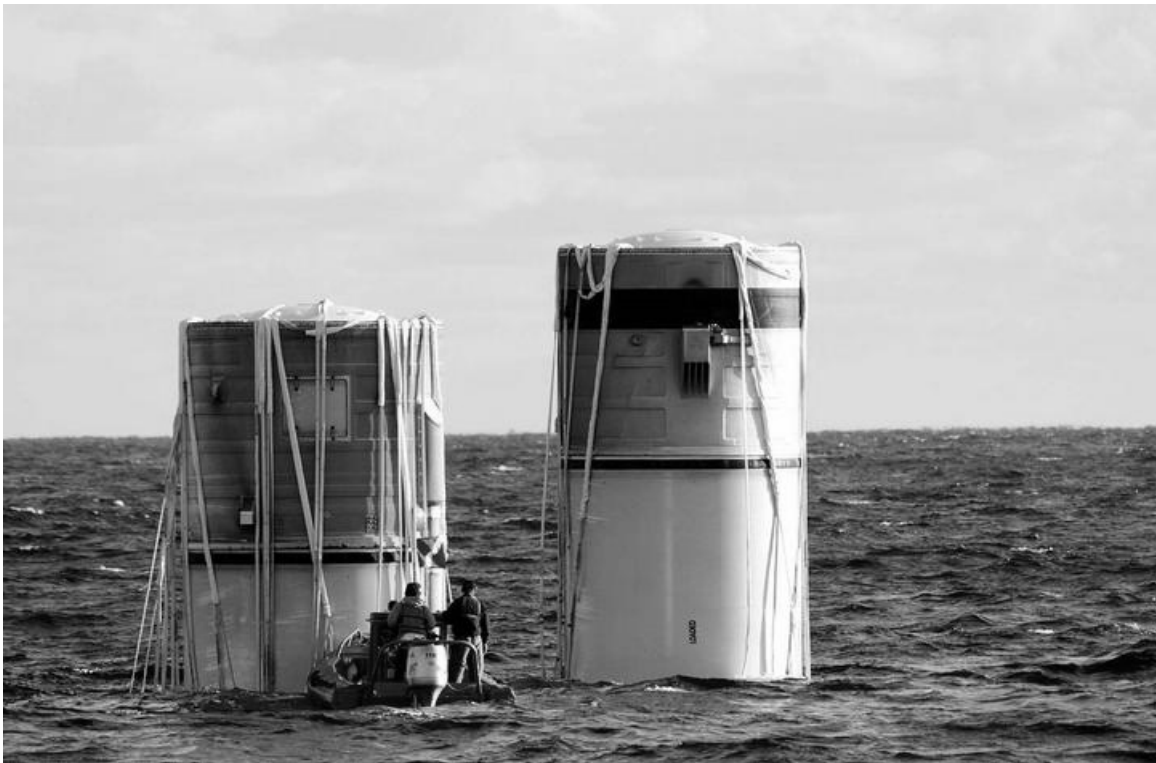
Figure No. E-32. Right and left SRBs in Atlantic Ocean after jettison on December 9 (*Discovery*, STS-116), December 10, 2006.

The SRB nozzle extension was jettisoned just before splashdown, in order to prevent damage to the TVC hardware, located inside the aft skirt, from water impact forces.¹⁶⁸³ This occurred about the time the canopies reached 100 percent of inflation.¹⁶⁸⁴ The dispersion bridles of the main parachutes separated from the risers via the SWAR, and the main parachutes remained attached to the booster via their 50'-long Kevlar retrieval lines. Air trapped in the motor casing of the booster allowed it to float vertically, with the forward end about 30' out of the water (Figure No. E-32).

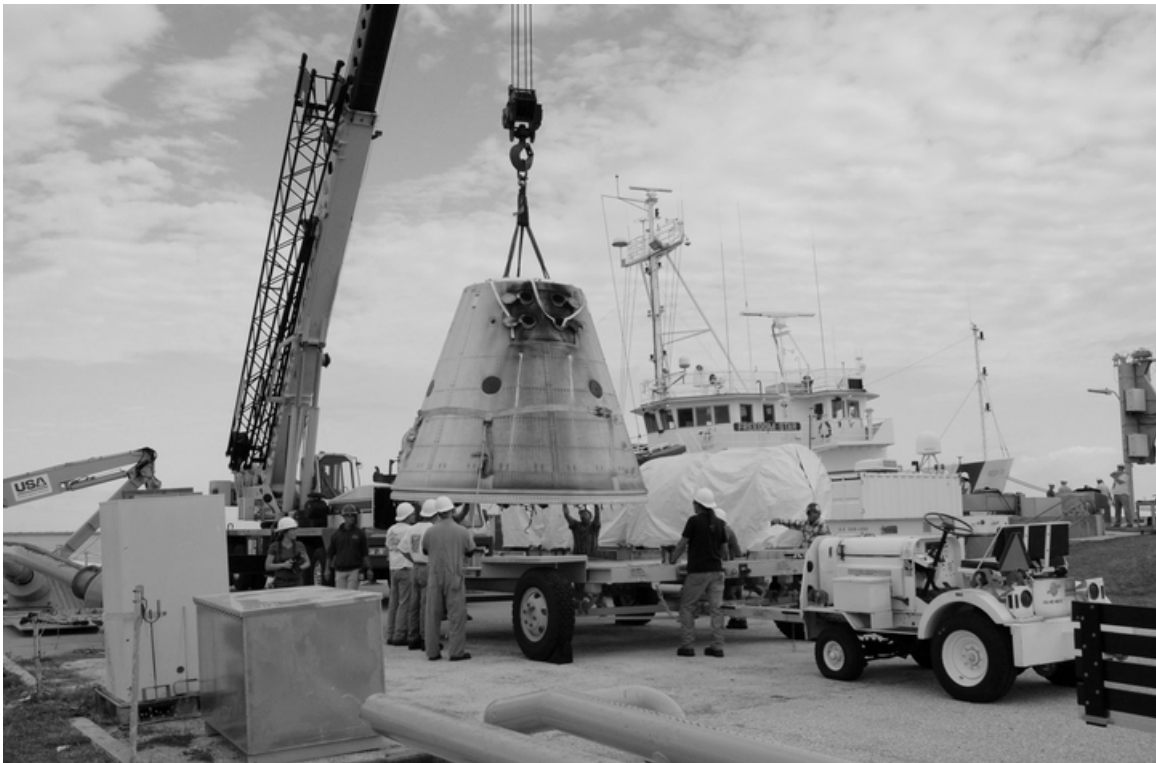
Figure No. E-36. The frustum of a SRB used during *Discovery's* launch on mission STS-119 is lifted onto a transporter at the Hangar AF dock, March 18, 2009.
Source: NASA Kennedy Space Center, KSC-2009-2140, accessed at <http://mediaarchive.ksc.nasa.gov>.

parallel rail dolly trains. The frustum and parachutes were off-loaded from the ship deck (Figure No. E-36). A two-week open assessment period preceded the start of disassembly operations. During assessment, the SRBs were thoroughly inspected and checked to see if large pieces of TPS or other materials had come off that might have damaged the orbiter. The main parachutes were moved and transported to the Parachute Refurbishment Facility (PRF) at KSC for cleaning and refurbishment.

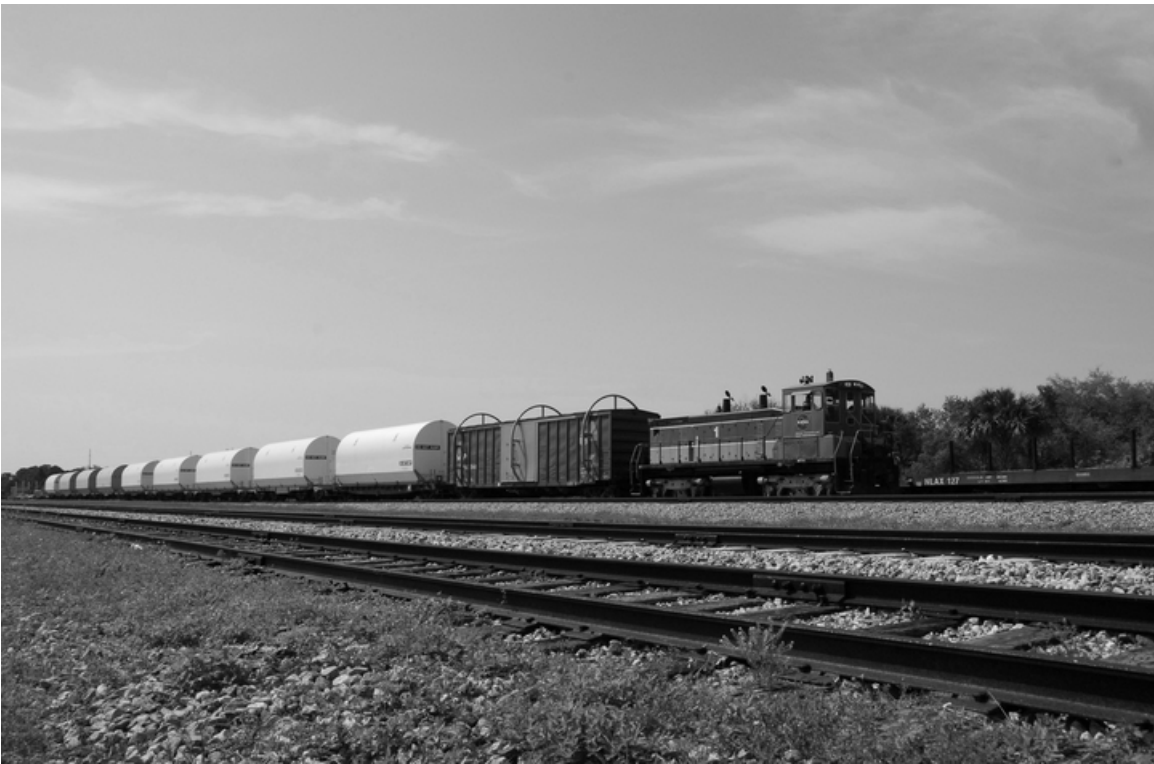
Figure No. E-38. Empty RSRM segments en route to Utah following STS-122, March 5, 2008.
Source: NASA Kennedy Space Center, KSC-08PD-0630, accessed at
<http://mediaarchive.ksc.nasa.gov>.

washed 6' back from both ends to prevent joint corrosion during shipment to Thiokol. Handling rings were installed to prepare the segments for transport to Utah. The segments were then moved from the rail dollies to trailers, and subsequently moved by trailer to the railhead where they were loaded onto special rail cars, covered, and prepared for overland travel back to Utah (Figure No. E-38).¹⁶⁹²

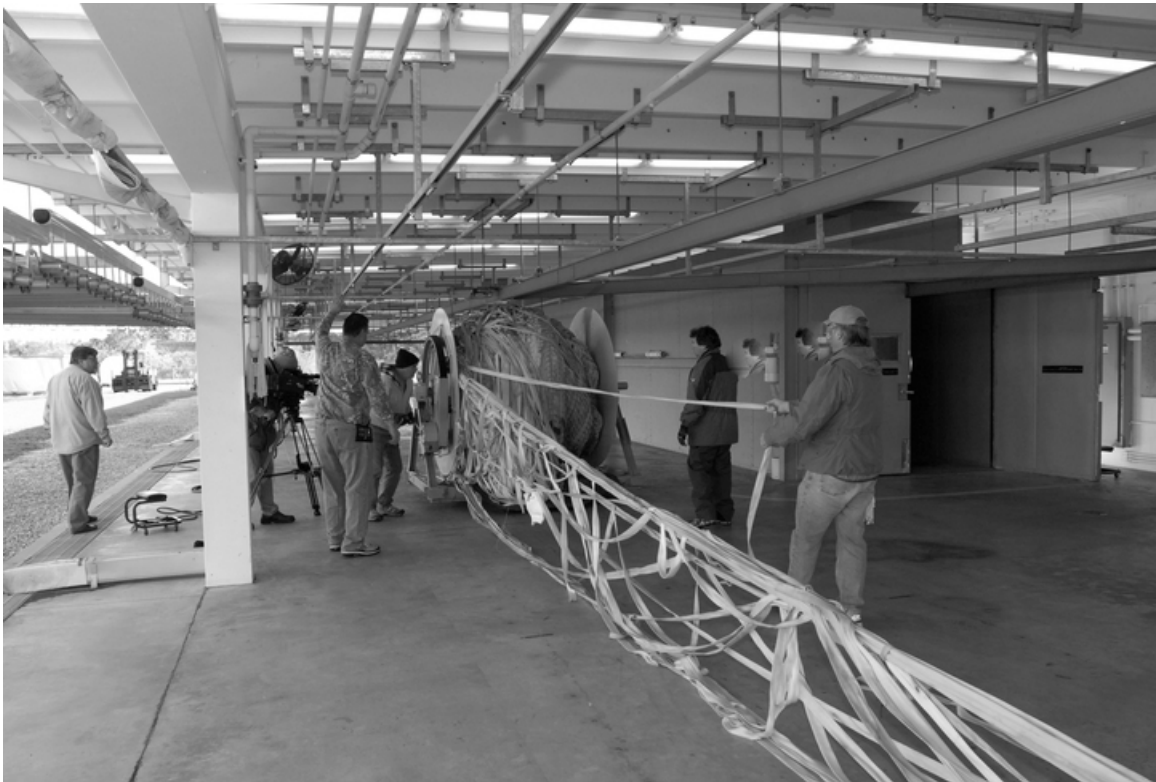
Figure No. E-42. Parachute from *Endeavour's* STS-126 mission is unreeled at the Parachute Refurbishment Facility, November 19, 2008.
Source: NASA Kennedy Space Center, KSC-08PD-3748, accessed at <http://mediaarchive.ksc.nasa.gov>.

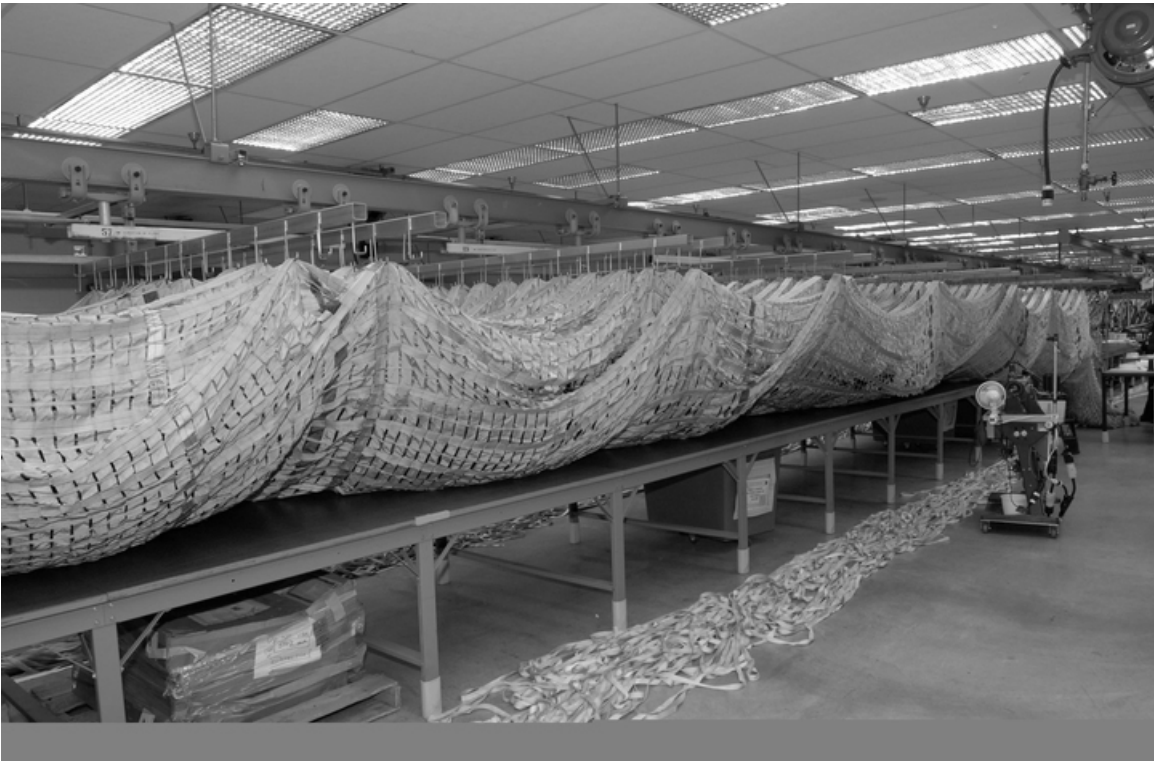
Figure No. E-44. Parachute from *Endeavour's* STS-126 mission is suspended from a hanging monorail system at the KSC Parachute Refurbishment Facility, November 19, 2008.
