(NASA-CR-135169) AEROSPIKE THRUST CHAMBER  
PROGRAM Final Report (Rocketdyne) 167 p HC  
A08/MF A01 CSCL 21H

AEROSPIKE THRUST CHAMBER PROGRAM  
FINAL REPORT

by J. Campbell, Jr. and S. M. Cobb

ROCKETDYNE DIVISION  
ROCKWELL INTERNATIONAL

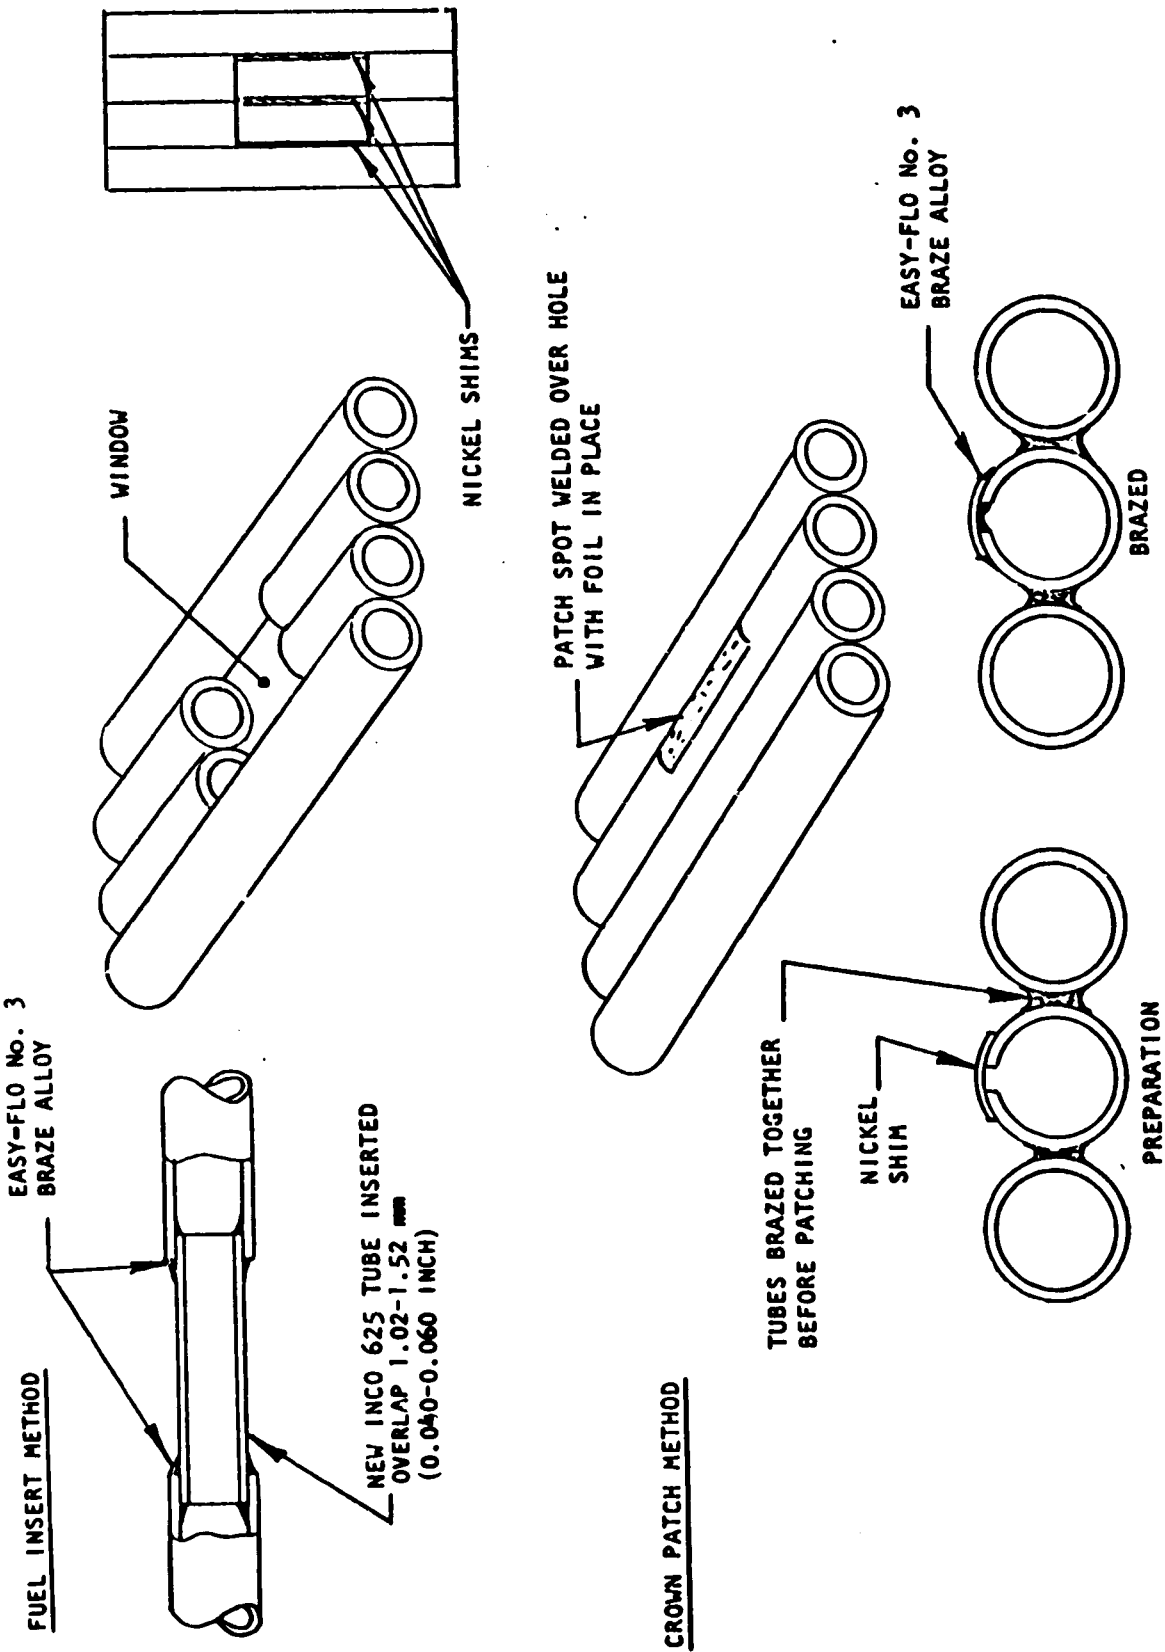
Figure 5. Tube Repair Methods

During the test stand fire which terminated the Air Force program, the nozzle had suffered localized overheating on its interior portions (i.e., the "cold" side), because it was sprayed with molten titanium from the burning inner combustor support ring. Repairs to this type of tubular nozzle had not previously been attempted on the scale represented in this instance. Because of a general need for developing the technology for repairing complex lightweight tubular nozzles, a company-sponsored technology program was undertaken which utilized the 111 kN (25K) aerospike nozzle for development purposes. Two basic methods of repair were developed, the saddle-patch repair and the inserted tube repair as defined in Fig. 5. When properly applied, these two methods sufficed to repair all of the damage that had been incurred by the 111 kN (25K) aerospike nozzle.

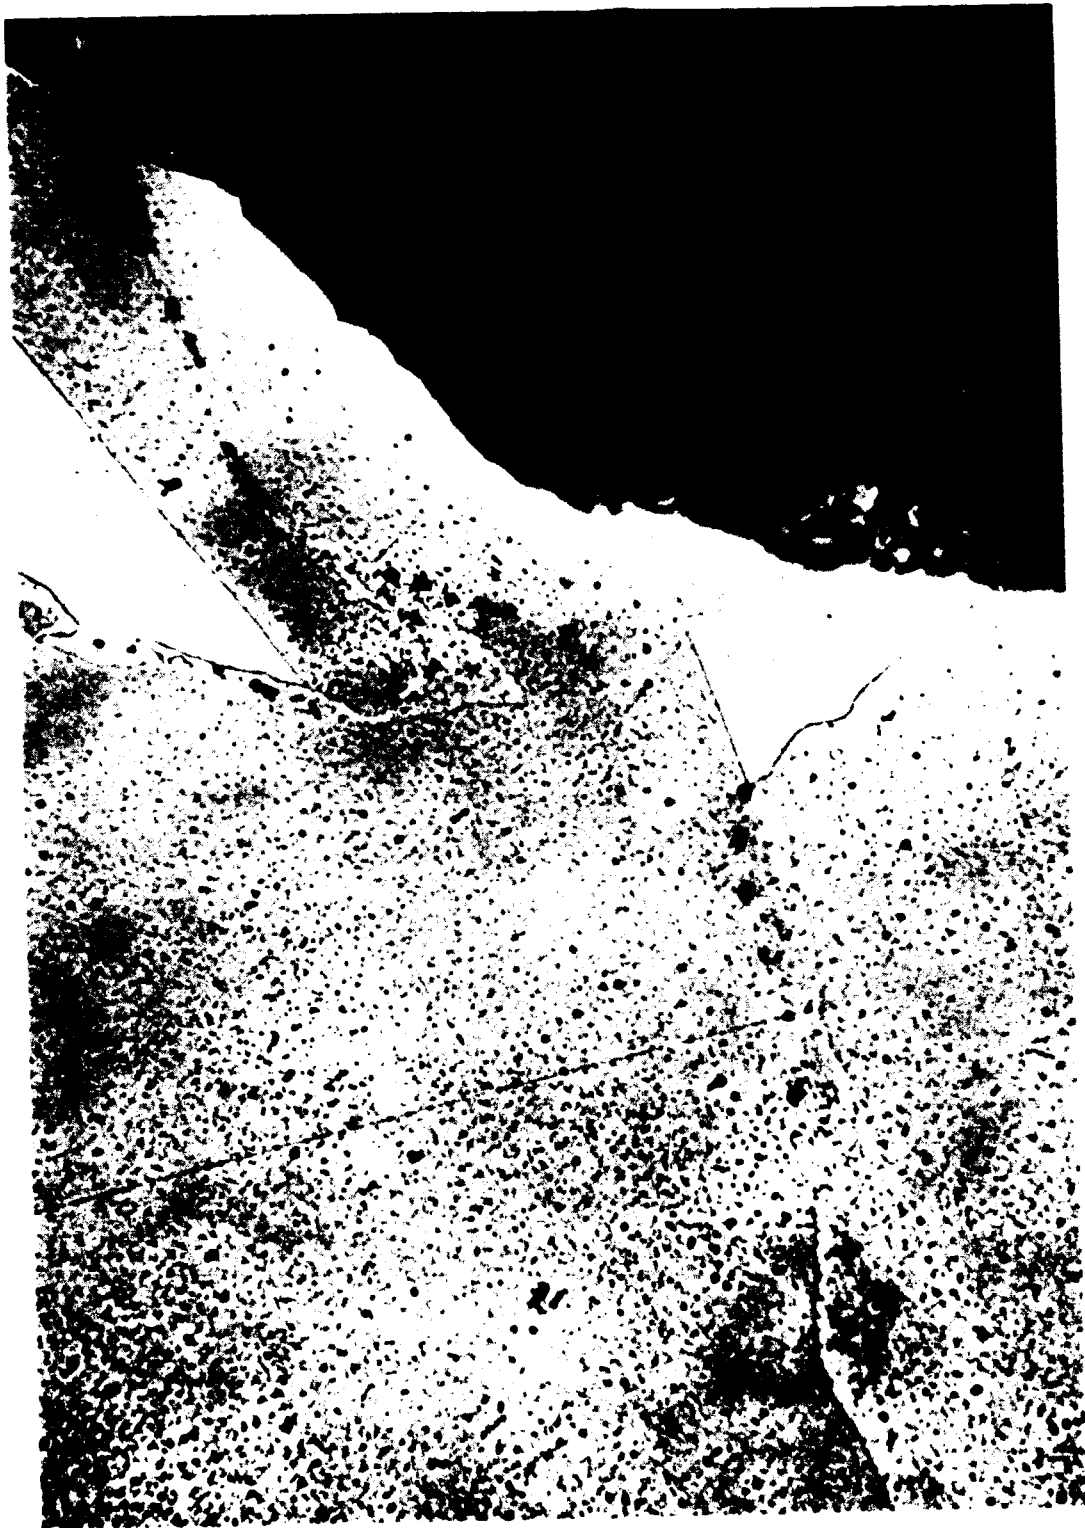
Figure 43. Section From Outer Half of Segment 516, Showing Slight  $O_2-H_2$  Reaction (Blowup of Fig. 42) (400X)

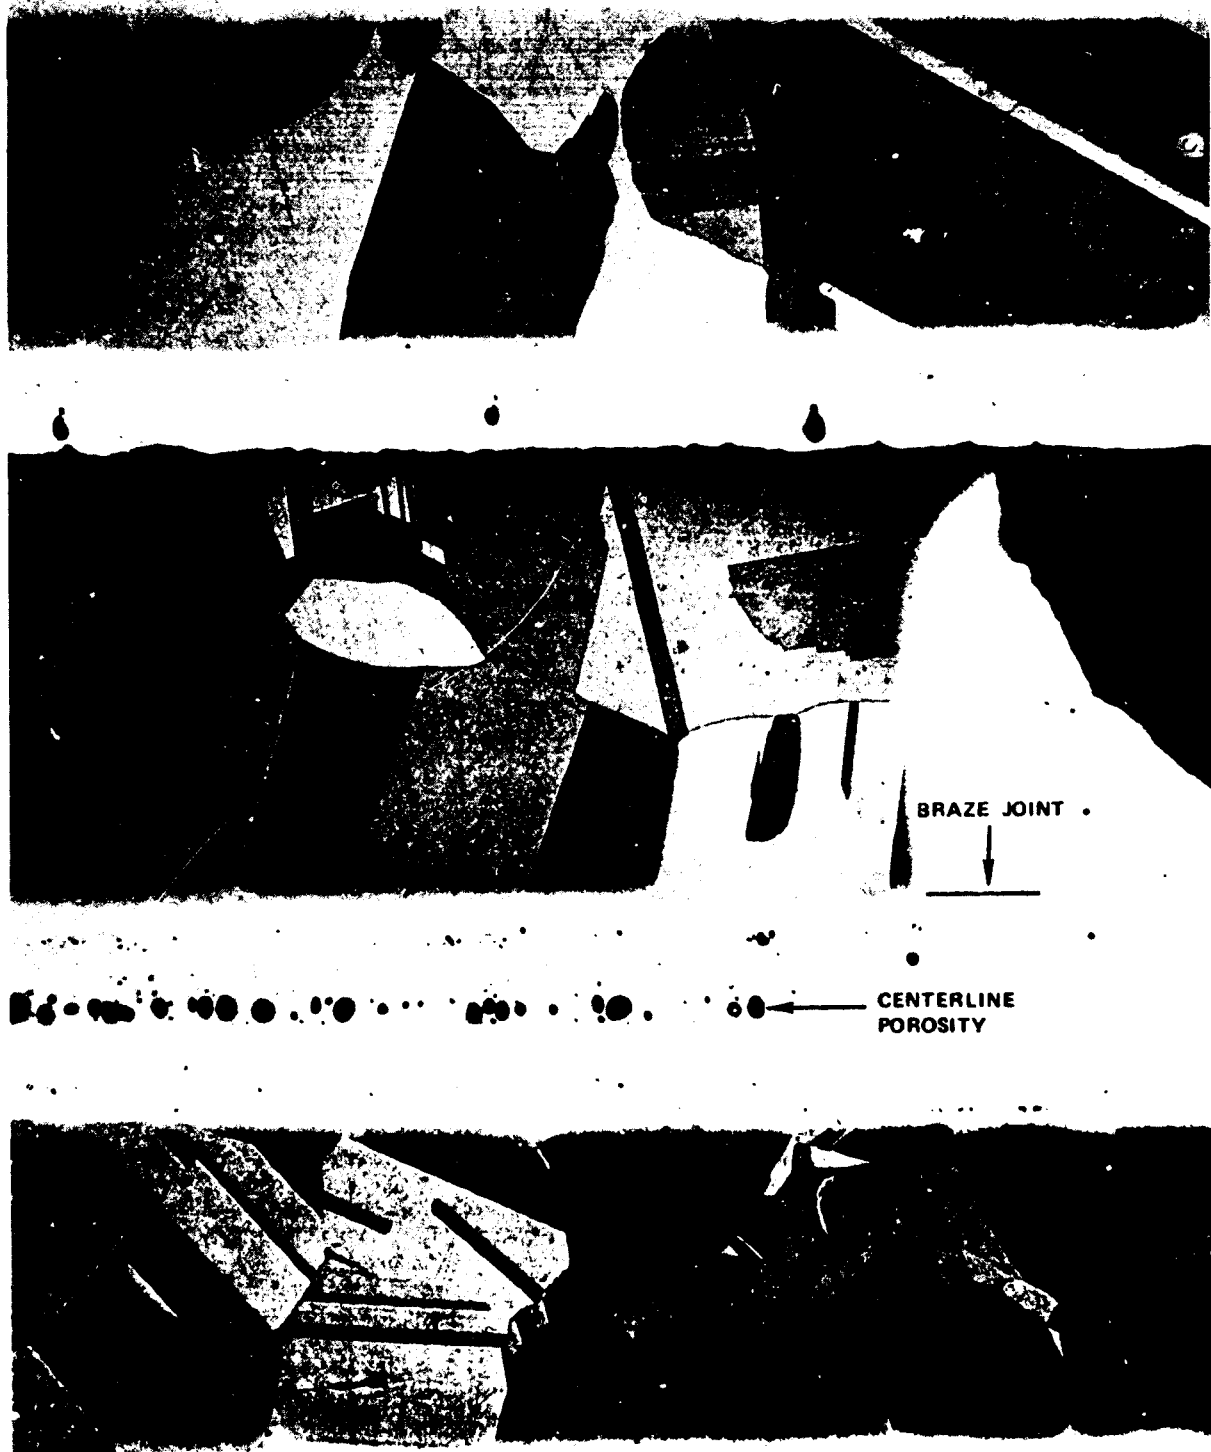
Figure 44. Test Specimen From NARloy-A Cover Sheet, Furnaced Brazed in Argon (No  $O_2-H_2$  Reaction Present; Centerline Porosity in Braze Joint) (.100X)

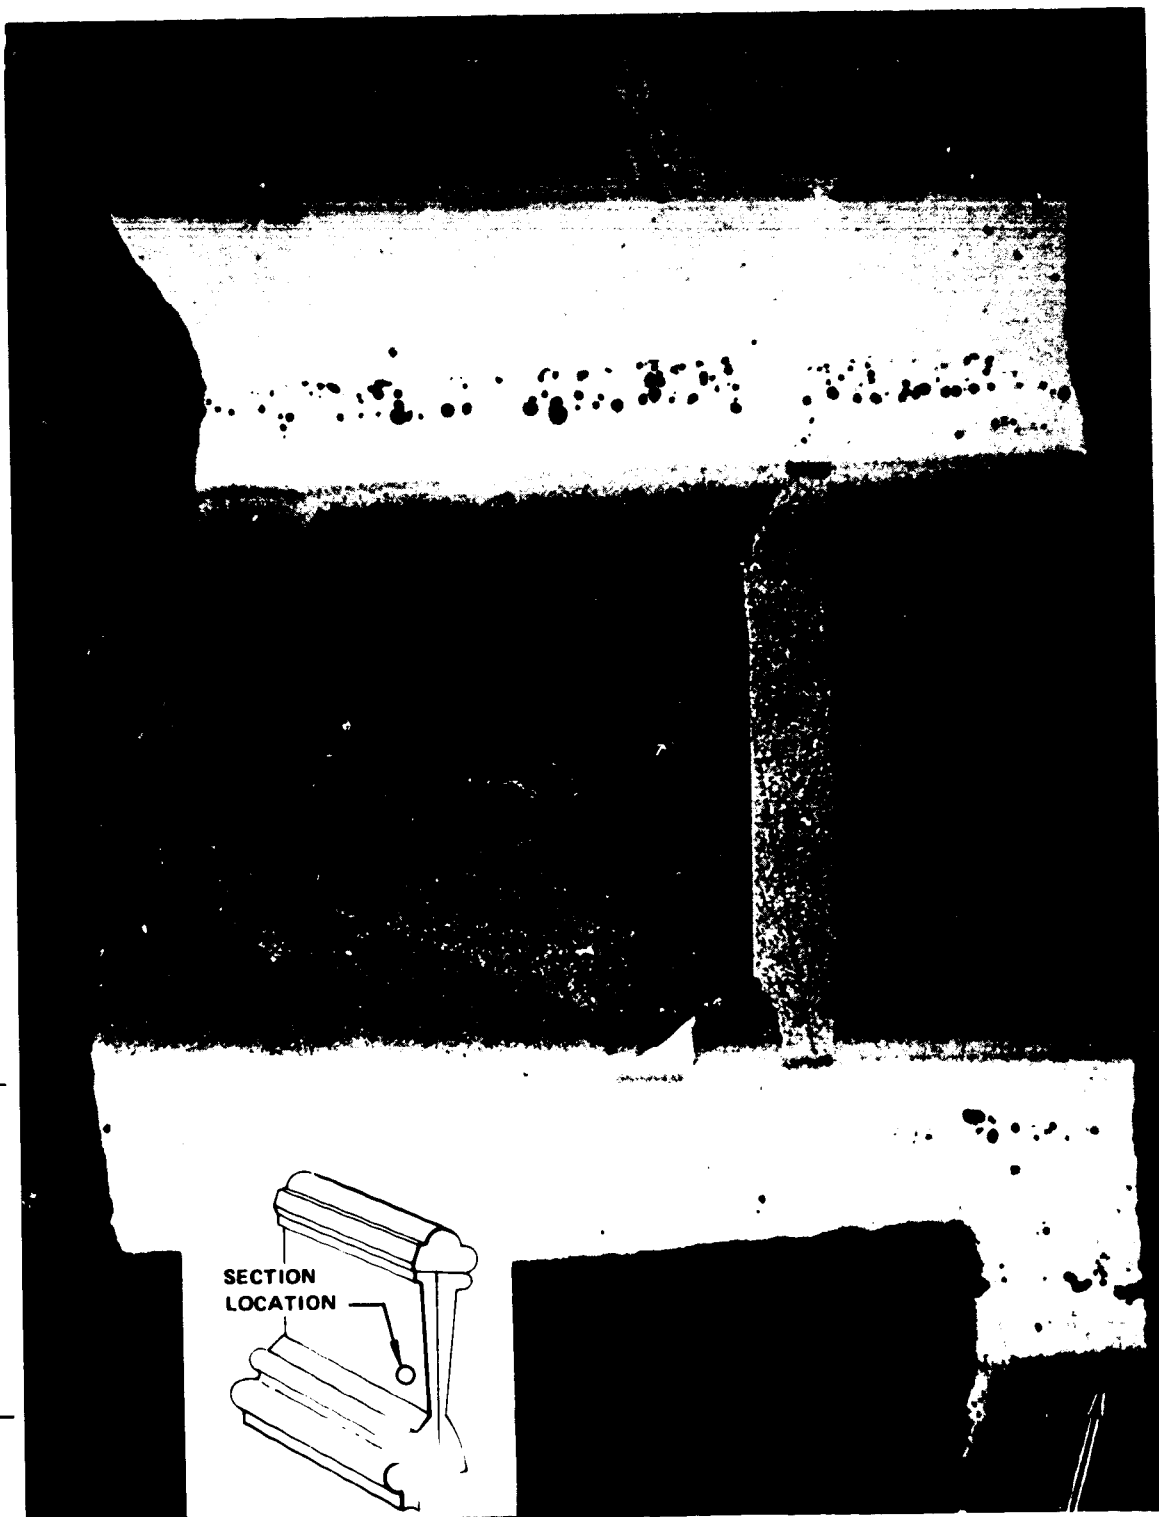
Figure 45. Section From Inner Half of Segment 510  
(No  $O_2-H_2$  Reaction Present) (100X)

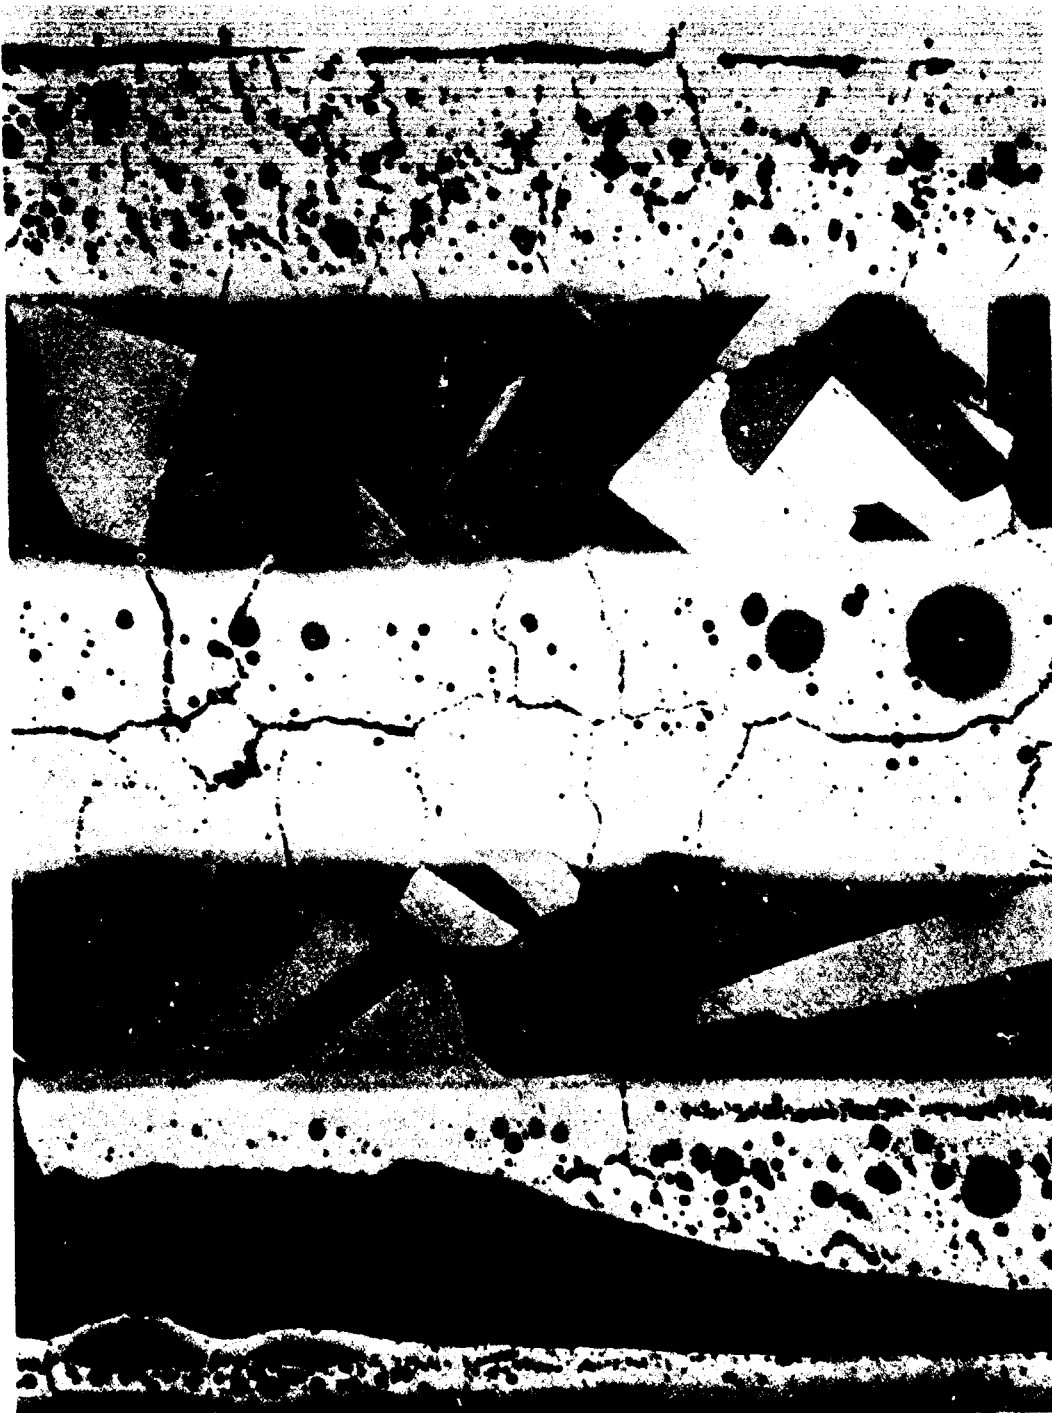
Experiments were then run to demonstrate that oxygen diffusion from an oxide-coated surface can occur in normal furnace operations. Figures 47 and 48 show the results. The section in Fig. 47 and 48 was taken from a specimen which was furnace brazed in argon for 30 minutes at 910 C (1670 F) and then held in argon for two hours at 871 C (1600 F). It was removed from the furnace and the surfaces were oxidized by heating in air with an oxyacetylene torch until the surfaces were black and slightly scaled. The specimen was then returned to the furnace, and held at 871 C (1600 F) in argon for 120 minutes followed by 30 minutes in hydrogen at 871 C (1600 F). The long hold time in argon approximated the multiple furnace cycles on combustors which were furnace repaired several times. Severe

Figure 47. Test Specimen From NARloy-A Cover Sheet, Furnace Brazed in Argon, Surface Oxidized With Torch, Reheated in Argon Furnace to 871 C (1600 F), Then H<sub>2</sub> at 871 C (1600 F) (Shows Severe O<sub>2</sub>-H<sub>2</sub> Reaction) (100X)

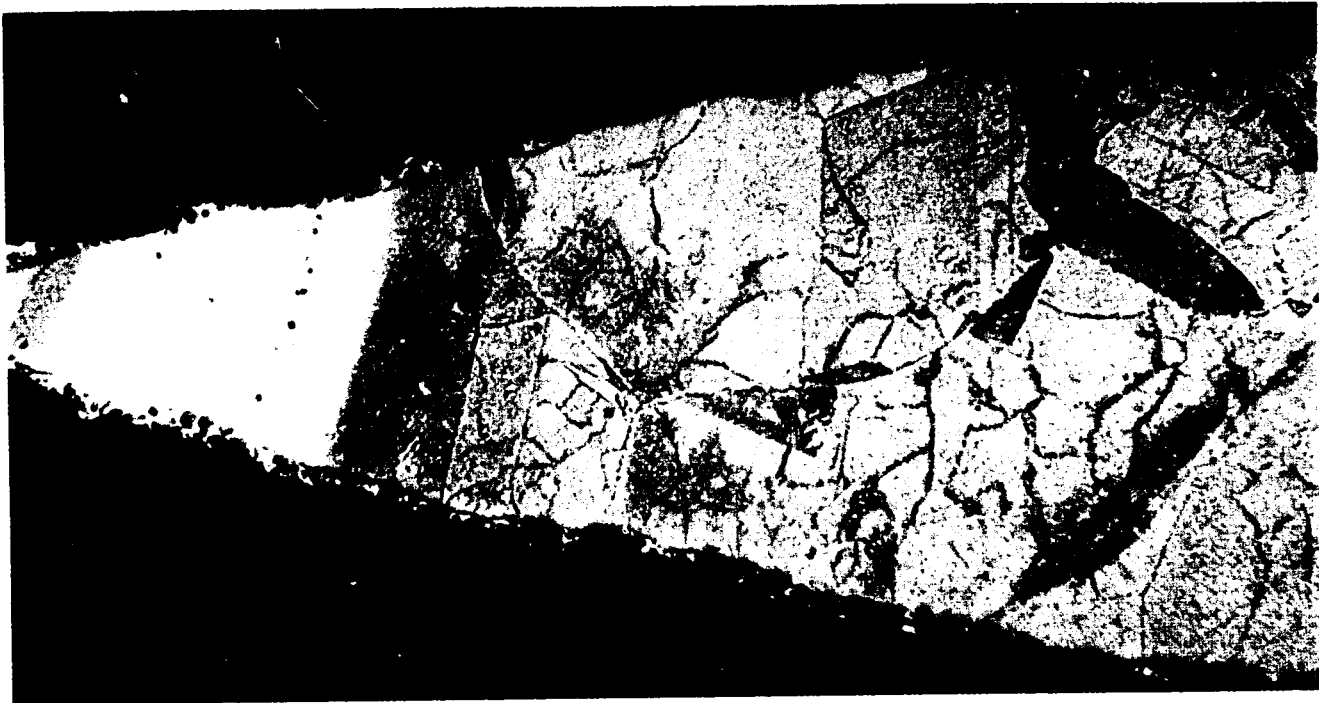
Figure 57. Section From Outer Half of Segment 522 [No  $O_2-H_2$  Reaction Present; Same Location on Combustor as Fig. 42 (100X). The Large Section to the Right of the Braze Joint is From the Liner Land.]

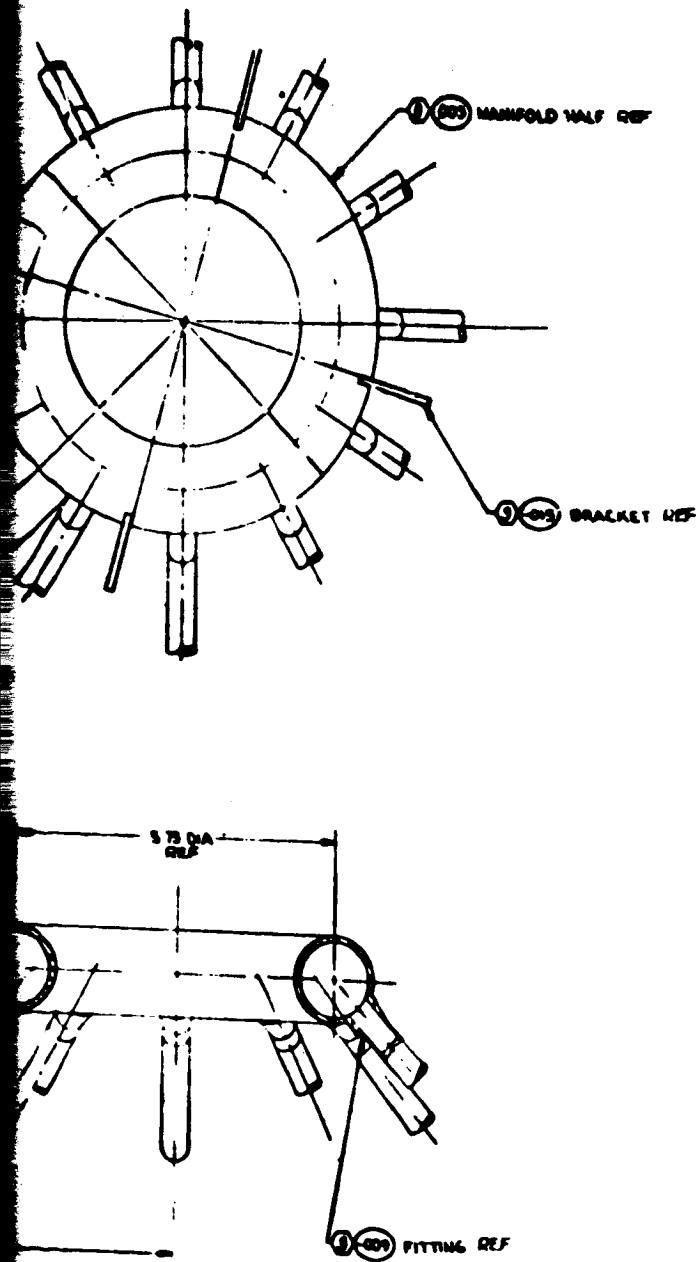
Figure 72. Oxidizer Manifold Inlet Assembly

The major interconnect components, i.e., fuel and oxygen distribution manifolds, are illustrated in Fig. 27. These parts were severely damaged during the fire and required substantial replacement. Additionally, a design modification was made to provide better access than previously existed for completion of the assembly welds, there being a substantial probability that it was one of the assembly welds whose failure triggered the test stand fire incident of 19 November 1975. The redesign of the fuel and oxidizer interconnecting components was completed and drawings RS005835X and RS005836X, presented here as Fig. 72 and 73, were released to support fabrication and assembly effort. The usable portions of the previous manifolding were cleaned and refurbished and necessary replacement parts identified. Fabrication of new parts was never initiated.
