CRITICAL ITEMS LIST (CIL)

No. 10-02-01-27R/02

SYSTEM:	Space Shuttle RSRM 10	CRITICALITY CATEGORY:	1
SUBSYSTEM:	Nozzle Subsystem 10-02	PART NAME:	Throat Inlet-to-Fwd Exit Cone Joint, Sealing Compound (1)
ASSEMBLY:	Nozzle and Aft Exit Cone 10-02-01	PART NO.:	(See Section 6.0)
FMEA ITEM NO.:	10-02-01-27R Rev N	PHASE(S):	Boost (BT)
CIL REV NO.:	N (DCN-533)	QUANTITY:	(See Section 6.0)
DATE:	10 Apr 2002	EFFECTIVITY:	(See Table 101-6)
SUPERSEDES PAGE:	334-1ff.	HAZARD REF.:	BN-03
DATED:	27 Jul 2001	DATE:	
CIL ANALYST:	B. A. Frandsen		
APPROVED BY:			
RELIABILITY ENGINEERING: <u>K. G. Sanofsky</u>		<u>10 Apr 2002</u>	
ENGINEERING: <u>B. H. Prescott</u>		<u>10 Apr 2002</u>

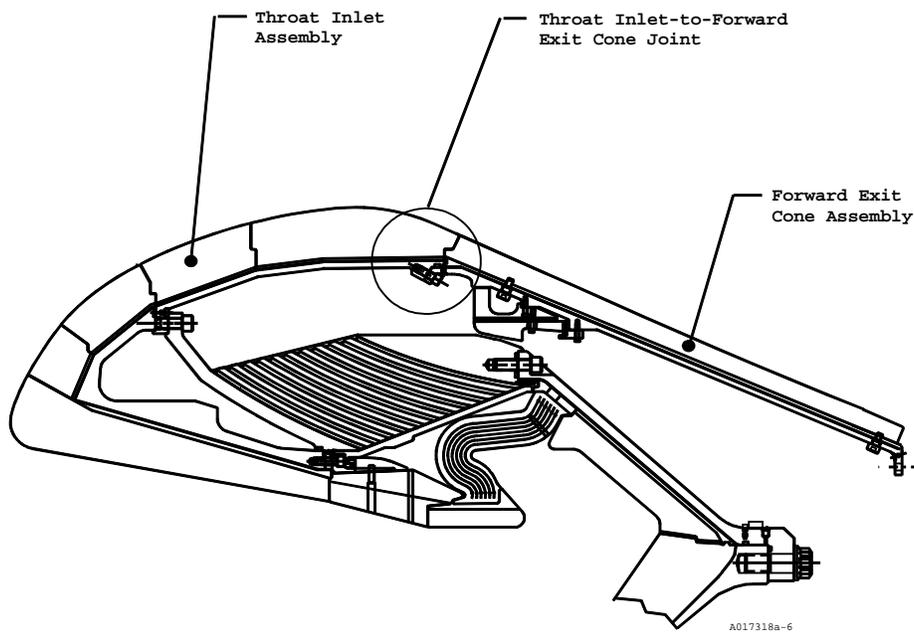
Figure 1. Throat Inlet-to-Forward Exit Cone Joint Location

1. Sealing compound provides thermal protection between two nozzle assembly items at their phenolic surface interface (Figures 1 and 2). A gap is provided between the two phenolic surfaces for the following reasons:
 - a. Allow for thermal expansion of the nozzle assembly parts during boost
 - b. Allow for positive and full surface mate-up while providing for surface contour tolerances
2. Sealing compound is pressure-back-filled into the gap between the two nozzle assembly items after the two items are bolted together and the leak test was successfully performed. The assembled joint is shown in Figures 1 and 2. Materials are listed in Table 1.

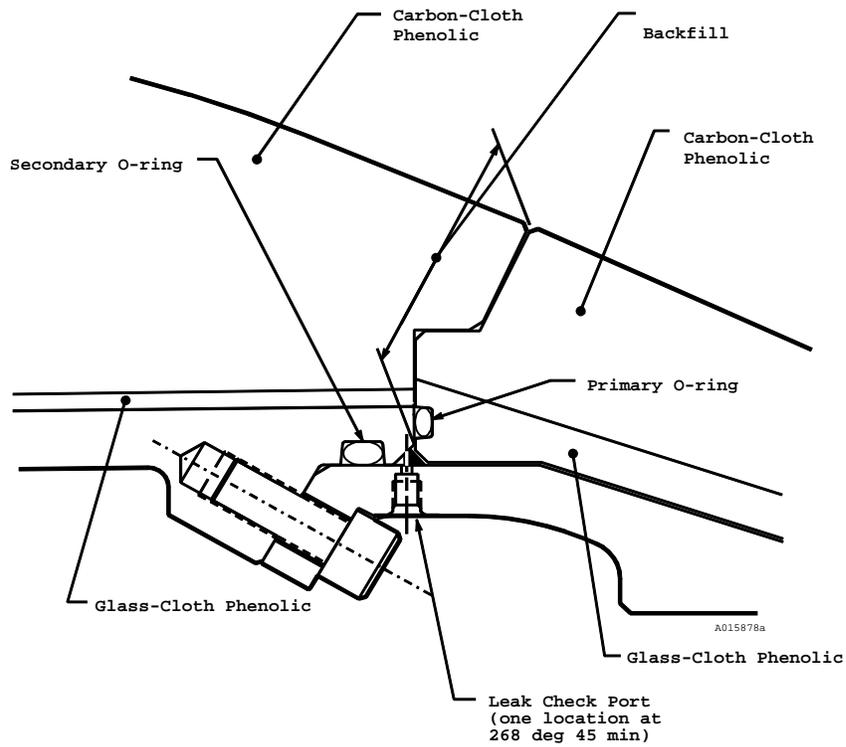
Figure 2. Throat Inlet-to-Forward Exit Cone Joint, Sealing Compound
