Atlantis STS-104

SSME Flight Readiness Review

June 28, 2001

SSME BLOCK II

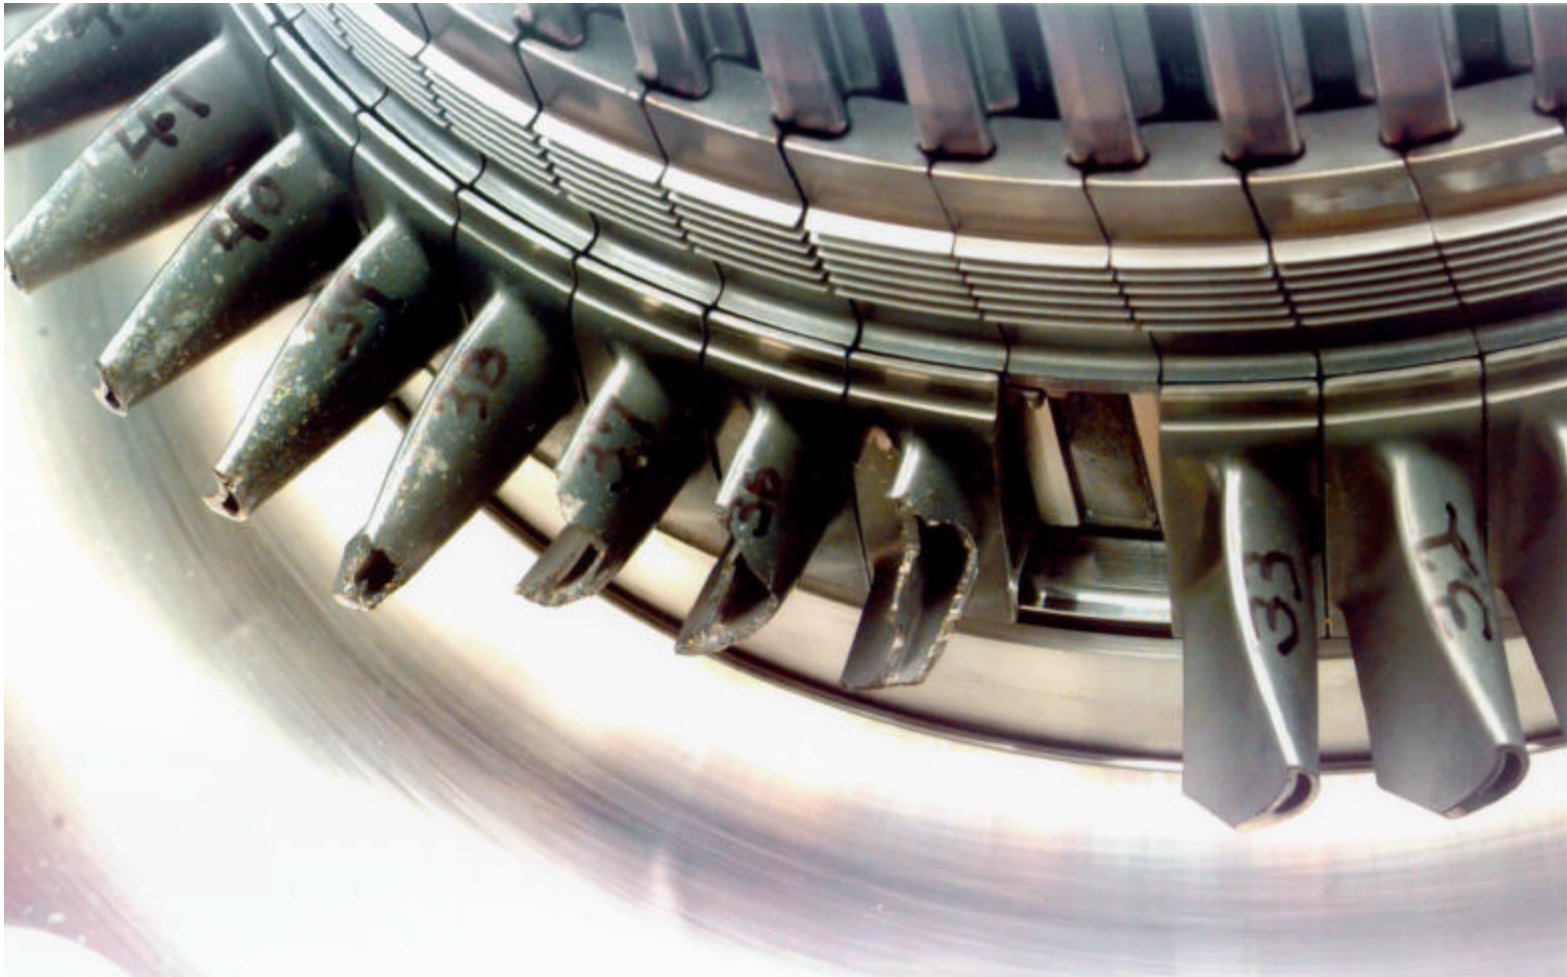
Blade Cracking Failure – 7/1/96

Damaged Turbine Blades (8-1a)

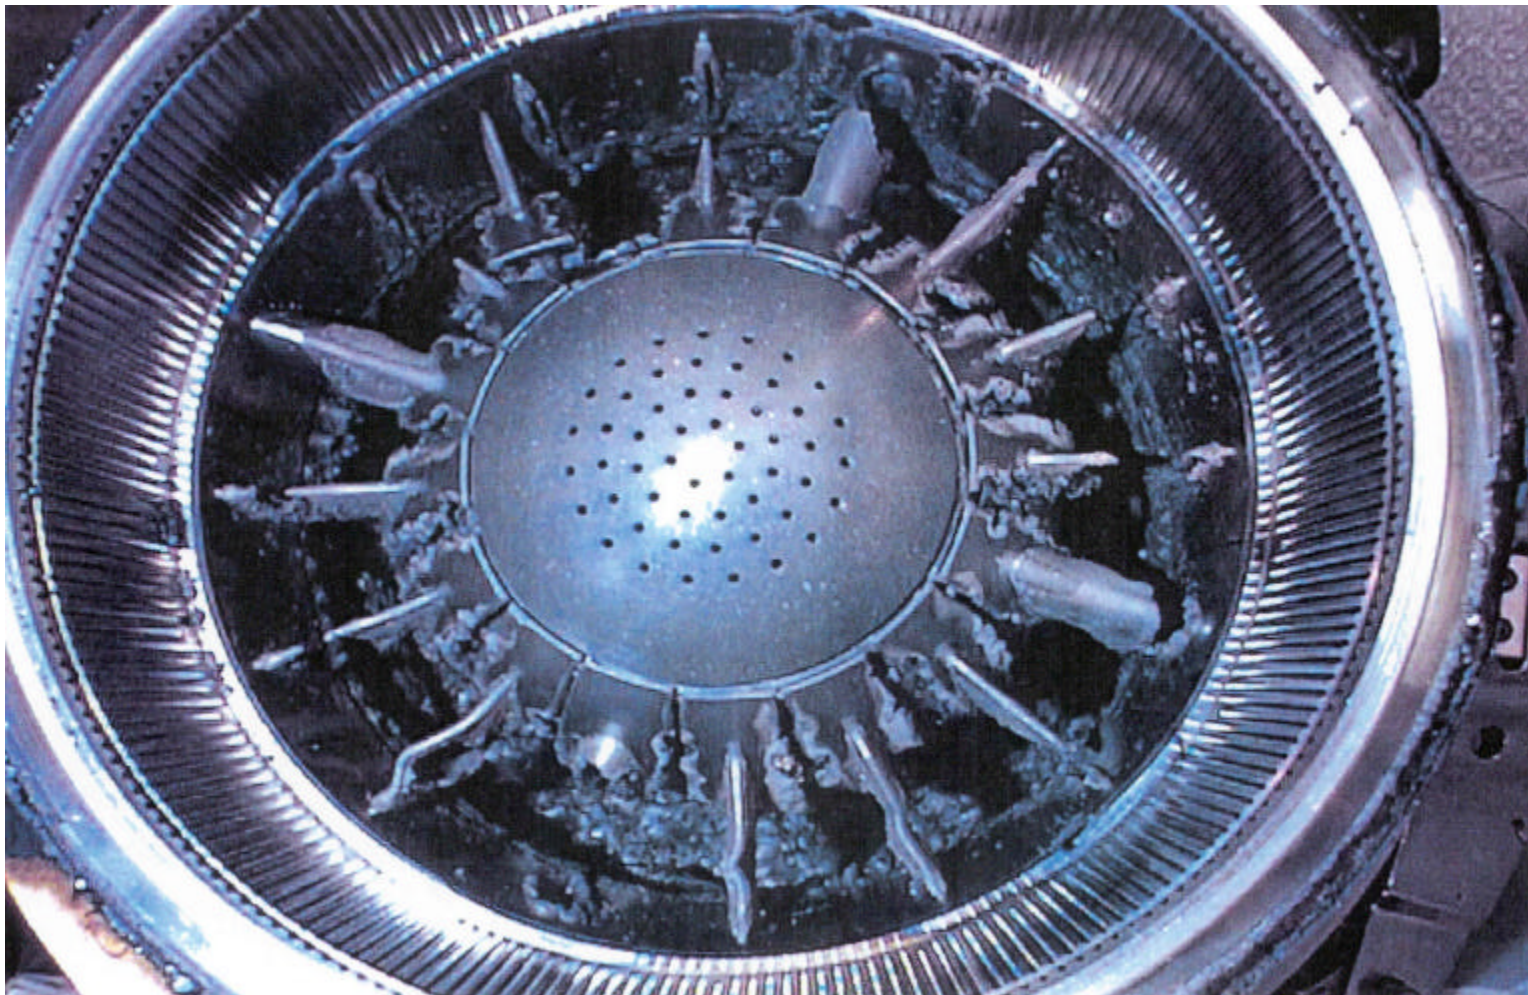
Nozzle Tube Rupture - 8/27/97

Damaged Turbine - SSME 0524

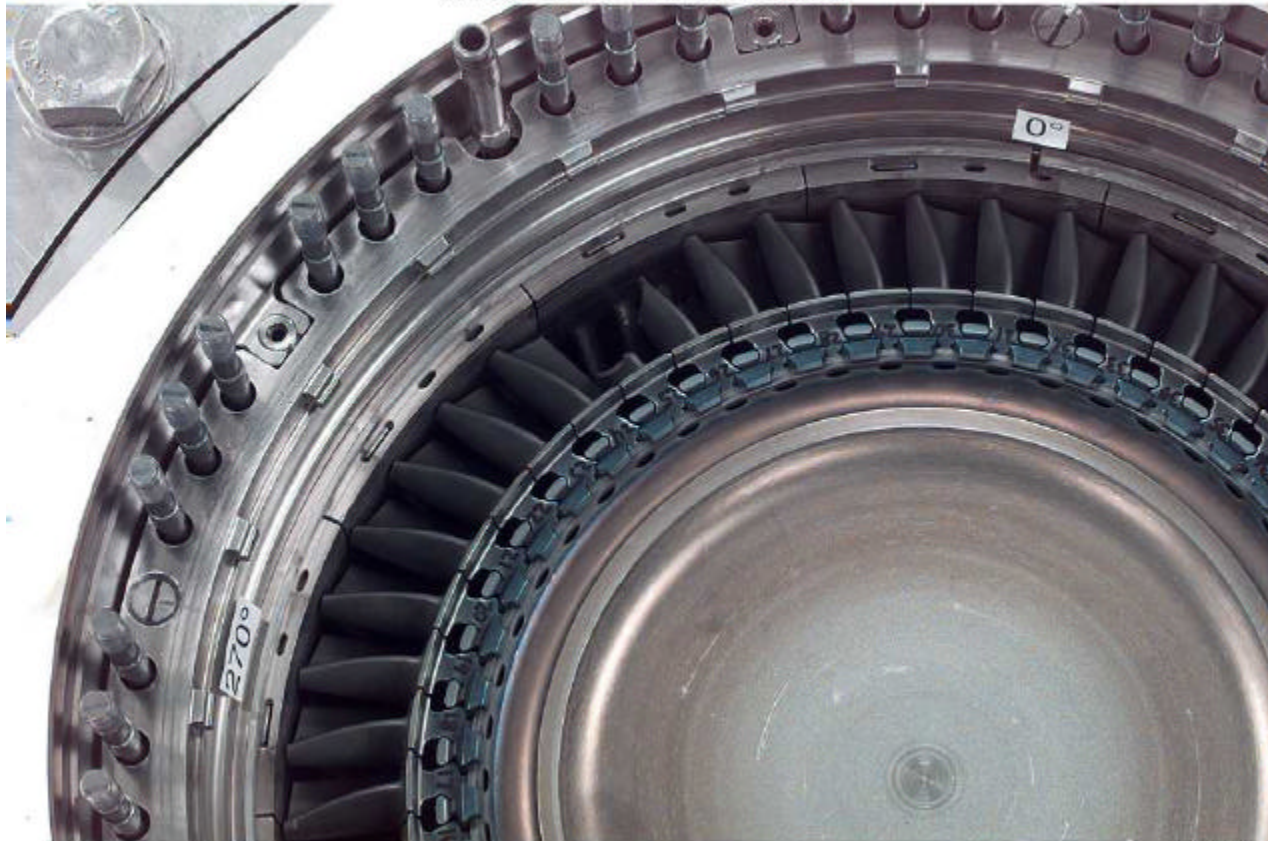
Turbine Vane Failure – 10/11/97

Damaged Turbine Blades (3-4b)

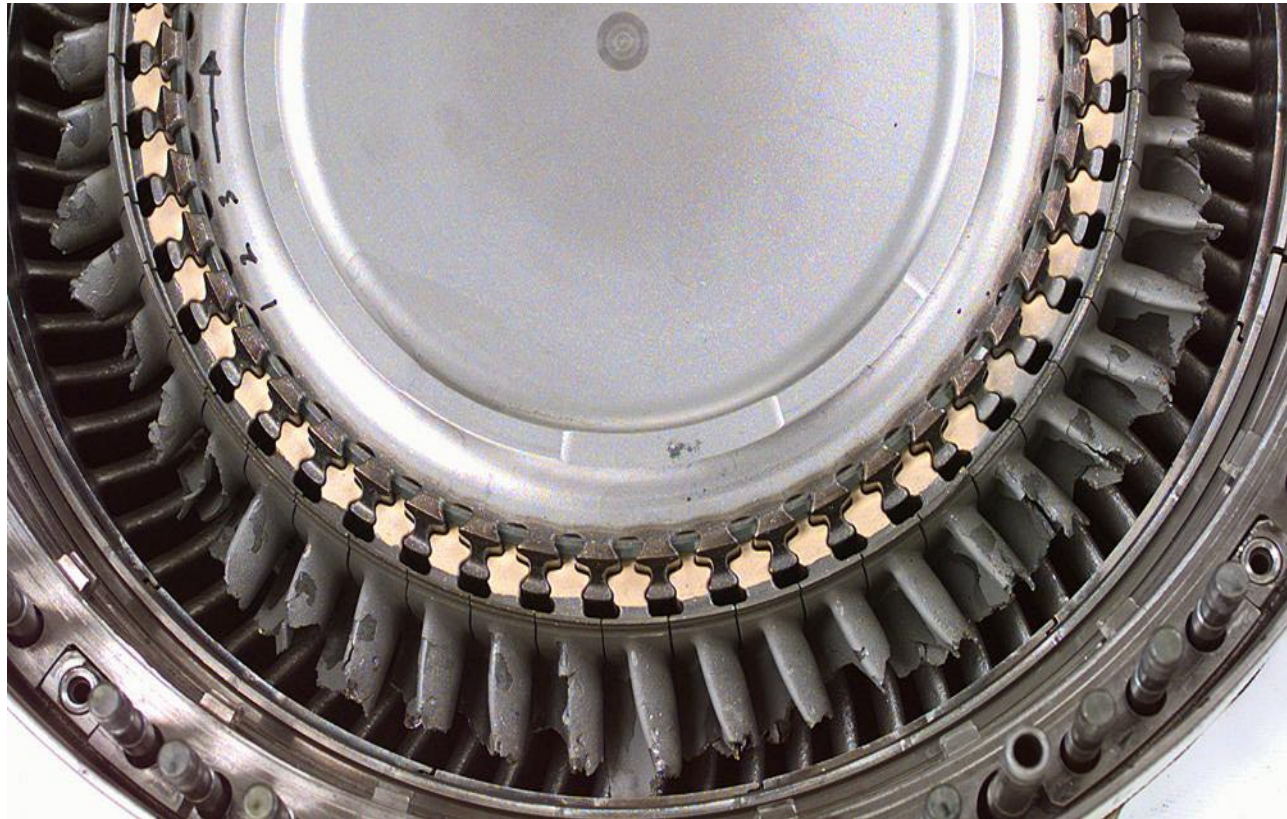
Foreign Object Obstruction in Fuel Preburner - 6/16/00

Damaged Turbine - SSME 0523

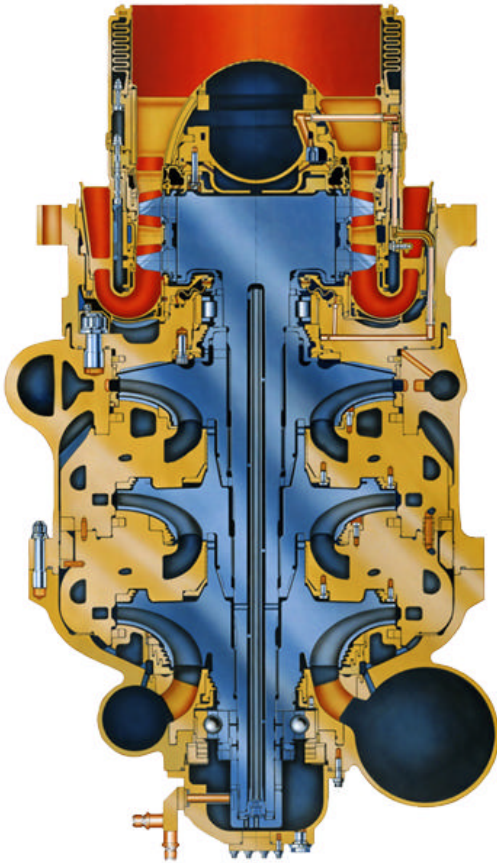
- Extensive use of precision investment castings
 - Elimination of welds and sheet metal flowpath shielding
- Cast INCO 718 Pump Inlet Housing
 - 2X margin on surge / burst failure mode
- Robust bearings
- Stiff rotor and rotor support system
 - Very low synchronous vibration levels
 - Tolerant to induced rotor damage / unbalance (FOD)
- Liquid Air Insulation system common with LPFTP
 - Minimizes maintenance material requirements
- Post-flight bearing drying eliminated
 - No time constraint on general turbine drying
- No coolant liner pressure cavity
 - Eliminated one LCC, Redline and Redline Sensor

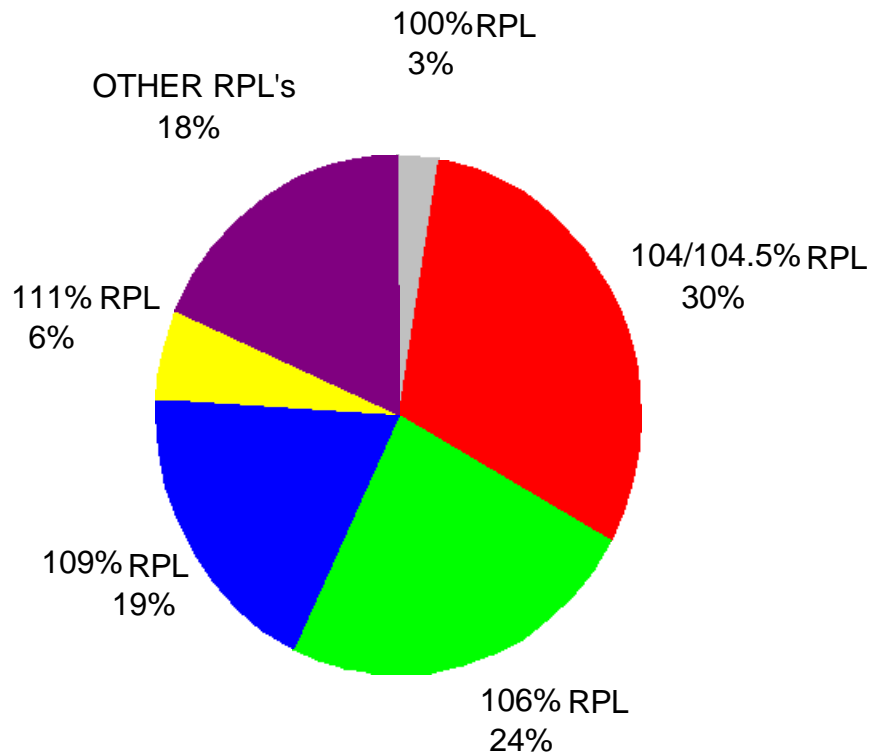
Block II HPFTP Development

(219 starts / 123,799 seconds)

- 49% of testing is above 104.5% RPL

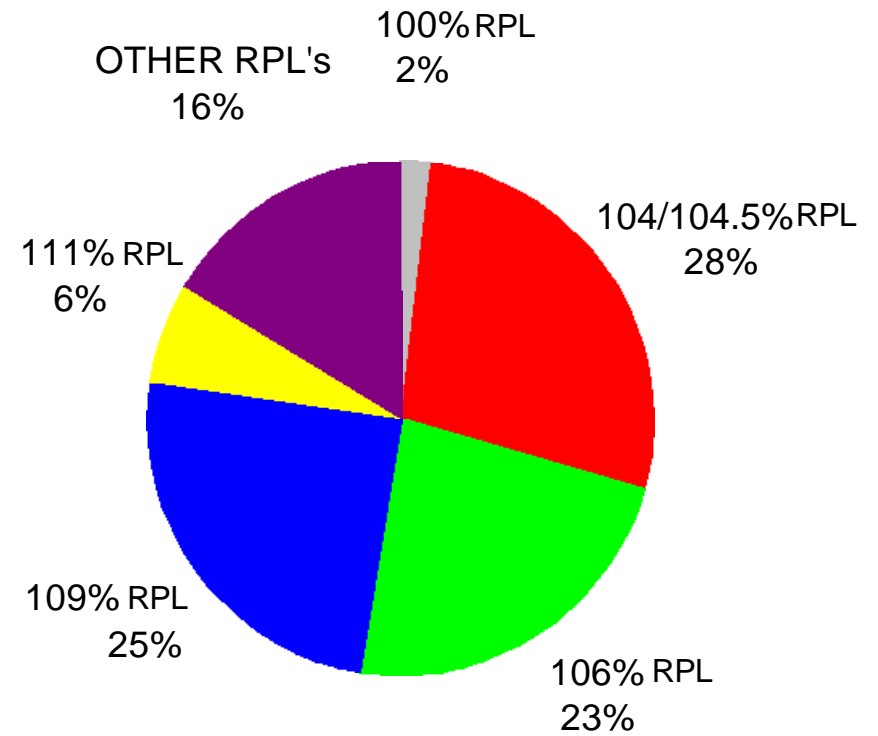
Block II HPFTP Certification

(44 starts / 24,494 seconds)

- 54% of testing is above 104.5% RPL

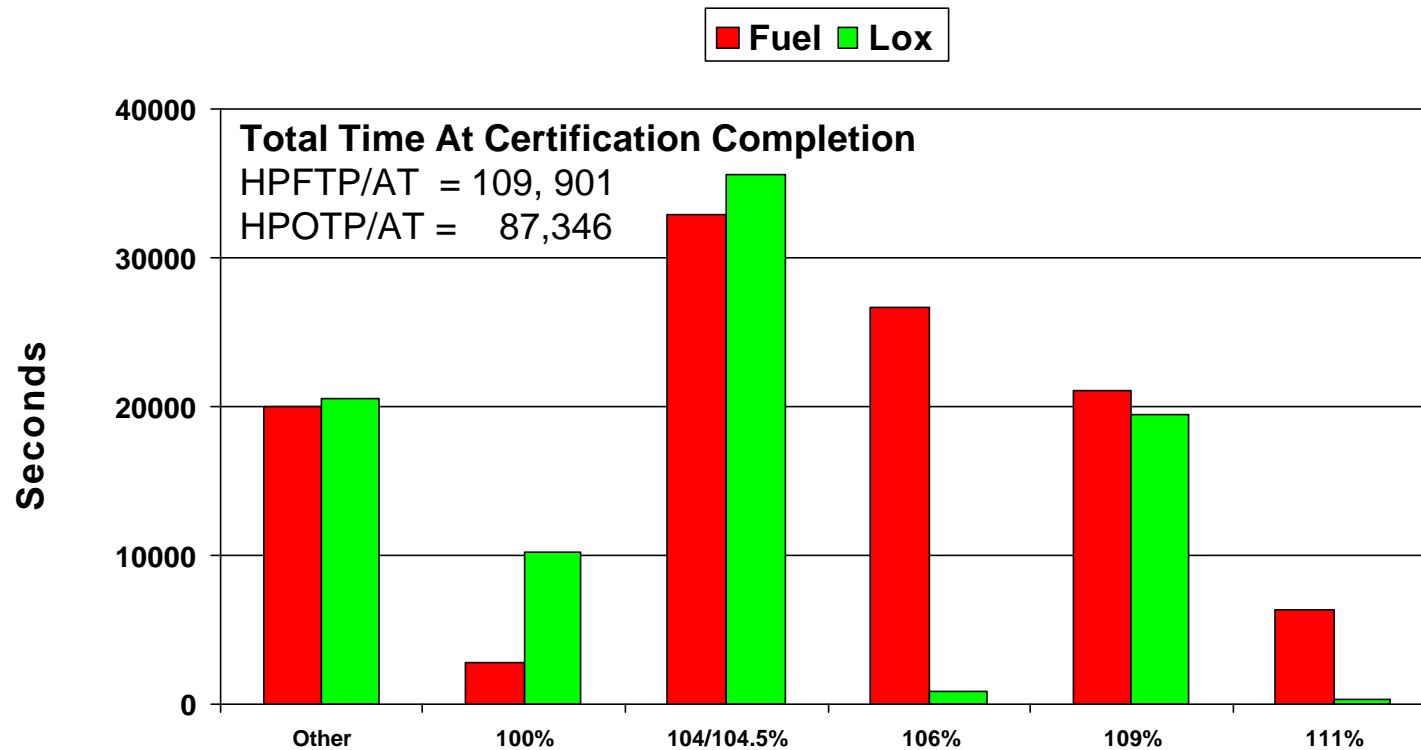
Block II HPFTP Tested At Flight / Margin Power

- At Cert completion, HPFTP/AT time at or above 104% RPL exceeds the HPOTP/AT by 54%

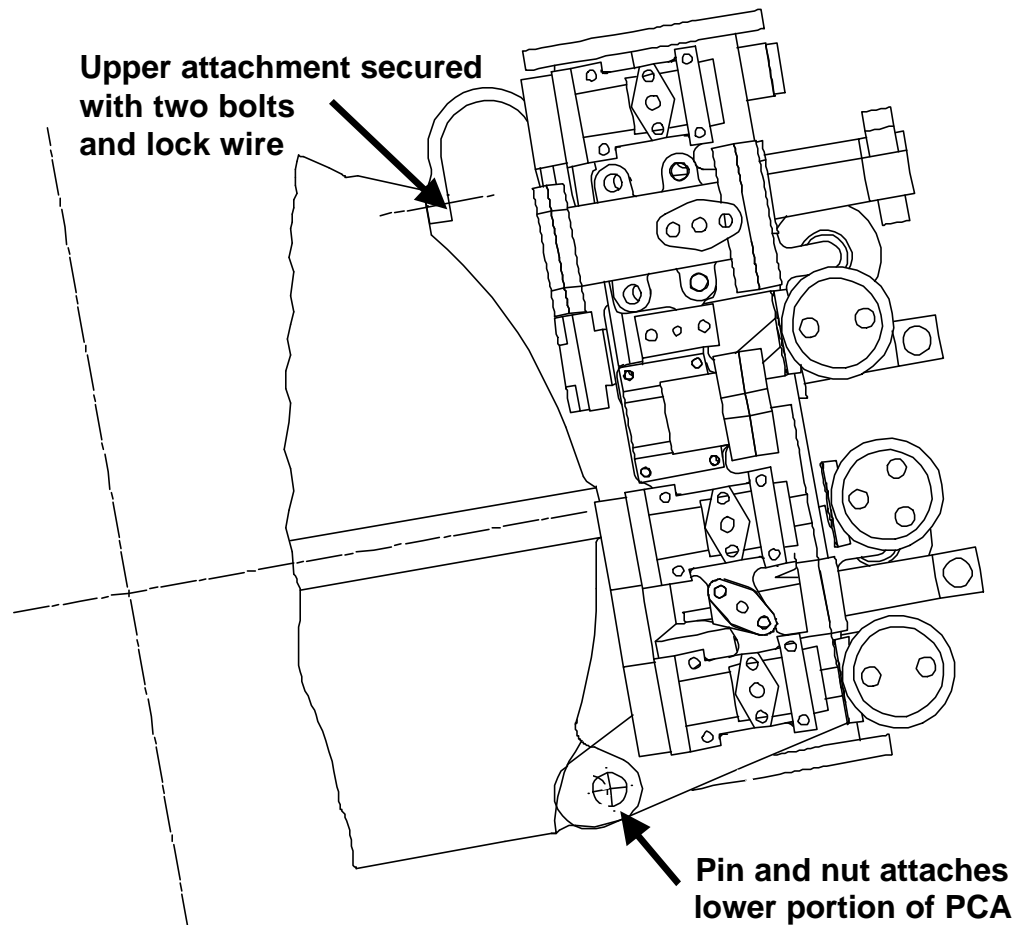
PCA / Powerhead Interface

- Aft end of PCA attached to powerhead by means of a clevis / pin assembly
 - Pin held in place with washer and self locking nut
- Upper end of PCA bolted in two places to Preburner
 - Torqued and secured with lock wire
- Following test 902-802, PCA aft attachment nut and washer found on test stand deck
 - PCA mounting pin remained in place
 - Test was eighth test (4559 total seconds) since installation of PCA
- No prior history of nut and/or pin loosening
 - Over 2870 starts and 942,000 seconds hot fire exposure

- **Rationale for Flight**
 - Torque and bottoming verified on all STS-104 PCA aft attachment nuts
 - No anomalies
 - Extensive successful SSME experience with no anomalies indicates an isolated occurrence

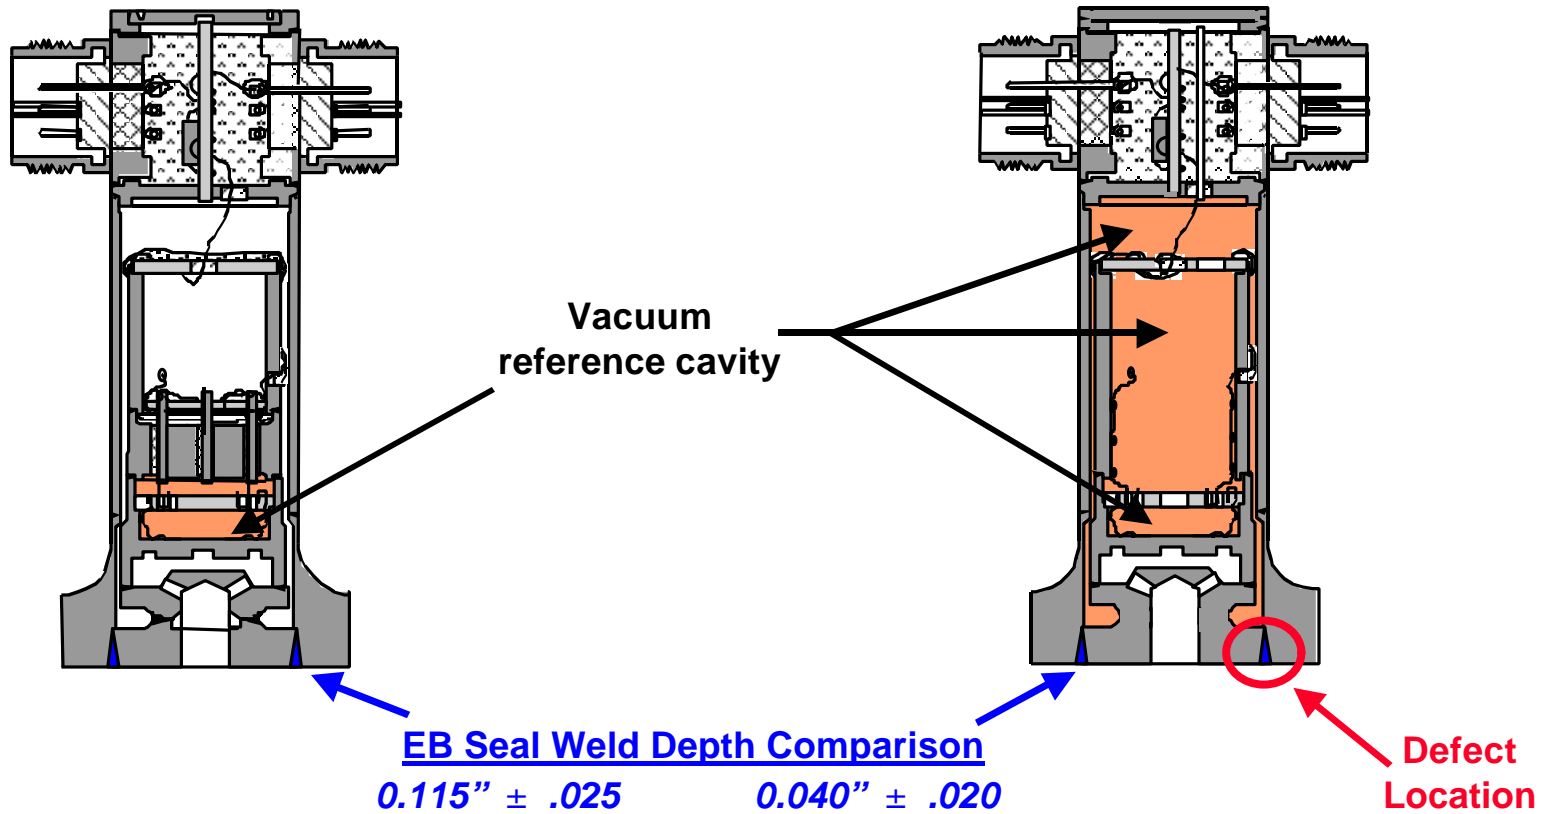
Configuration Comparison

Original -200 Configuration

-300 Series Configuration

- **Design**
 - Weld Penetration Deeper (.090" min vs. .020" min)
 - Normal aspect ratio for EB weld spike produces wider fusion zone
 - More tolerant to mistracking
- **Experience**
 - Extensive hot fire experience with no EB weld failures
 - 693 sensors: 17,017 starts / 7,106,000 seconds
 - Dye penetrant inspection of 24 sensors - no defects
- **Failure Effects are Benign**
 - Leak in seal weld does not result in loss of vacuum reference
 - Secondary header maintains vacuum
- **-200 Series Sensors Acceptable for Flight**

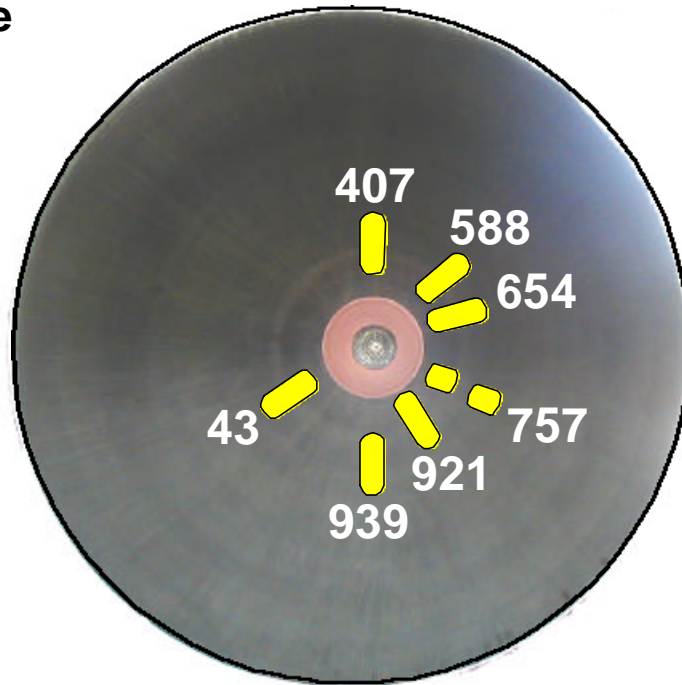
Nozzle Condition Post 902-795

- **Issue**
 - Nozzle tube hot-wall ruptures observed post test 902-795
- **Background**
 - Ruptures indicative of fuel system contamination
 - 8 total ruptures noted in 7 tubes
 - 17 prior occurrences of contamination related tube ruptures
 - Coolant flow blocked, tube overheats and ruptures
 - All Crit 3 failures with no additional engine damage
 - Test 902-795 completed planned 520 second duration
 - No other engine damage

- Coolant Tube Rupture

View from aft looking forward

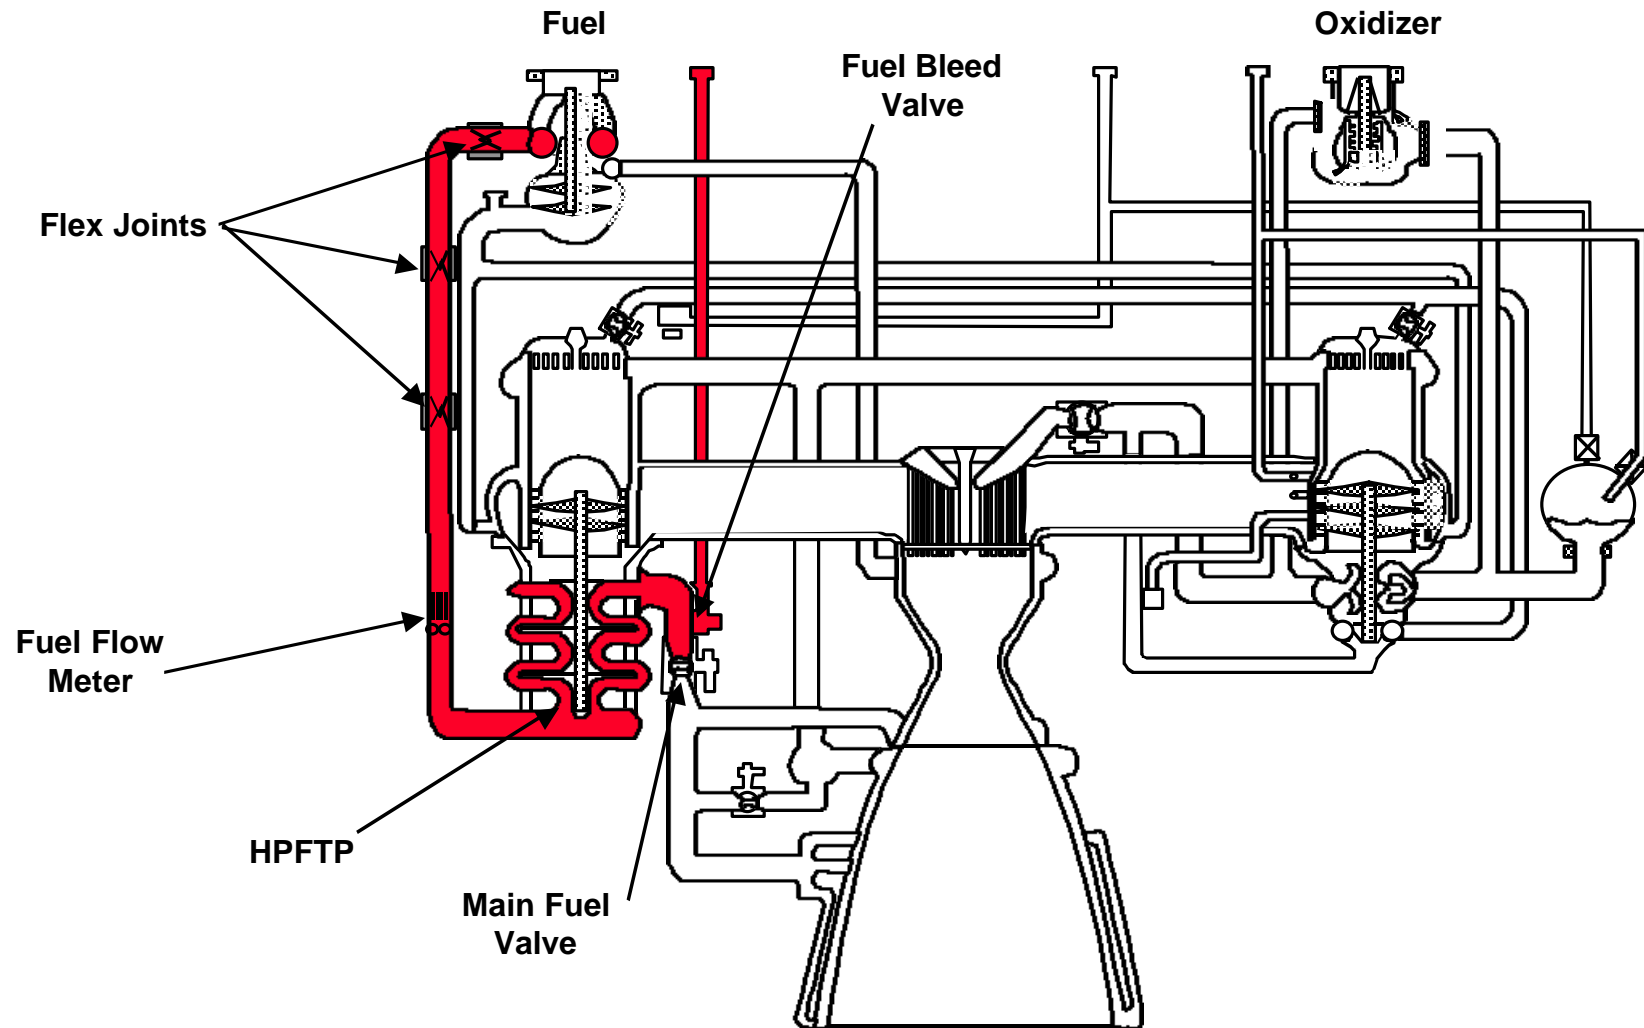
SSME Simplified Schematic

Fuel Side Flow System

- **Contamination observed in turbine and pump inlet and discharge of HPFTP 8018 post 902-794 (ruptures occurred during next test)**
 - Identified as Viton (O-ring material: 3/8" x 3/16" x 1/8" max size)
 - O-ring mold surfaces identified (0.210" cross-section dia.)
- **Subsequent disassembly of E0525 Main Fuel Valve also revealed Viton particles**
 - Dust and particles entrapped within deadheaded cavities
- **No Viton utilized in engine fuel system**
- **Viton O-Rings utilized in GSE (Canoga, SSC and Pratt & Whitney)**
 - Various leak test and flushing fixtures and tooling
- **Search for source ongoing**
 - Cryogenic fracture surfaces verified
- **Next test (902-796) conducted with no anomalies**
 - Additional single tube rupture occurred during test 902-802
 - Likely from residual entrapped contamination
